SAFETY RECOMMENDATION

Subject: ATR-72, registration marks TS-LBB. Accident occurred on 6 August 2005 offshore Palermo airport (Sicily - Italy).

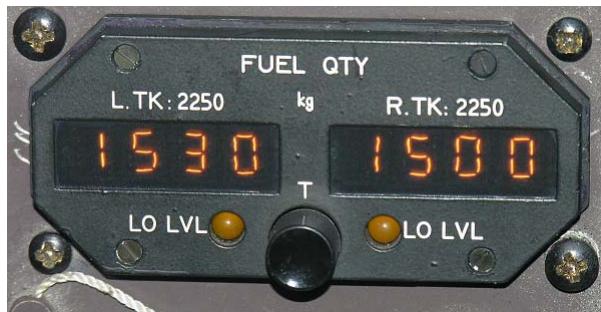
Fuel Quantity Indicator ATR-42

Nevertheless the FQIs for the ATR-72 and ATR-42 have the same dimensions and installation interface; this means that an FQI for the ATR-42 could erroneously be installed on a ATR-72 model and viceversa. The only visible difference between the two FQIs is the indication in small white digits of the maximum fuel quantity per tank, which is “2500” for the ATR-72 and “2250” for the ATR-42.

- should require an ATR-72 and ATR-42 fleet inspection in order to verify the installation of the applicable Fuel Quantity Indicator.

- should consider the possibility to mandate a modification of the Fuel Quantity Indicator installation in order to prevent any incorrect fitting.

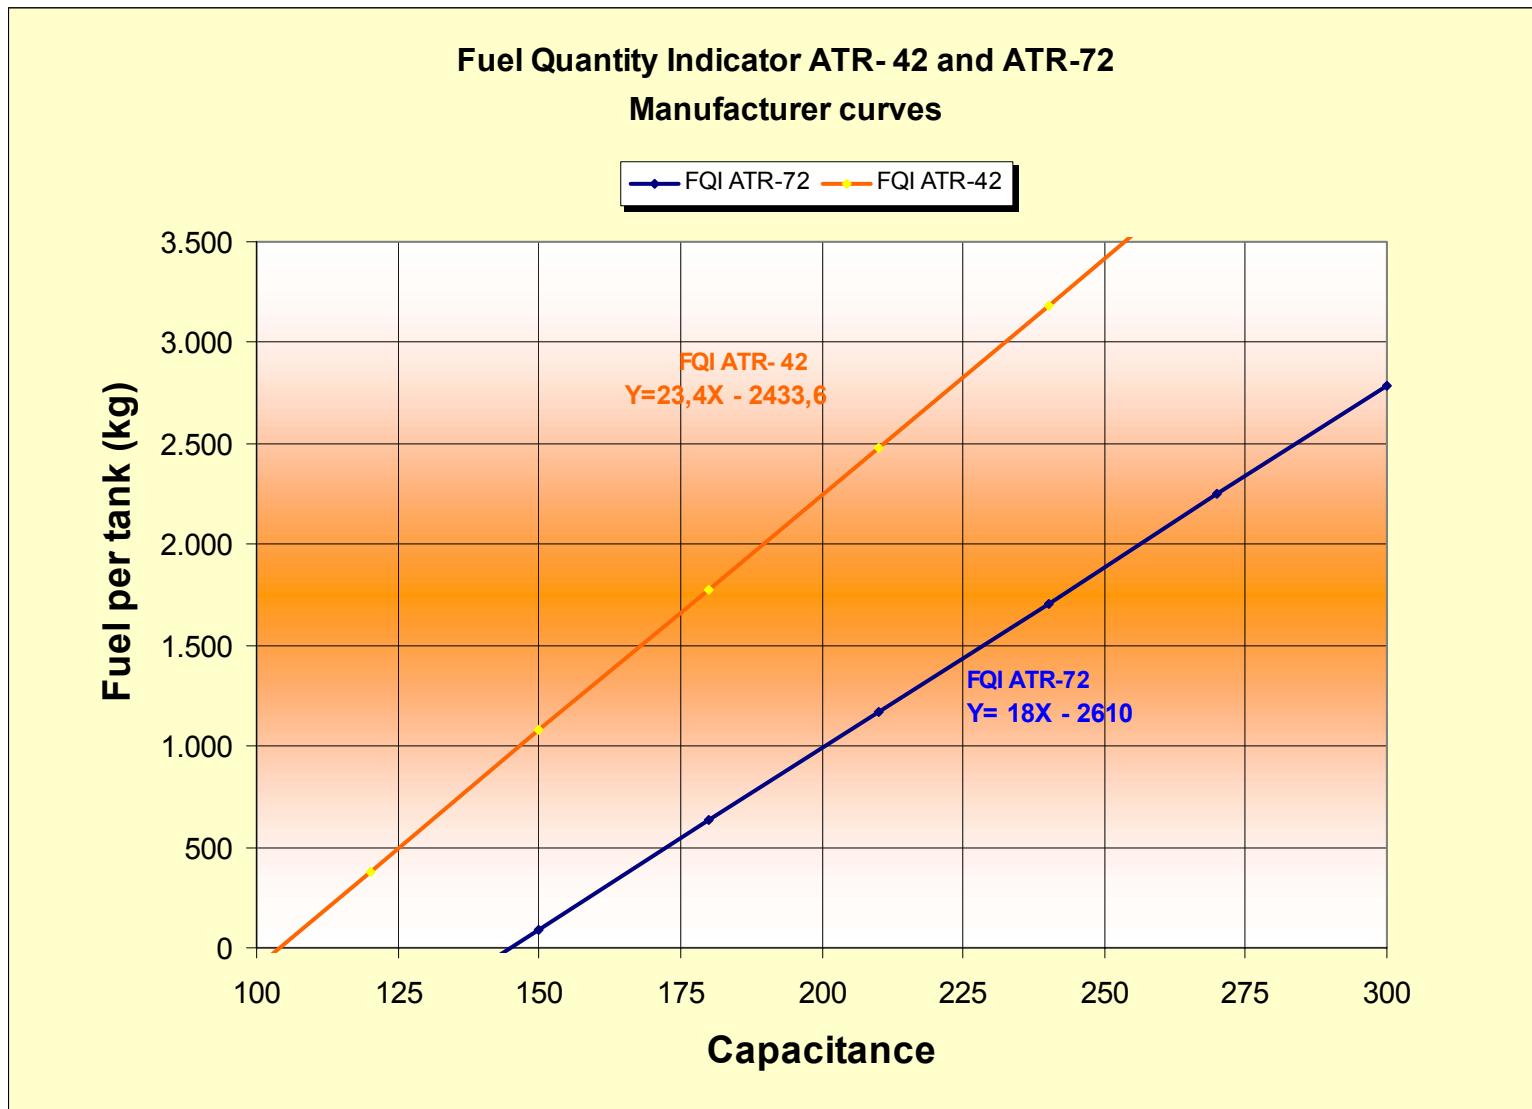
Refuelling tests aircraft ATR-72

Test results showed that a FQI for the ATR-42 installed on a ATR-72 introduces a non conservative error (i.e. the indicated values of the fuel quantity is greater than the fuel actually present on board),

which is linearly increasing with the fuel quantity and not less than 900 kg per tank; this means that with zero fuel on board the FQI ATR-42 readings for each tank is 900 kg (e.g. total fuel on board indicated by the FQI is not less than 1800 kg, see figure in Annex).

Readings with ATR- 42 and ATR-72 FQI

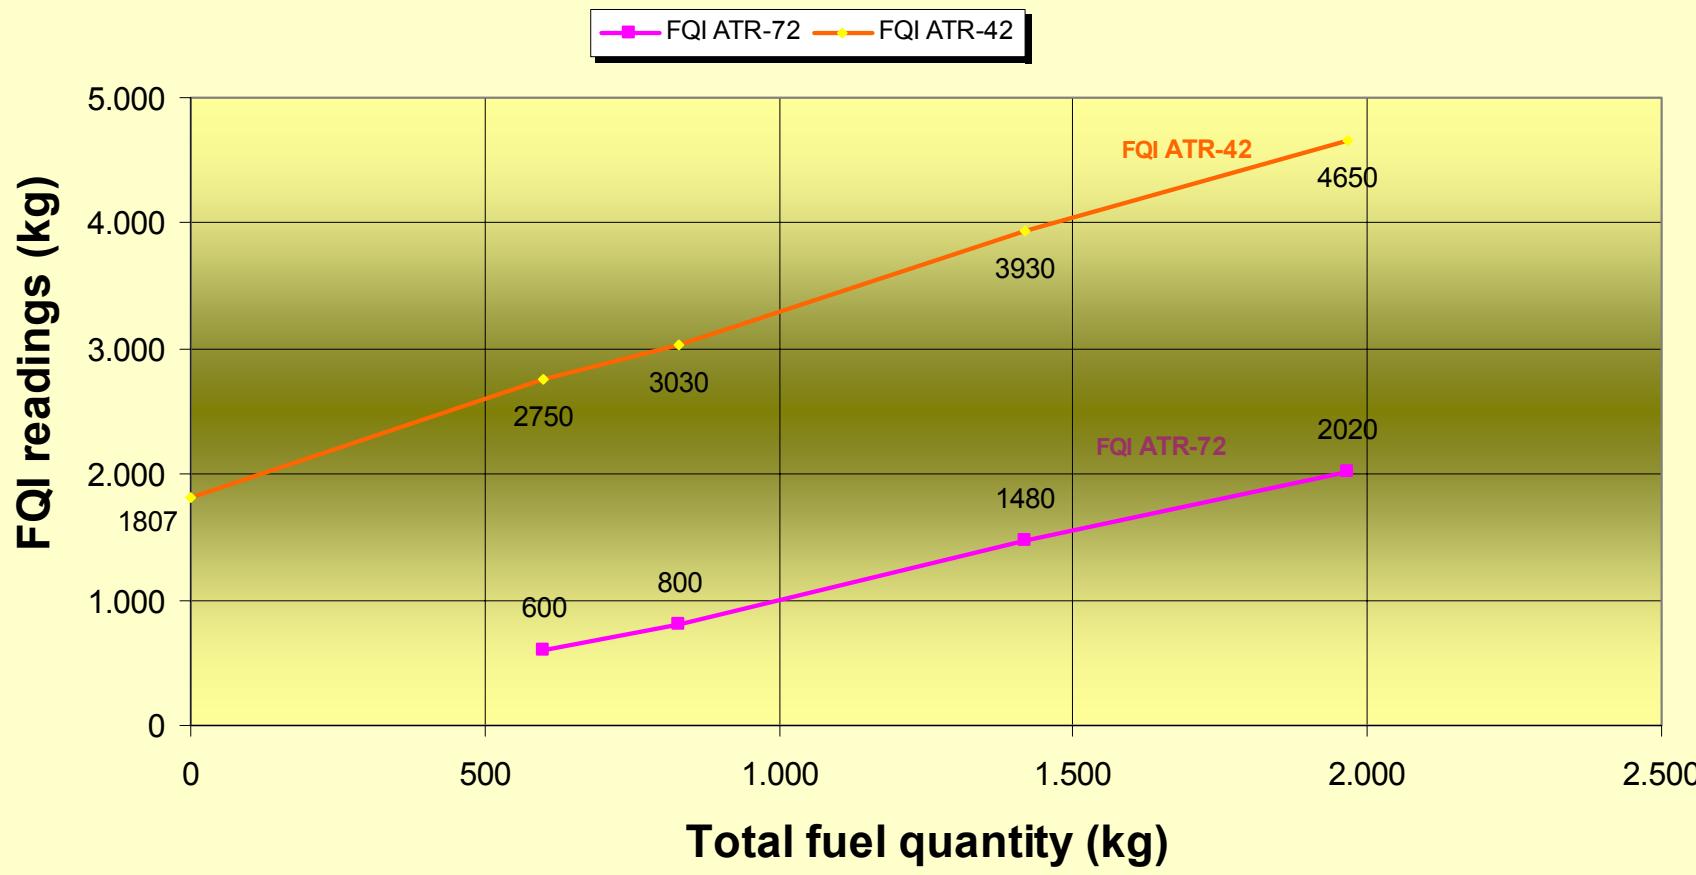
The wing tanks of the ATR-72 and ATR-42 differ in terms of maximum fuel capacity and shape, as well as number of the probes; as a consequence FQIs for the ATR-72 and for the ATR-42 utilize different algorithms to process the input capacitance signals coming from the tank probes and therefore they are not interchangeable (see manufacturer curves in Annex).
