## GENERAL INFORMATION OF THE SERIOUS INCIDENT

| Place: | Amsterdam Airport Schiphol, runway 24 |
| Aircraft: | Boeing 767-300 |
| Type of occurrence: | Aborted take off due to obstructed runway |

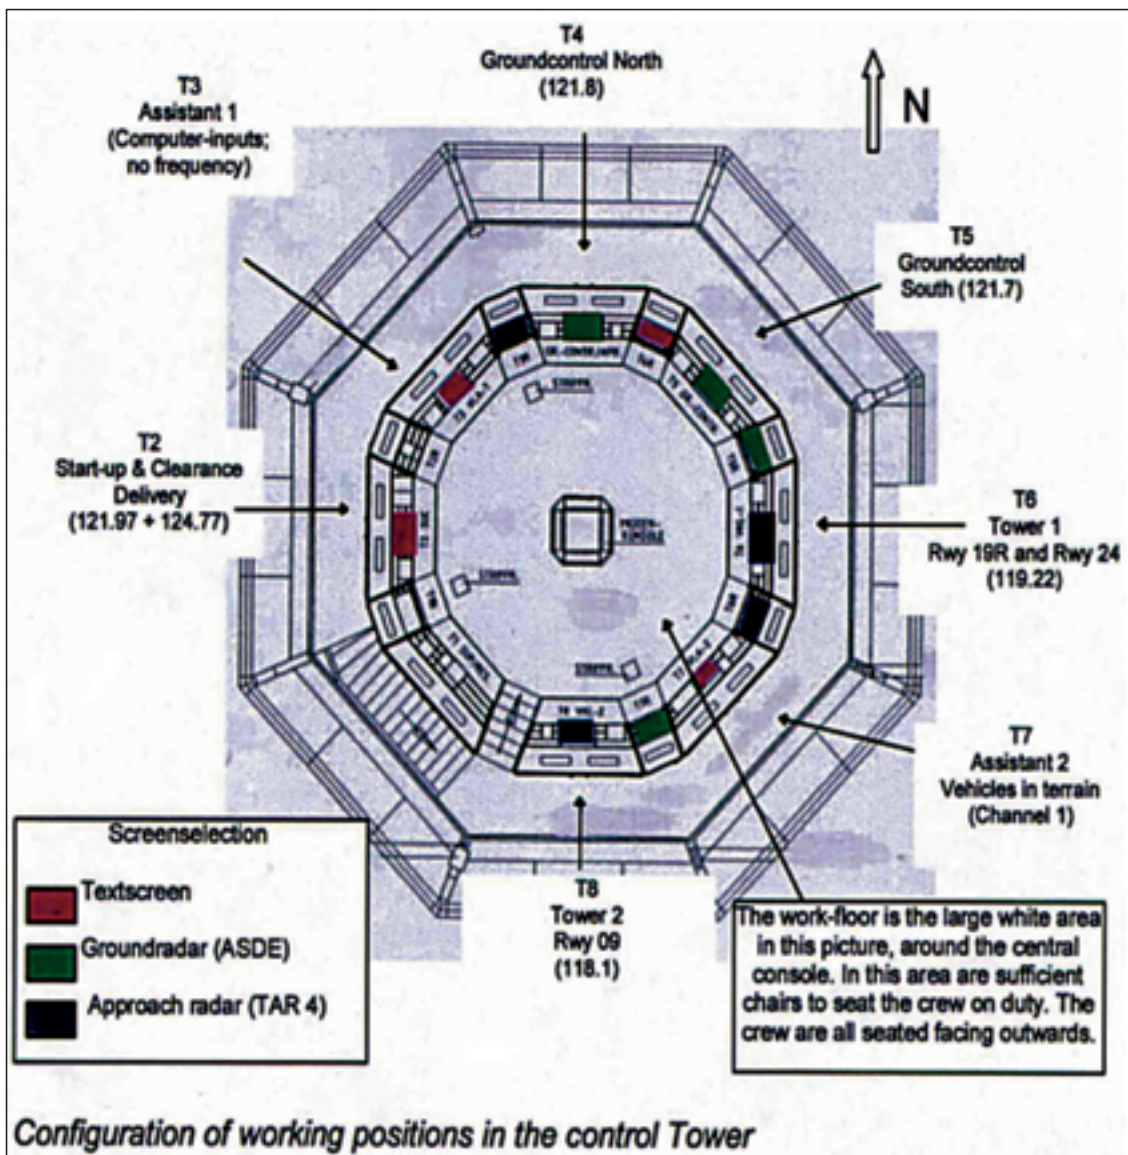
*Configuration of working positions in the control Tower*

In the picture the working-positions of the Schiphol control tower are indicated by the character “T” (for Table), followed by a number. The coloured rectangles indicate the selected equipment at the working positions at the time of the incident.

*Note: the textscreen at T7 (Assistant 2) is a permanent textscreen, while all other screens can be operated in three different modes. The text below the indication of a working-position refers to the use of the working-position at the time of the incident (type of control, responsibility and frequency).*

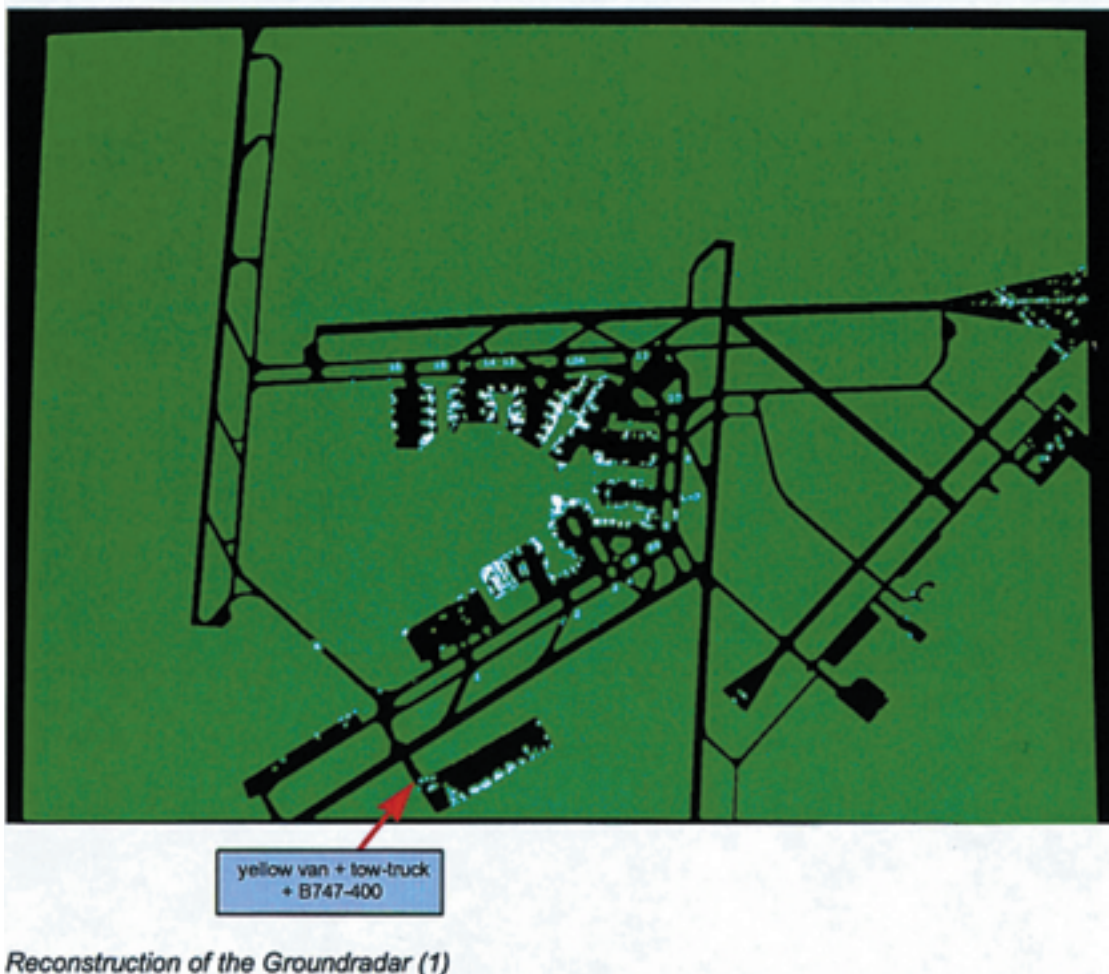
This picture (number 1) above shows T5R with the yellow van and tow holding short at exit 2 of runway 06/24, in front of the stopbar, coming from the “S”-apron. The controller at T6 was expecting the yellow van and tow from the opposite side.

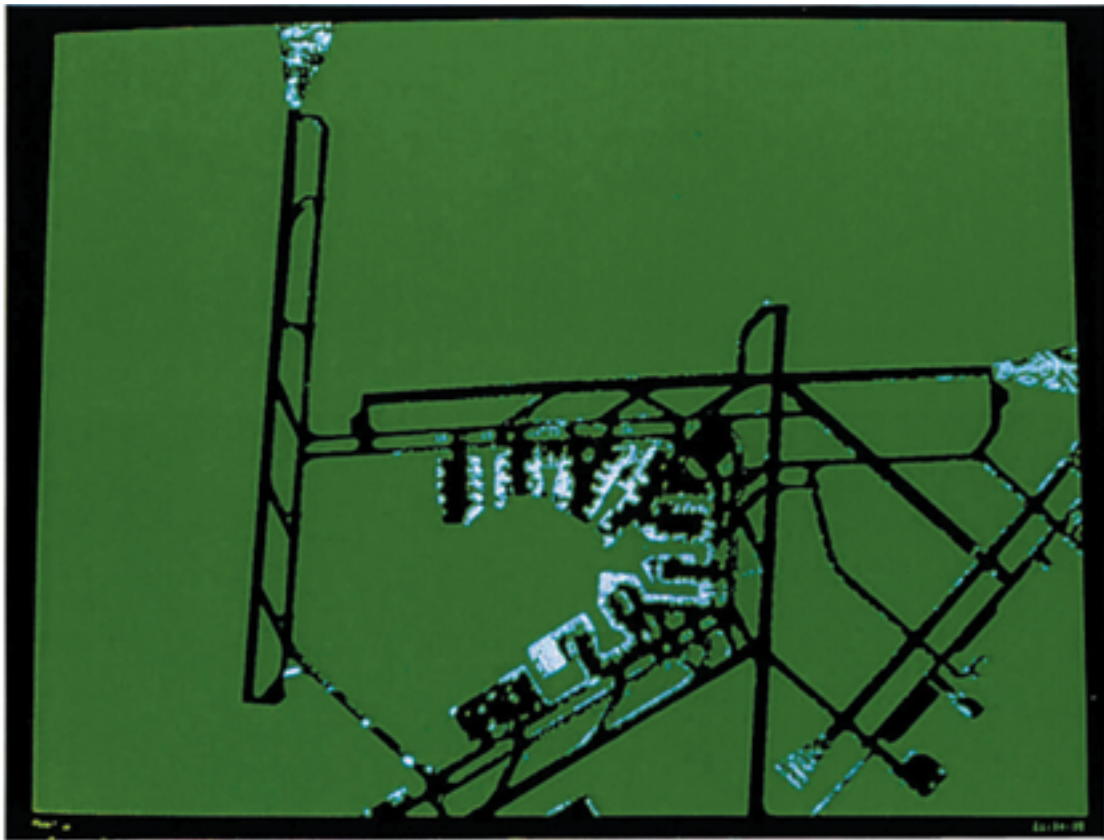
*Reconstruction of the Groundradar (2)*

The picture above (number 2) shows the same situation as in the picture number 1, but now on the display at T7R. Notice that the lower limit of the screen is just on the north side of exit 2 of runway 06/24. The yellow van and tow are not visible. The screen was adjusted for observing runway 09.

From picture number 2 it is evident that on the screen of T7R (the one to the right of the Assistant Controller) the yellow van and towed Boeing 747 were not visible in this position either.

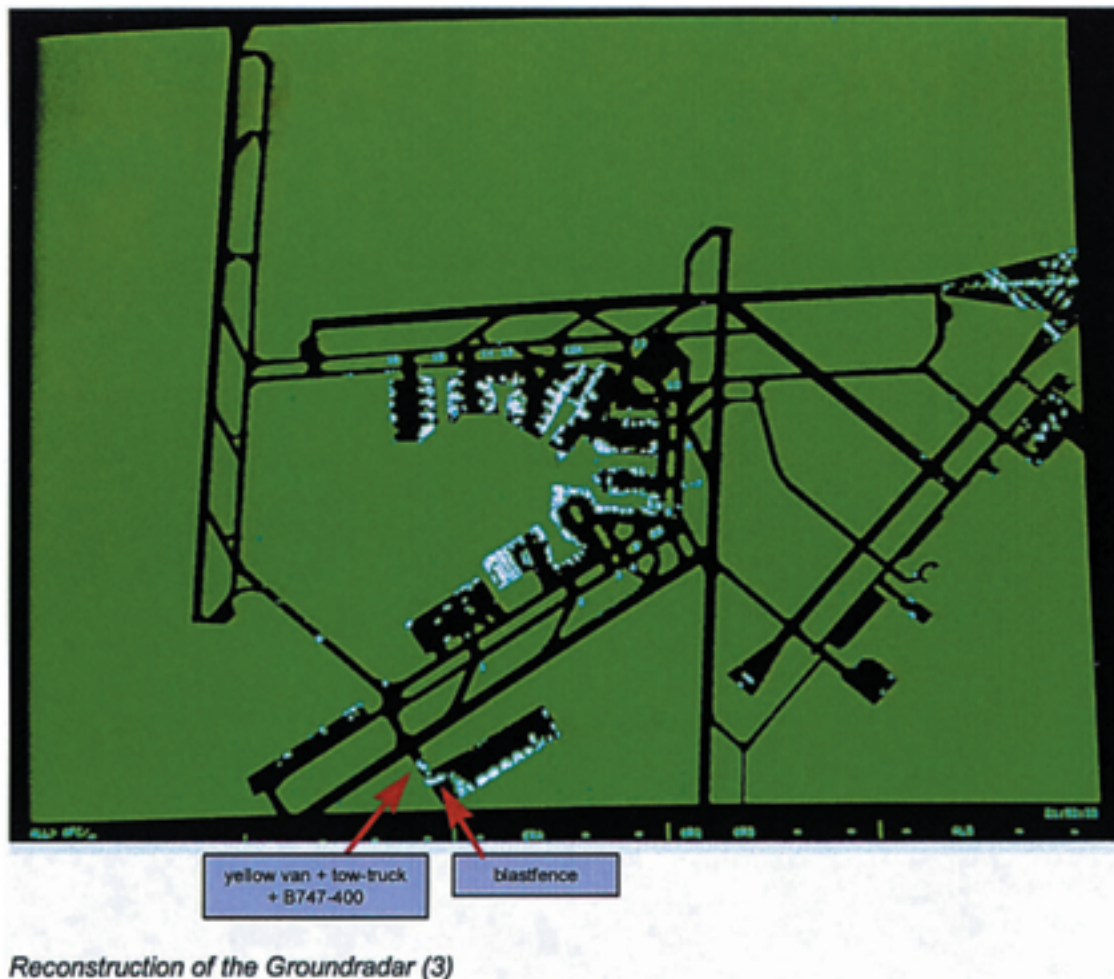
For the picture above (number 3), taken of the screen at T5R, the investigators asked the controller to position the yellow van followed by the towed Boeing 747 the way he remembered seeing it just before he cleared Delta 39 for take-off. To get to this position, the yellow van and tow moved from the situation in picture number 1, i.e. from the “S”-apron. Just below (or south of) the yellow van and the tow the radar return of a blastfence at the entrance of the “S”-apron can be seen. This blastfence appears also in the first picture.

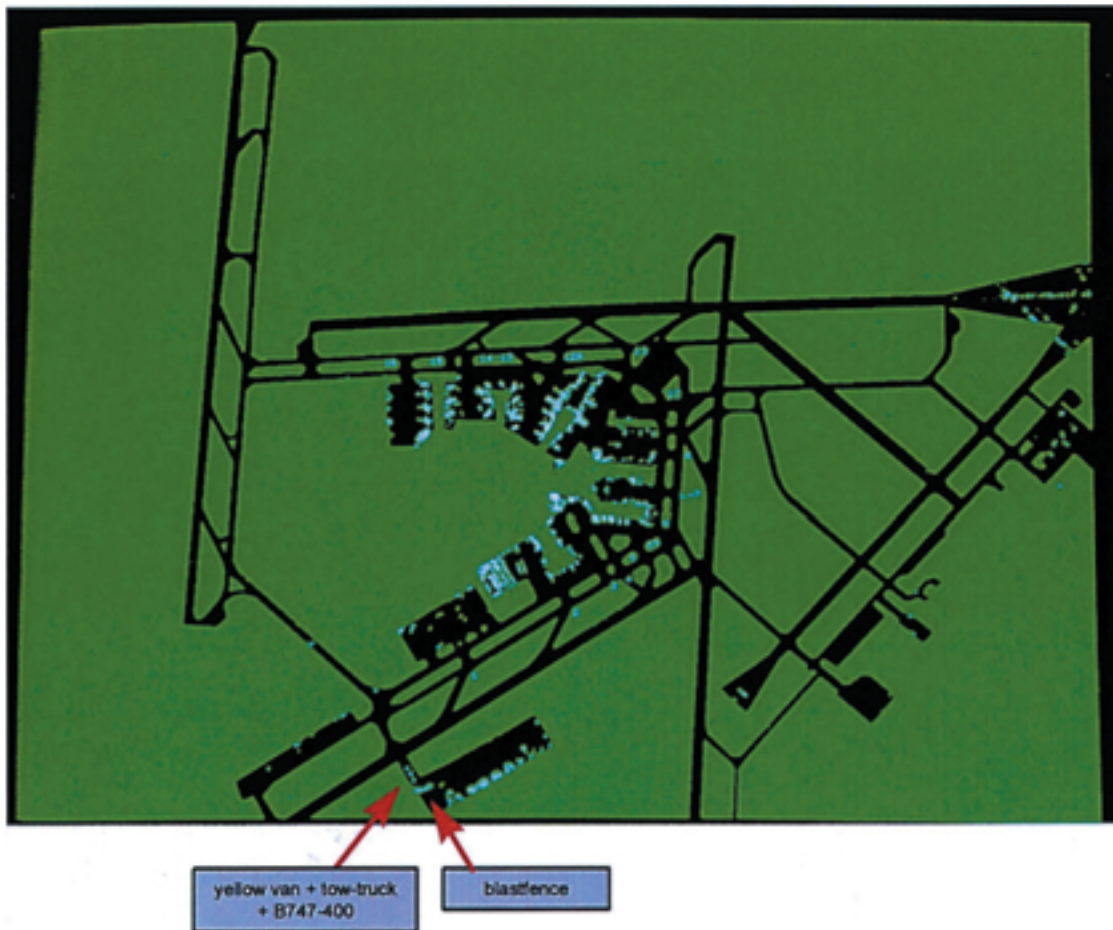
*Reconstruction of the Groundradar (4)*

The investigators also asked the yellow van and the towed Boeing 747 to cross exit 2 of runway 06/24 from the centre of the airport to the “S”-apron, i.e. in the direction as expected by the trainee. The car-driver was asked to stop the towed aircraft as soon as its tail was clear of the runway, or to be more exact, when the tail had crossed the yellow clearance-lines on the apron side of the crossing. After checking that the aircraft had reached the desired position, the car driver then resumed his position in front of the tow-truck.

This is the resulting picture 4 from the screen at T5R.

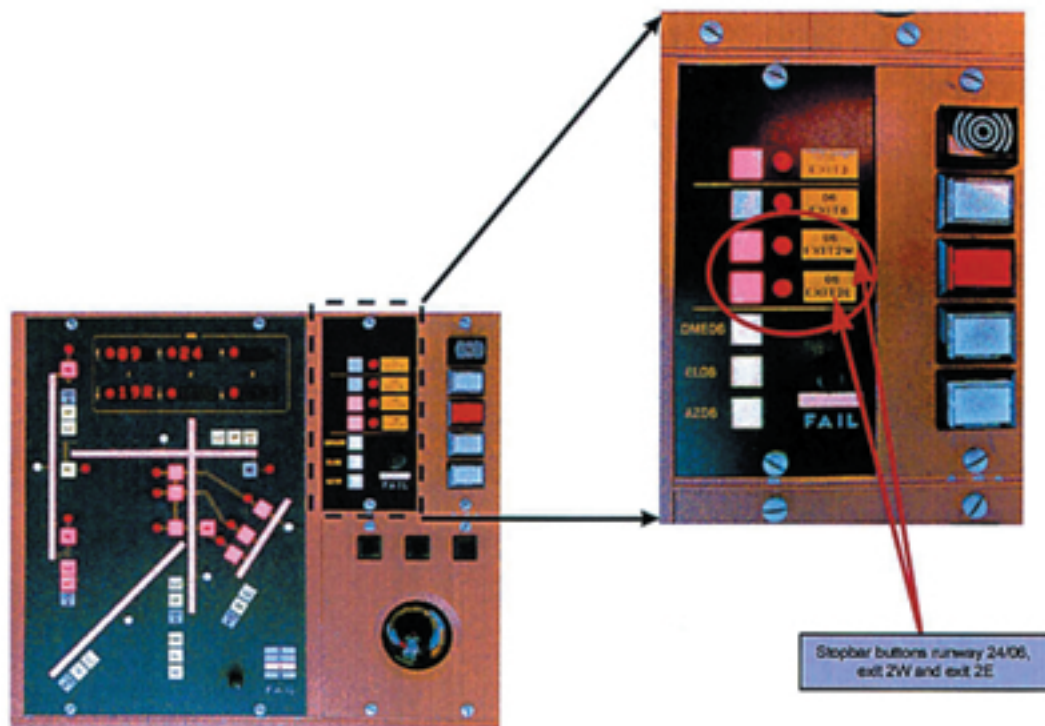
*Control panel at working-position T8*

The control panel comprises four sectors: North (runway 09/27), East (runway 04/22), South (runways 01 R/19L and 06/24) and West (runway 01 L/19R). The combination of the two runways in the South sector is a consequence of the permanently active stopbar at both sides of exit 1 of runway 01 R/19L (which point is also the far end of runway 06). Control of each sector may be allocated independently to any position in the control tower that is fitted with a control panel, but is usually restricted to T6 and/or T8.

The three small, round buttons, aligned vertically in the centre of the picture, are control-buttons for the stopbars at the exits of runway 01 R/19L. These stopbars are connected to the traffic lights at the intersections.

The two similar buttons at both ends of runway 01L/19R, at the left side of the picture, are examples of control-buttons for stopbars at the holding points.

The stopbars at exit 2 of runway 06/24 were constructed after the design and installation of this geographical control panel. Since it was technically impossible to add the control-buttons for those stopbars to the geographical panel, it was decided to create a separate control-panel for the stopbars at exit 2 of runway 06/24. This separate control-panel would also include feedback lights for the new Microwave Landing System (MLS) of runway 06, which can be seen in the picture above as three square, green lights, aligned vertically at the lower end of the separate panel on the right.

bar on the north side of the runway, the lower button is labelled “06 EXIT2 E” and controls the stopbar on the south side of the runway.

The stopbar control panels were however still configured for the previous set-up of the control tower and his action had no effect. When the following actions to extinguish the stopbar for which Charlie 8 was waiting, failed, the Controller, with the consent of the Supervisor/Coach, pushed the buttons to extinguish the stopbars on both sides i.e. 2W and 2E. The possibility of a wrong interpretation of the position of Charlie 8 was not considered.

- 5.1 Technical facilities with regard to the protection of runway exits at Amsterdam Airport Schiphol should be identical to allow standard procedures for all runway crossings (in particular so with regard to exit 2 of runway 06/24). In the meantime movements to/from S-apron other than by taxiing aircraft should not be allowed during low visibility weather conditions (Amsterdam Airport Schiphol); In this connection it is recommended to follow up ICAO Annex 14 Standards as soon as possible.
