DUTCH
SAFETY BOARD

Runway Incursion

Runway Incursion Runway 24 Amsterdam Airport Schiphol

The Hague, January 2013 (project number 2010094)

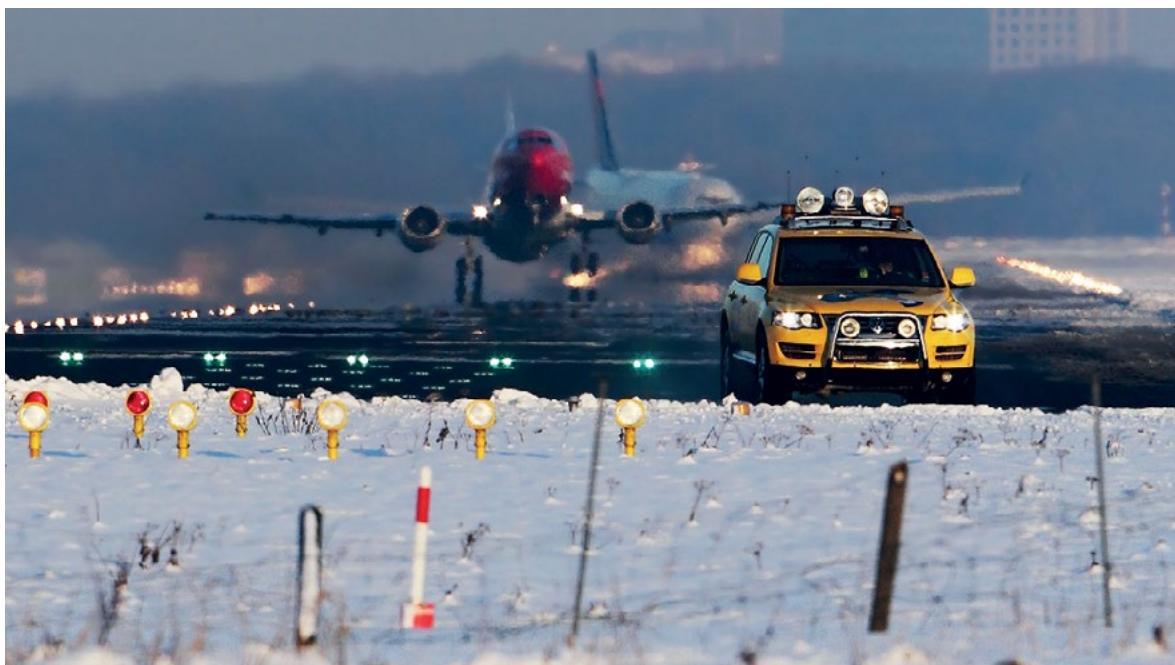
On 18 December 2010 at 15.26¹ an aircraft took off from Runway 24 at Amsterdam Airport Schiphol while a Bird Control vehicle was on the same runway. The bird controller was present on the runway with permission from Air Traffic Control. A runway incursion² occurred when the aircraft received take-off clearance while the bird controller had not yet vacated the runway. On account of their possible consequences, runway incursions constitute one of the most serious threats to aviation safety. In the three years prior to the incident, eight incidents took place in which a bird controller had been granted permission and was still driving on a runway-in-use while take-off or landing clearance had been issued, see Appendix C. On 21 January 2012 a virtually identical incident occurred, in which an aircraft had been issued take-off clearance while a bird controller was still present on the runway.

Figure 1: The time of the incident on 18 December 2010. The Bird Control vehicle (KV2) is pictured in the foreground with the Boeing 737 that has just lifted off from Runway 24 in the background. (Source: NustyR Air Team Images' photo stream).

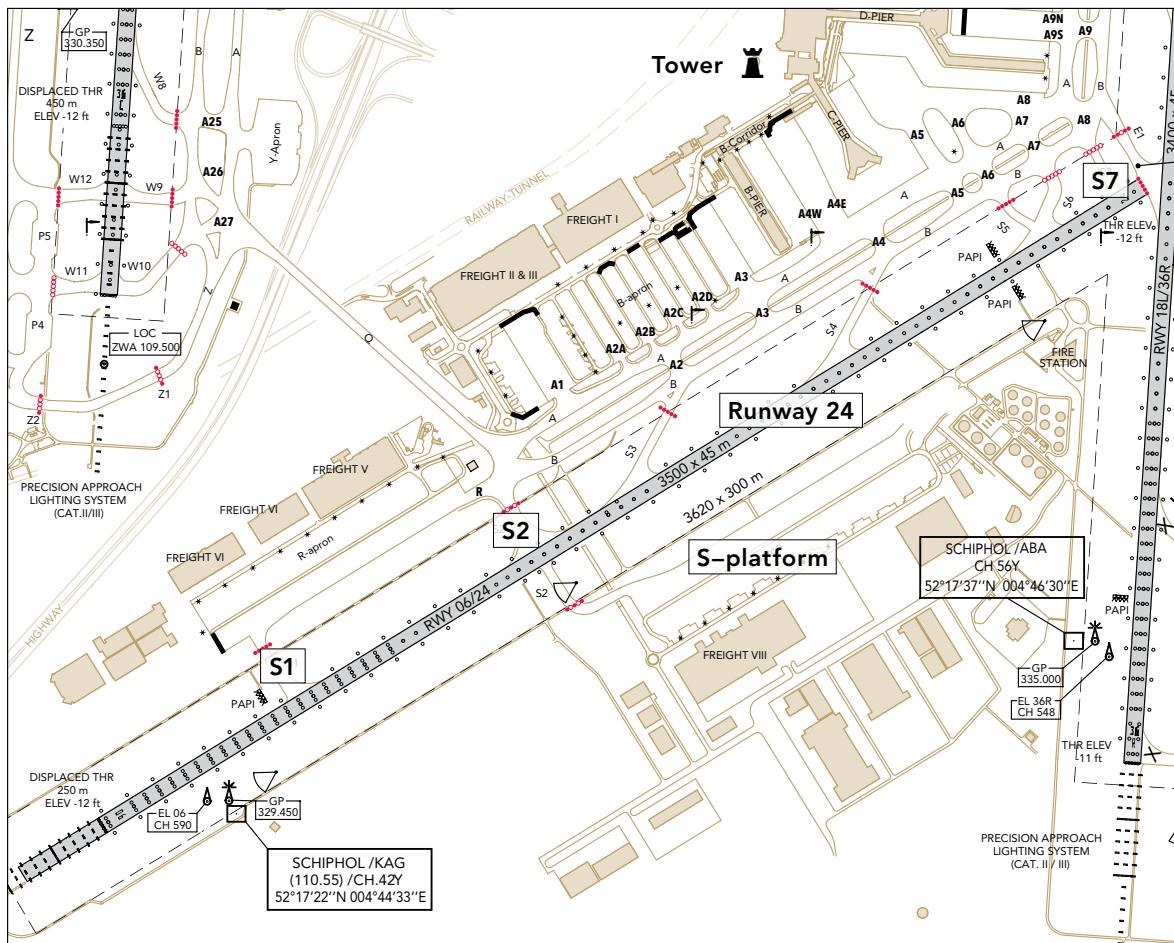
Figure 2: Runway 24 with intersections S1, S2 and S7

The runway controller stated that the bird controller had requested permission (via assistant 2) at Intersection S7 (see figure 2) to drive down Runway 24. The runway controller granted the request and, as required²⁰, switched on the 'runway occupied' signal for the relevant runway on the 'runway allocation panel' (see figure 3).

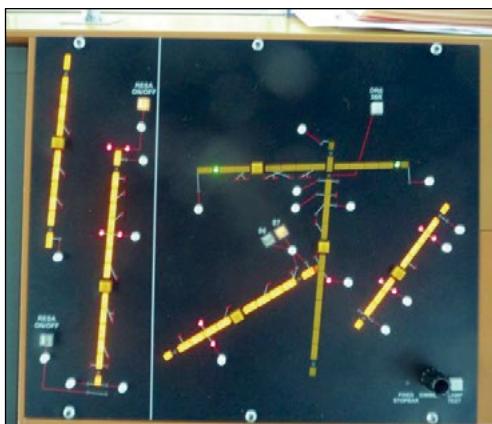
Figure 3: Runway allocation panel

The VDV does not set out a procedure for using the 'runway occupied' strip and for reversing the flight progress strip to indicate that a runway is occupied. As no rules have been set out in the VDV, the air traffic controller is free to decide whether to use these aids. This creates unsafe situations because there is no clarity on the work procedure of the individual team members within the changing teams of Air Traffic Control staff. Air Traffic Control the Netherlands Management has allowed this situation to persist and has not established procedures for using the 'runway occupied' signal.
