ACCIDENT

Aircraft Type and Registration:	Boeing 737-804, G-GDFJ	
No & Type of Engines:	2 CFM56-7B26 turbofan engines	
Year of Manufacture:	2000 (Serial no: 28229)	
Date & Time (UTC):	19 October 2012 at 0638 hrs	
Location:	Glasgow Airport	
Type of Flight:	Commercial Air Transport (Passenger)	
Persons on Board:	Crew - 6	Passengers - 187
Injuries:	Crew - None	Passengers - 1 (Serious) 15 (Minor)
Nature of Damage:	None	
Commander's Licence:	Airline Transport Pilot's Licence	
Commander's Age:	36	
Commander's Flying Experience:	7,600 hours (of which 2,200 were on type) Last 90 days - 227 hours Last 28 days - 69 hours	
Information Source:	AAIB Field Investigation

Synopsis

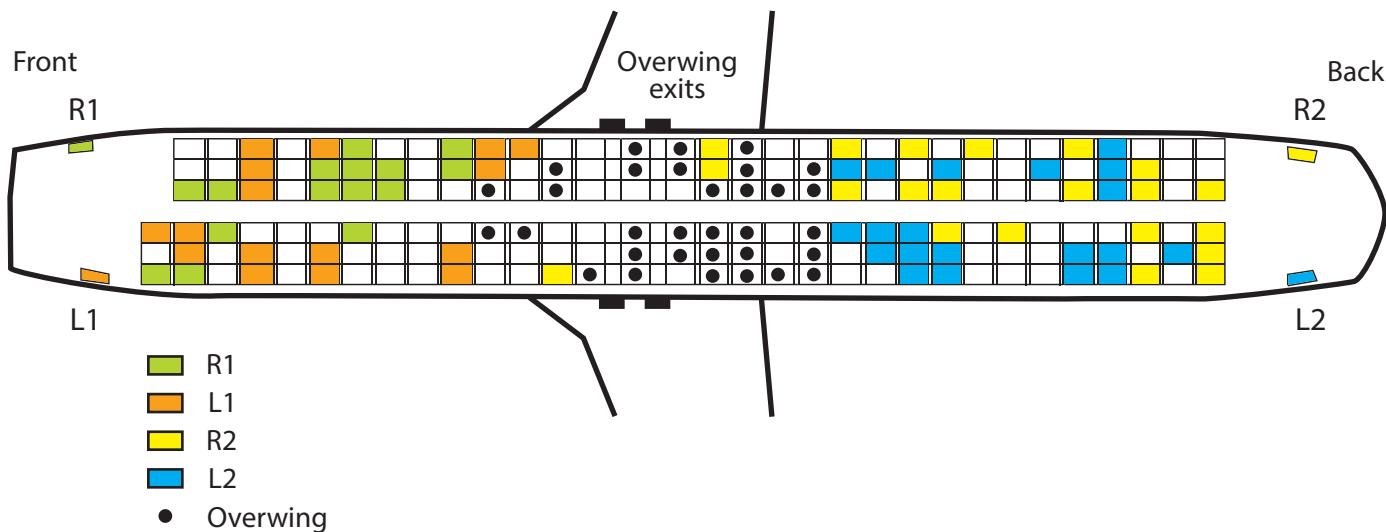
Figure 3
Cabin diagram showing the exits used by passengers

When all the passengers had cleared the cabin, the cabin crew left the aircraft and tried to gather the passengers together. The aircraft commander walked the length of the cabin and, having ensured all passengers had evacuated, the co-pilot, followed by the commander, exited the aircraft. Figure 3 shows the exits used by those passengers who returned questionnaires.

the runway, after descending down a slide. There were 15 minor injuries as a result of passengers sliding into one another at the bottom of slides and being knocked over as they slid off the end.

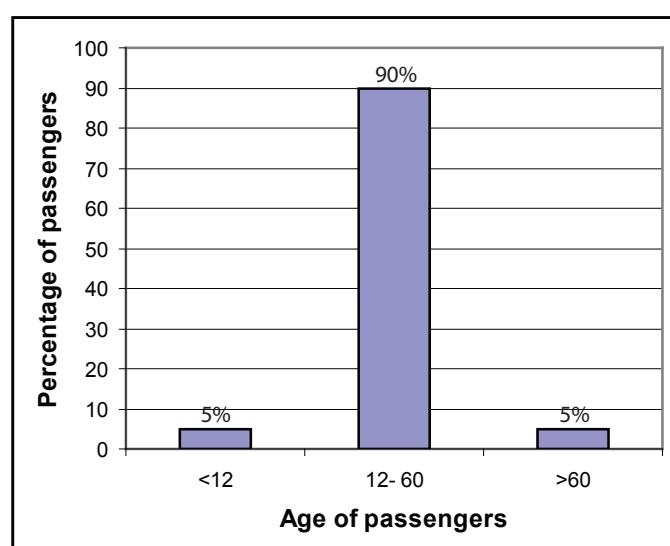
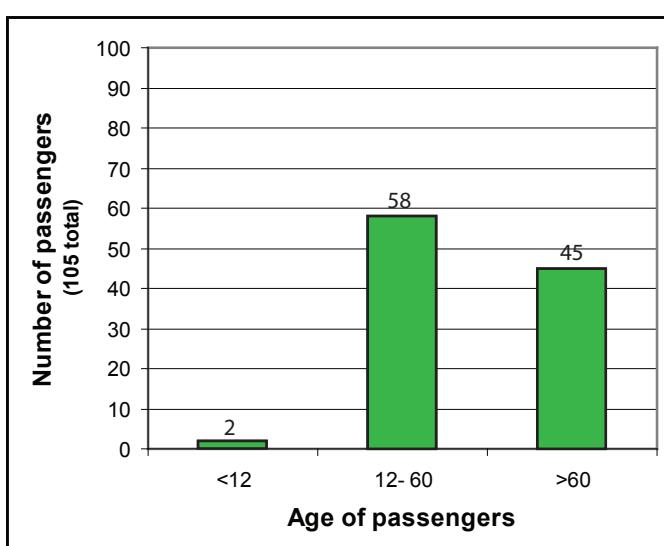
Figure 4
Certification and accident age distribution

The age group requirements for the demonstration, by percentage, are shown in Figure 4. They are compared with the actual age distribution in the accident, obtained from the 105 questionnaires returned.

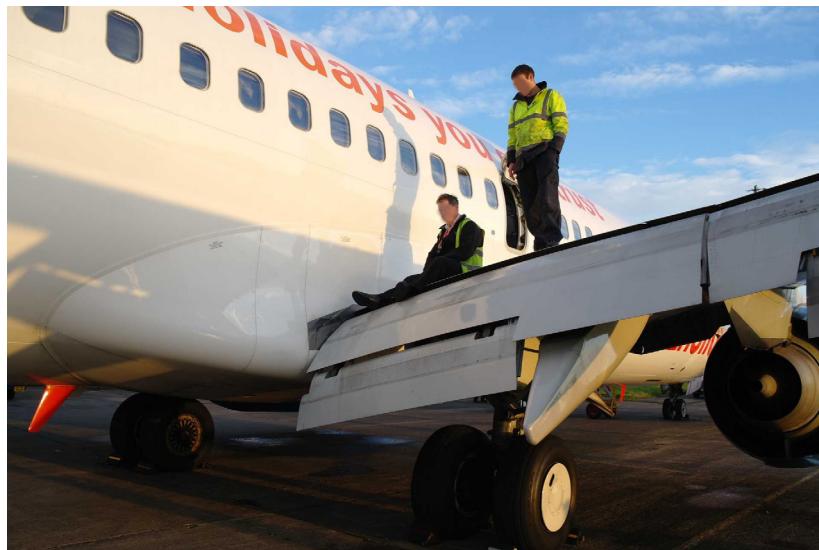
Figure 5

Showing the flaps in the fully lowered position.

height of the lowest part of the flap trailing edge with the flap fully lowered (see Figure 5) is 42 inches.

The injuries suffered were as a result of the evacuation, due to passengers bumping into each other on the slides or being knocked to the ground. In the case of the over-wing exits, sliding six feet to the ground off a wet flap can be a daunting experience but the aim is to escape from the aircraft and, as such, carries a degree of risk.

In addition, the operator has re-issued the on-board Safety Card to reflect the need for passengers, evacuating via the overwing exits, to slide down the trailing edge of the wing. Also, the verbal briefing given to passengers occupying seats adjacent to the overwing exits has been amended to stress the requirement to turn aft, immediately after evacuating through the exit, and to slide down the trailing edge of the wing.

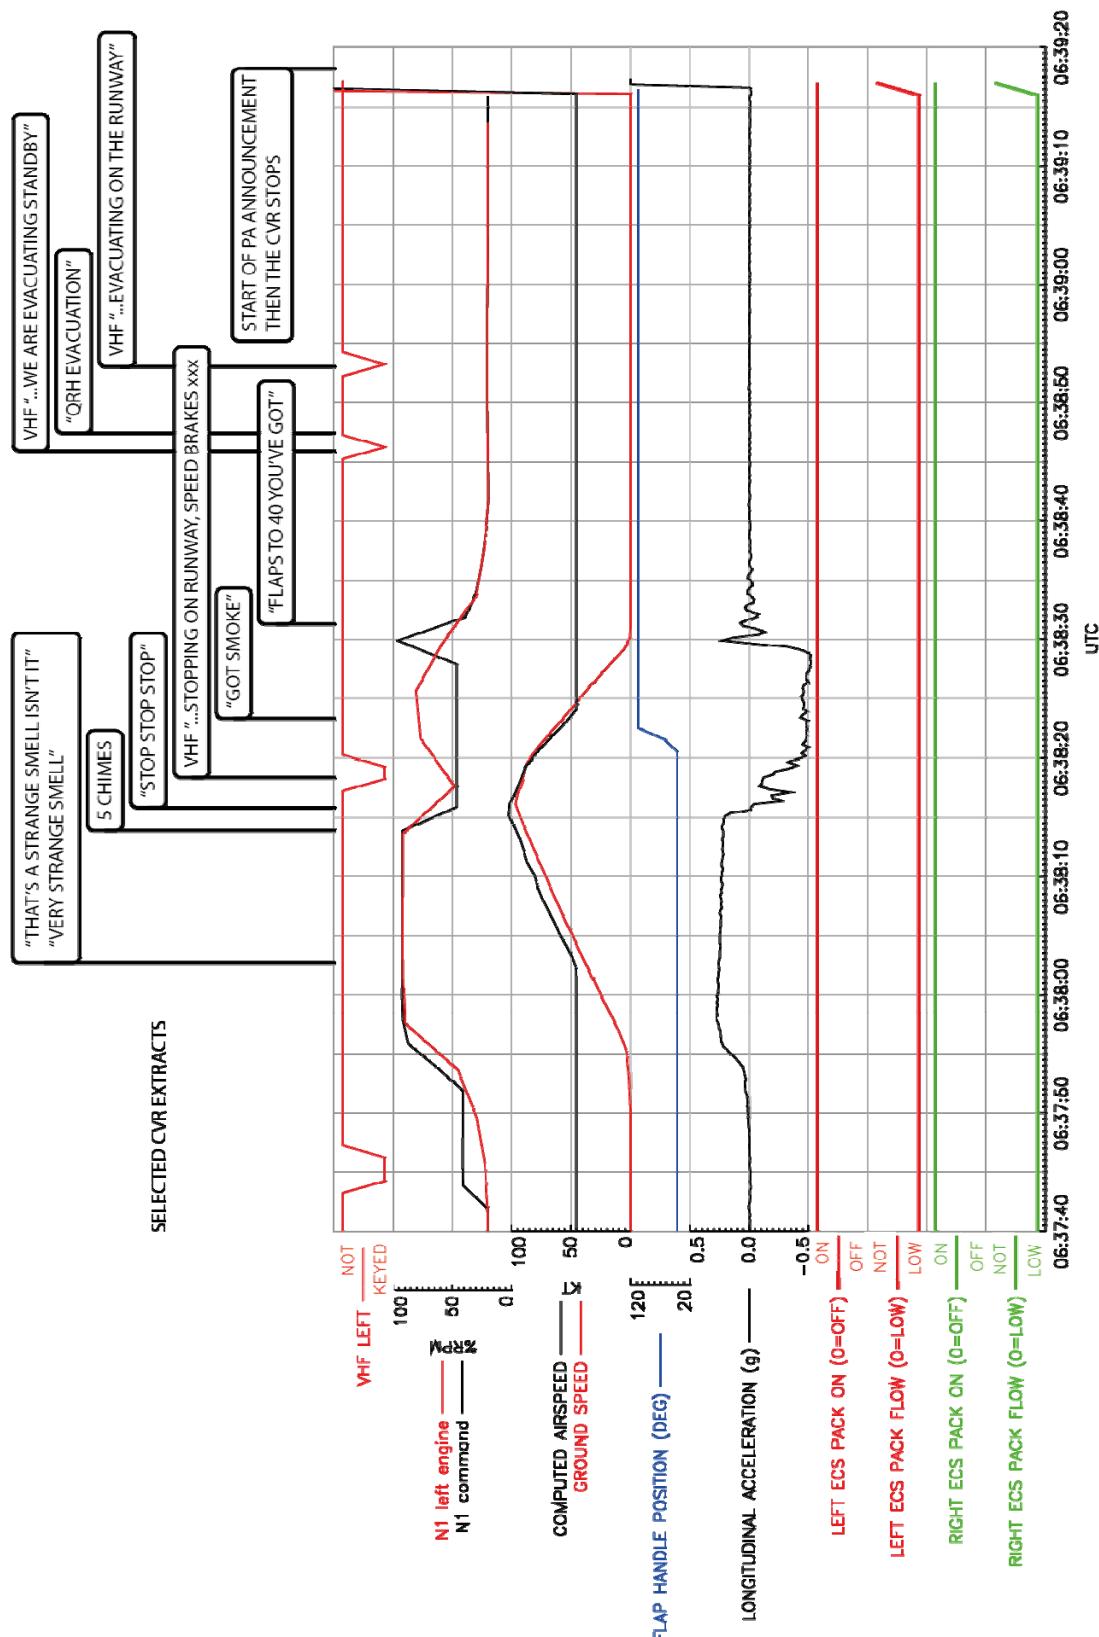
Figure 6

The recordings show that the pilots identified a “STRANGE SMELL” approximately five seconds after the engines reached their takeoff power. The flight crew did not make reference to any visual signs in the cockpit. Eleven seconds after the flight crew first commented on the smell, the cabin crew alerted the flight crew to a problem in the cabin. This was identified as smoke. There was no reference to heat or breathing problems.

Pertinent FDR parameters and CVR extracts

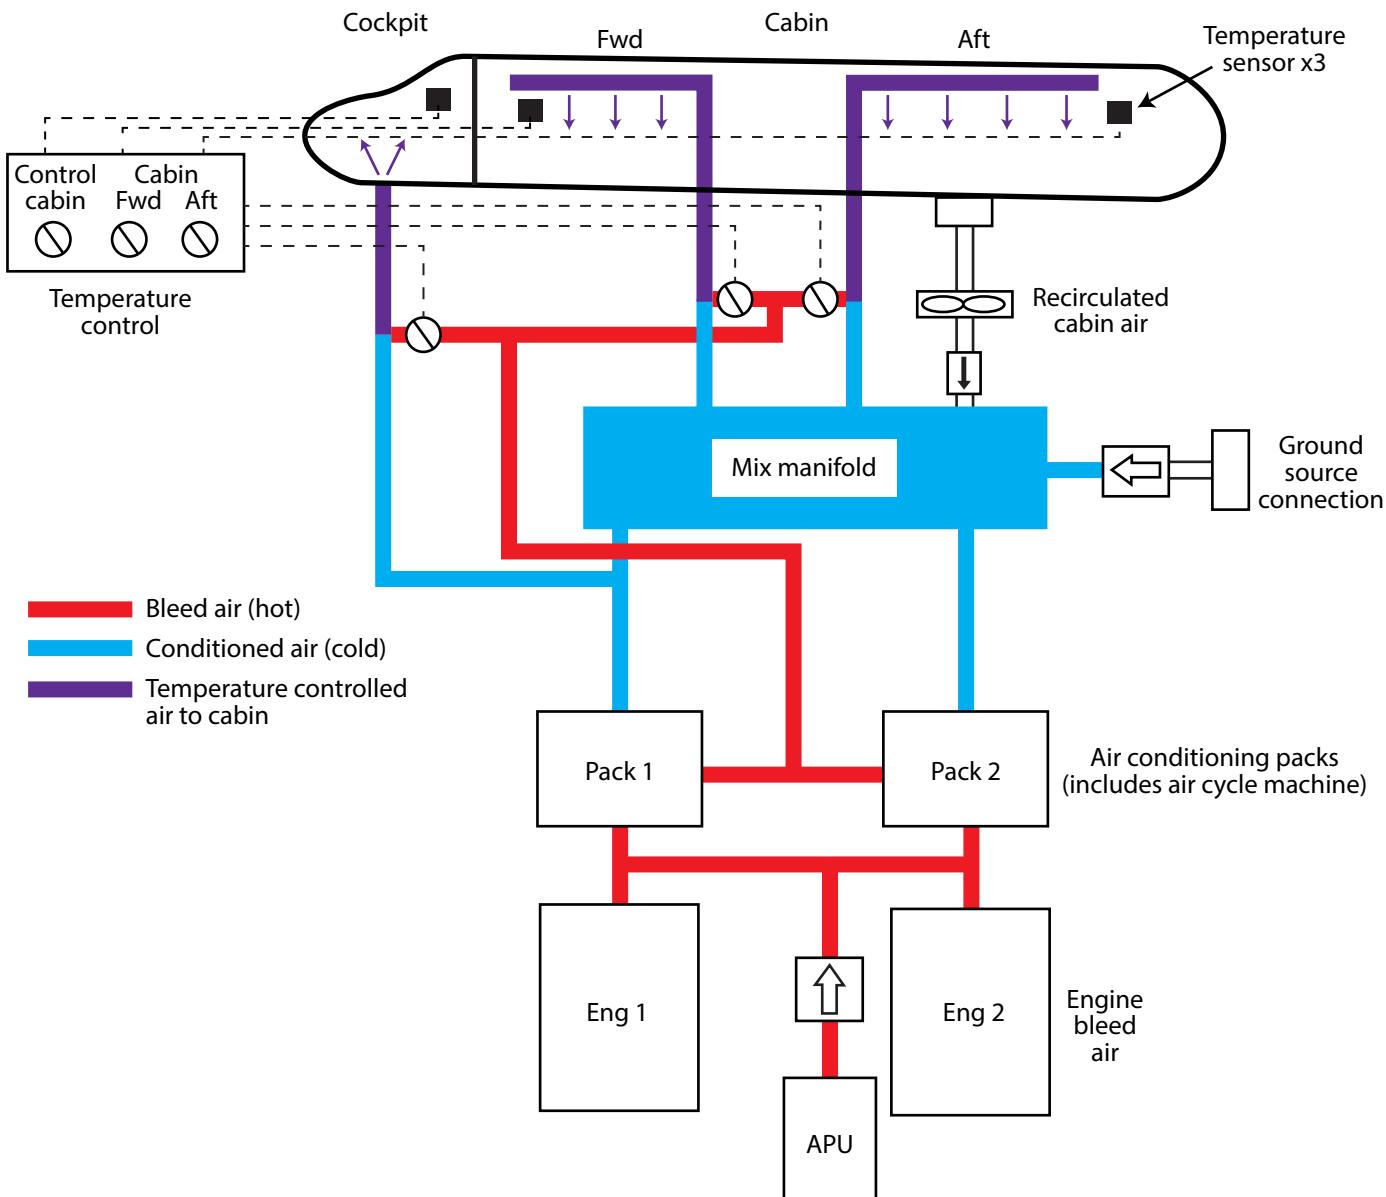
Figure 7
Simplified Schematic of Air Conditioning System

At the beginning of the flight, the air conditioning packs were selected ON after engine start, in accordance with the standard operating procedures, but later than on the other flights sampled. This, combined with the short taxi time, may have meant that the cabin was slightly warmer than usual by the time the takeoff commenced. The ambient conditions on the day meant the air was humid, with the temperature and dew point only one degree apart. As engine power was increased for takeoff, more air was available for air conditioning and the air conditioning system was able to supply colder air to the cabin to achieve the selected temperature. As the cabin was warm and humid, this sudden influx of cold air, potentially down to 1.7°C, could have caused the formation of mist or fog in the cabin which, in the low lighting conditions, could have given the appearance of smoke or fumes.

No reason for the acrid burning smell could be found and it did not recur at any time during ground tests or subsequent flights. There was no residual smell in the cabin or on people's clothing and none of the aircraft occupants reported any negative effects. It is possible that this smell may have been due to excessive moisture in the pneumatic system, vaporising from the ducting as it heated up to its normal operating temperature.

Excessive moisture in the air conditioning ducting was a possible factor in this event. Consequently, the operator has directed its maintenance personnel, by Quality

Notice 118A, to take additional action following all engine ground runs after maintenance. It states:

'The following shall be carried out for all engine runs after maintenance. In addition to the minimum idle of 5 minutes without load (as per AMM task 71-00-00), both air conditioning packs shall be run using engine bleed (as per AMM task 21-00-00) with cabin temperature selectors in the mid position for a further 5 minutes prior to engine shut down.'
