**COMISIÓN DE  
INVESTIGACIÓN  
DE ACCIDENTES  
E INCIDENTES DE  
AVIACIÓN CIVIL**

## **Report EXT A-001/2012 Afghanistan**

Accident involving an MD-83  
aircraft, registration EC-JJS,  
operated by Swiftair, S.A., at the  
Kandahar Airport (Afghanistan),  
on 24 January 2012

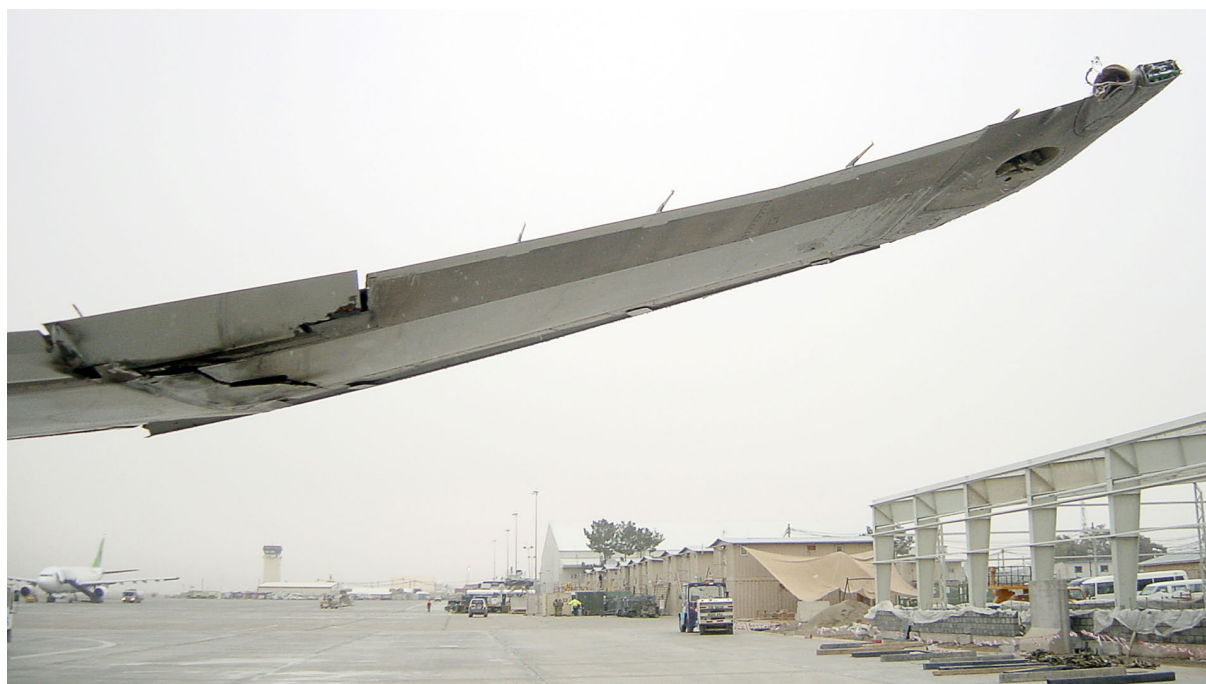
The last 3.6 m of the right wing (from section XRS 477 to the wingtip) was significantly and permanently bent upward. This entire area scraped along the ground, resulting in considerable scratches and gashes in this section of the underside of the wing. The outermost leading-edge slat (number 5) was severely damaged, while the number 4 slat was scratched.

As for the moving surfaces on the wing's trailing edge, the outermost aileron and its trim tab were heavily damaged, as was the outboard flap, though to a lesser extent. The wingtip and its lights also suffered significant damage.

Figure 1. Damaged right wing seen from behind

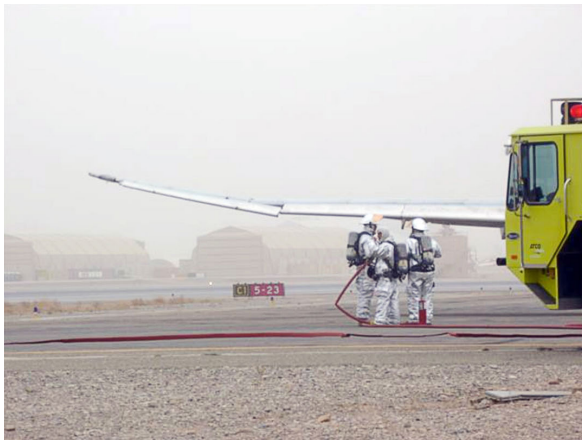
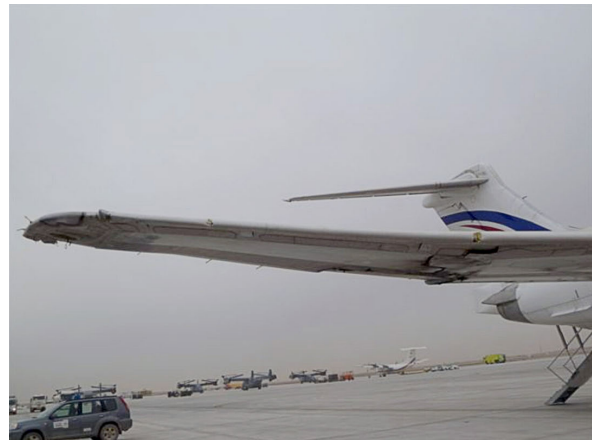
Figures 2 y 3. Damaged right wing seen from the front

The damage to the aircraft is consistent with an increasing right roll angle. In the last five seconds before impact the airplane was rolling right at a rate of 3 degrees per second, and at 4 degrees per second at the moment of impact. This resulted in a hard impact with the ground that radically halted the rolling motion, which dropped from +20° to +5° in one second and caused significant damage to the right wing, as well as an appreciable permanent deformation.

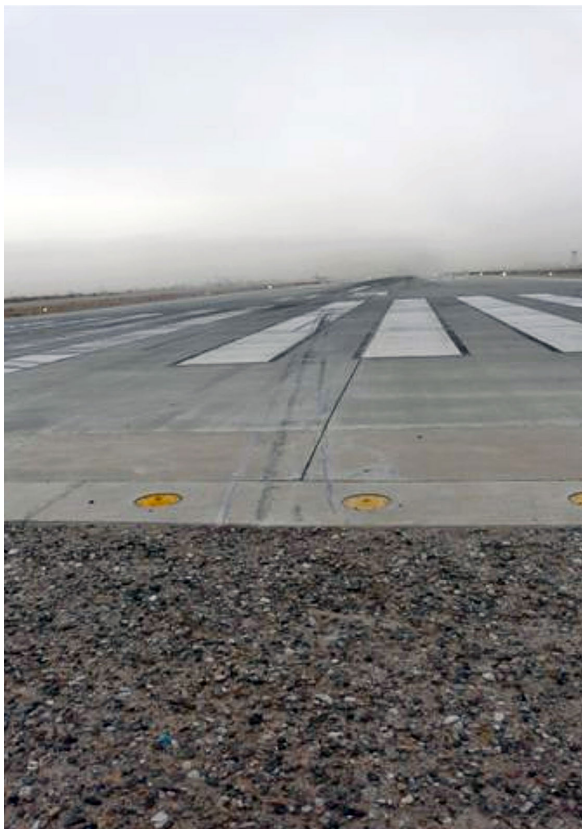
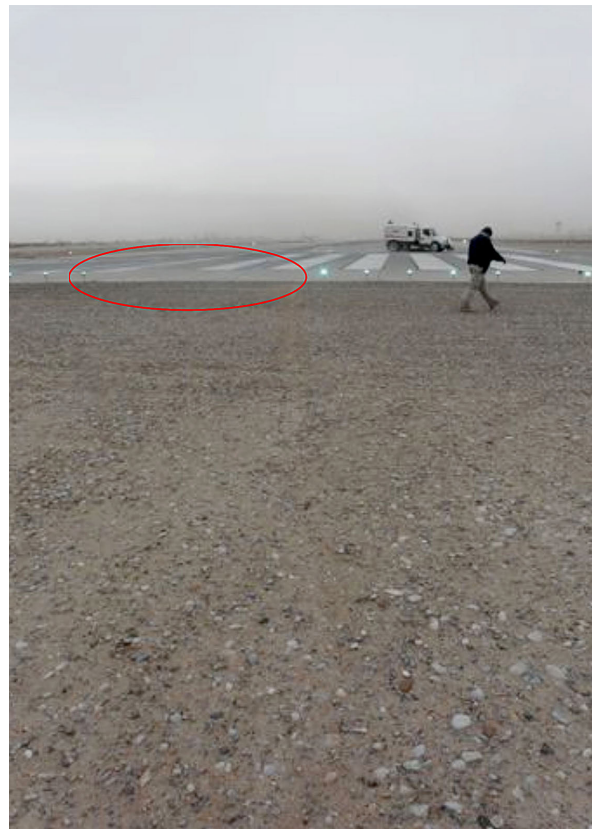
The wing made contact with the ground some 20 m before the threshold, resulting in damage to five threshold lights (see area in red in figure 5).

Figures 4 y 5. Runway 05 threshold after the accident

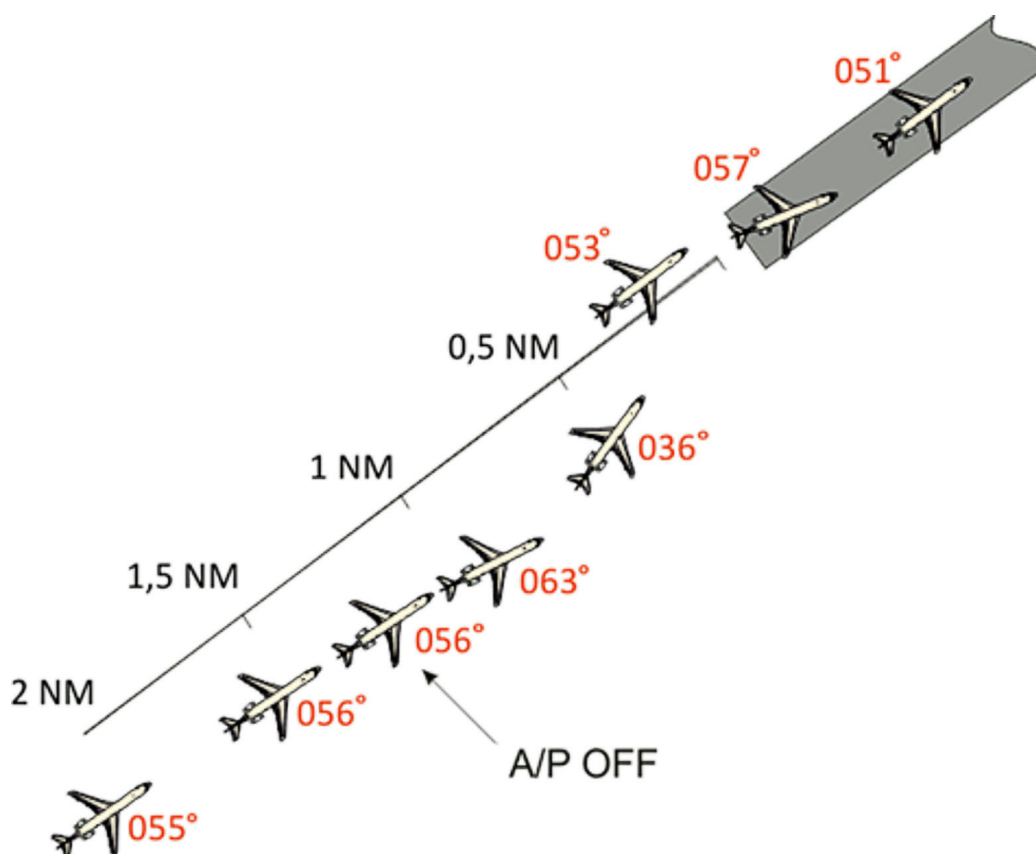
Figure 6. Aircraft's estimated flight path<sup>21</sup> and headings with respect to the approach centerline

At 03:57:44 (466 ft RA), the airplane's heading was more than  $5^\circ$  off the runway centerline and remained that way for the next 16 seconds, until 03:58:00 (142 ft RA). At 03:58:04 (77 ft RA), the airplane's heading exceeded  $-5^\circ$  with respect to the runway centerline, a condition that persisted for the next 18 seconds until 03:58:22 (25 ft RA), one second before the right wing made contact with the ground.

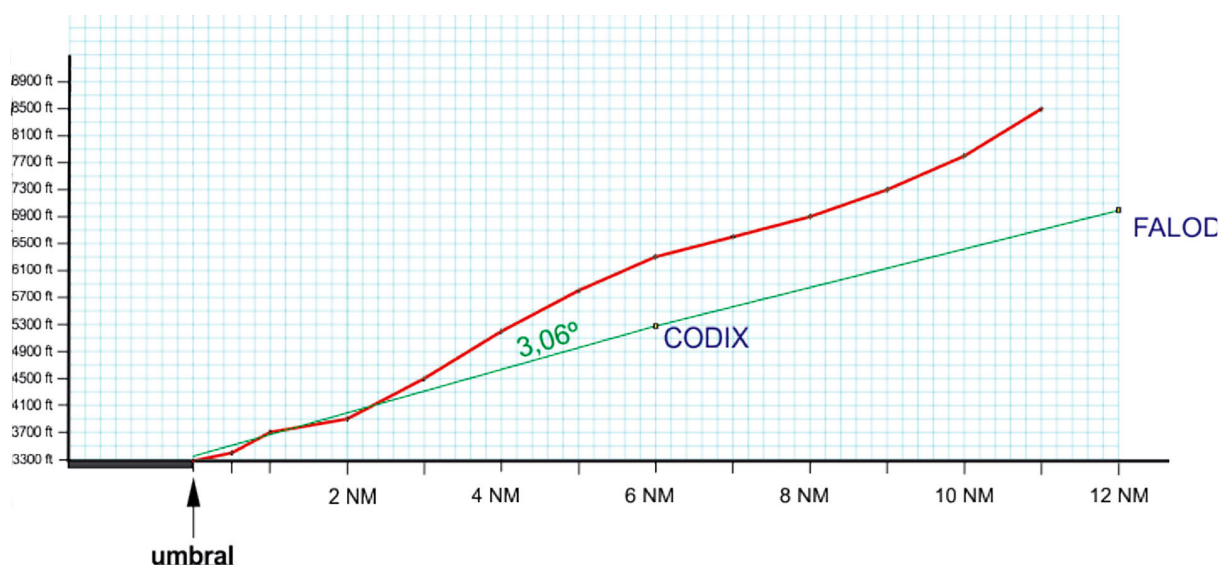
Figure 7. Approach profile – actual versus published

The graph shows that even though the profile was above the glide slope throughout the approach, in the last segment (final mile), the maneuver was conducted below the glide slope.

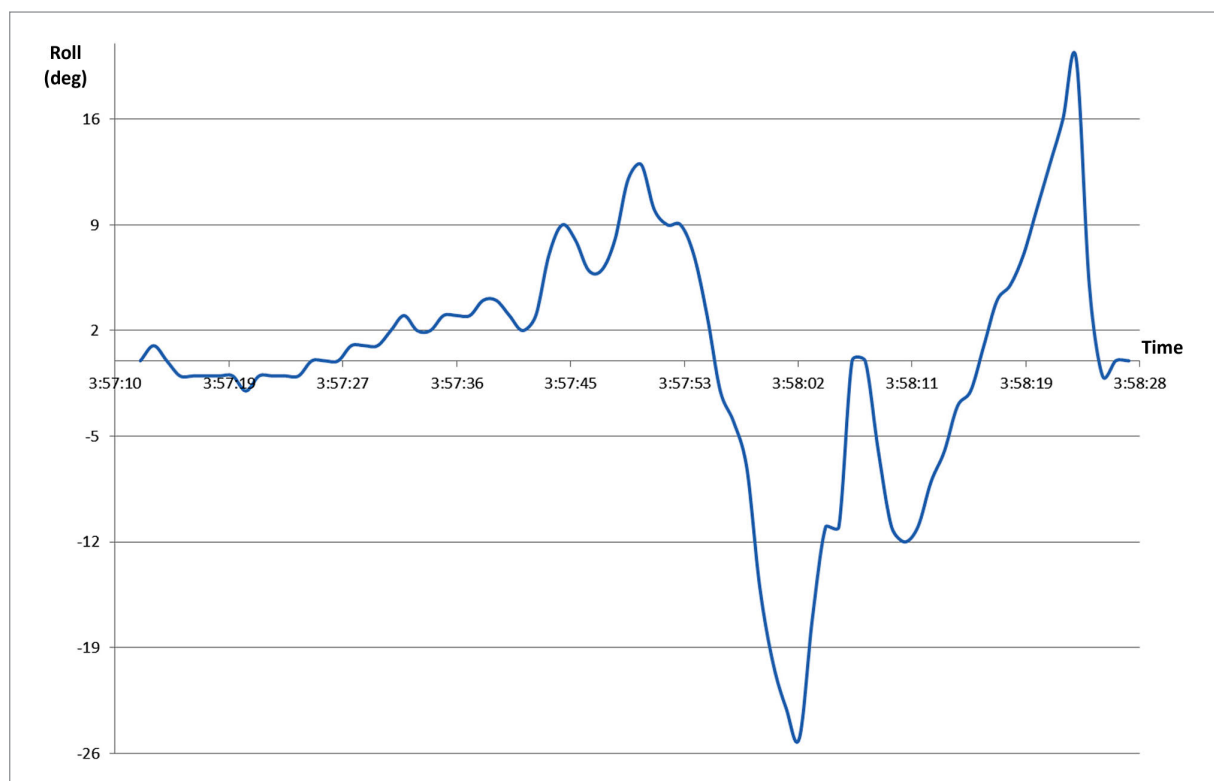
From 03:57:56 on, that is, 27 seconds before impact, the roll was to the left, while at 03:58:16, the roll tendency changed, with the roll angles shifting to the right. The altitude was 102 ft and the heading  $038^\circ$  with a speed of 130 kt. This maneuver at such a low altitude seems to indicate an effort to line up the aircraft with the runway by

Figure 9. Roll angle in the last 1,000 ft of RA

means of a sharp roll to the right that reached a value of  $20^\circ$  combined with an input to the right pedal that deflected the rudder up to  $15^\circ$  in the second before impact.

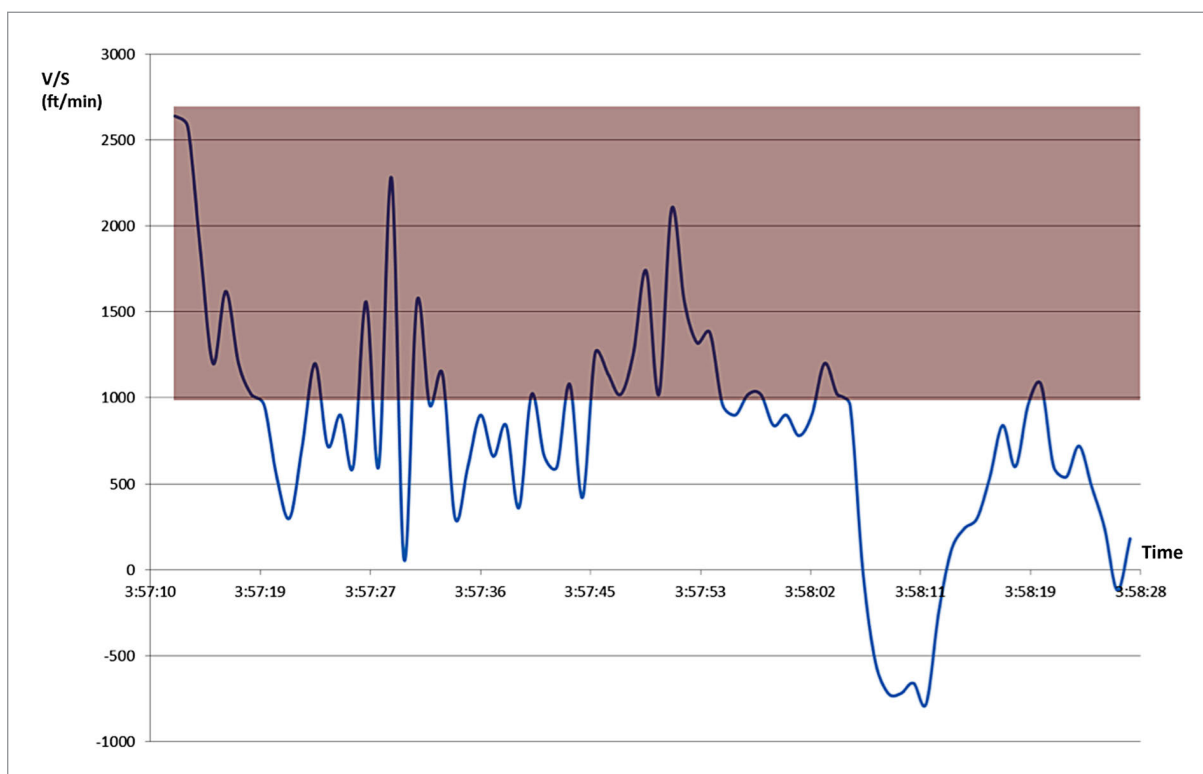
The maximum rate should have been 1,000 ft/min, but as the graph below shows, the descent rate exceeded this maximum on several occasions (red area).

There was even an interval between 03:58:07 (70 ft RA) and 03:58:12 (122 ft RA) when the aircraft climbed (shown in the graph 12 as a negative descent rate).

Figure 12. Descent rate in the last 1,000 ft of RA
