NATIONAL TRANSPORTATION SAFETY COMMITTEE

Aircraft Serious Incident Investigation Report

PT. Merpati Nusantara Airlines
De Havilland DHC 6-300 Twin Otter; PK-NUH
Dabra Airstrip, Papua
Republic of Indonesia

17 October 2011

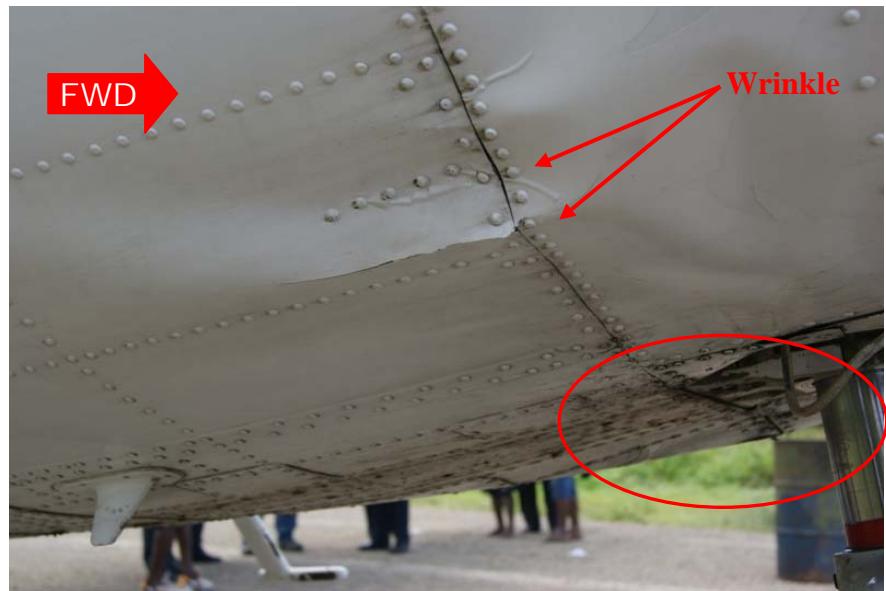
Figure 2. PK-NUH Station 60 (Lower Fuselage) Section

- Lower forward fuselage Station 60 twisted,
- Right wing leading edge damage,
- Right main landing burst,
- Left compressor block upper and lower broken,
- Left main gear shifted rearward.

About 18,4 metres from the end of runway 24, there was an scoured mark on asphalt of the runway surface that indicate the aircraft conducted a quick and steep turning (ground loop) on right main wheel. This action caused the right main wheel deflated, the left main gear shifted rearward and lower forward fuselage station 60 twisted.

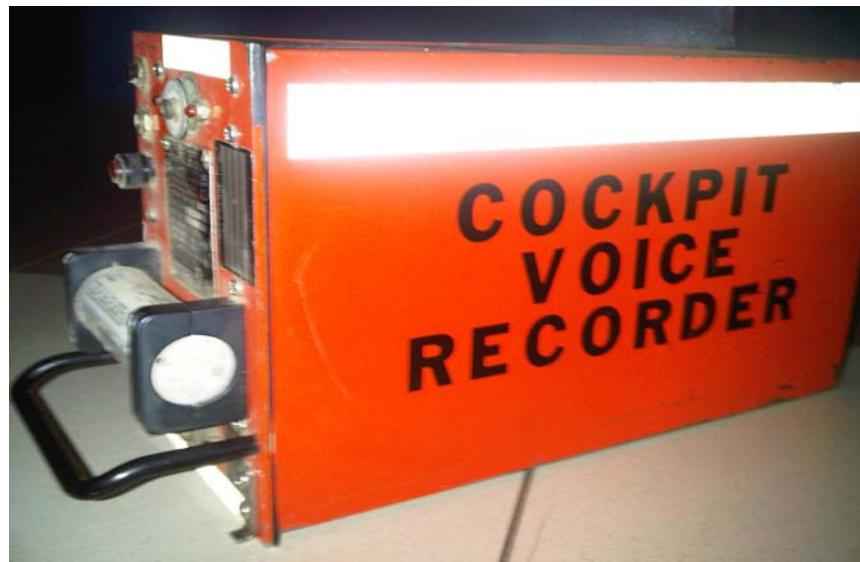
Figure 4. PK-NUH Cockpit Voice Recorder

The investigation could not find significant information related to PK-NUH occurrence, due to the relevant recorded data was overridden by the un-related conversation after the occurrence.

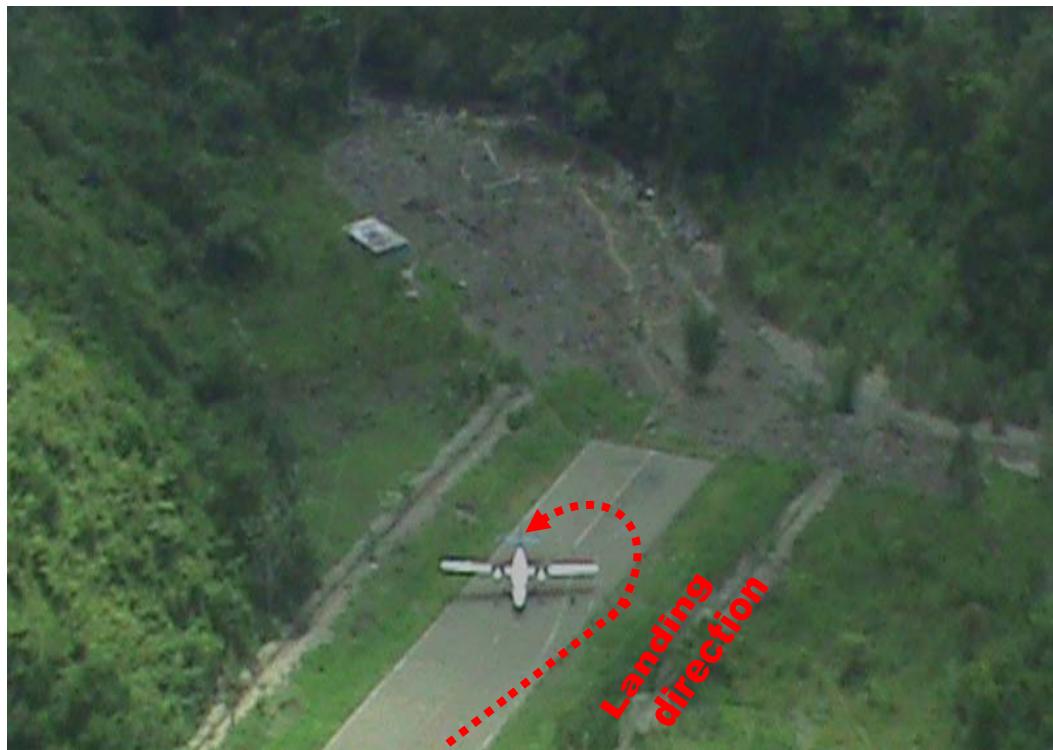
Figure 5. PK-NUH Final Position after the Occurrence

After the aircraft entering the runway, the flight crew recovered by ground loop about 18.4 metres before the end of runway 24. The aircraft stopped 35.8 metres before the end of runway 24 and heading 35°.

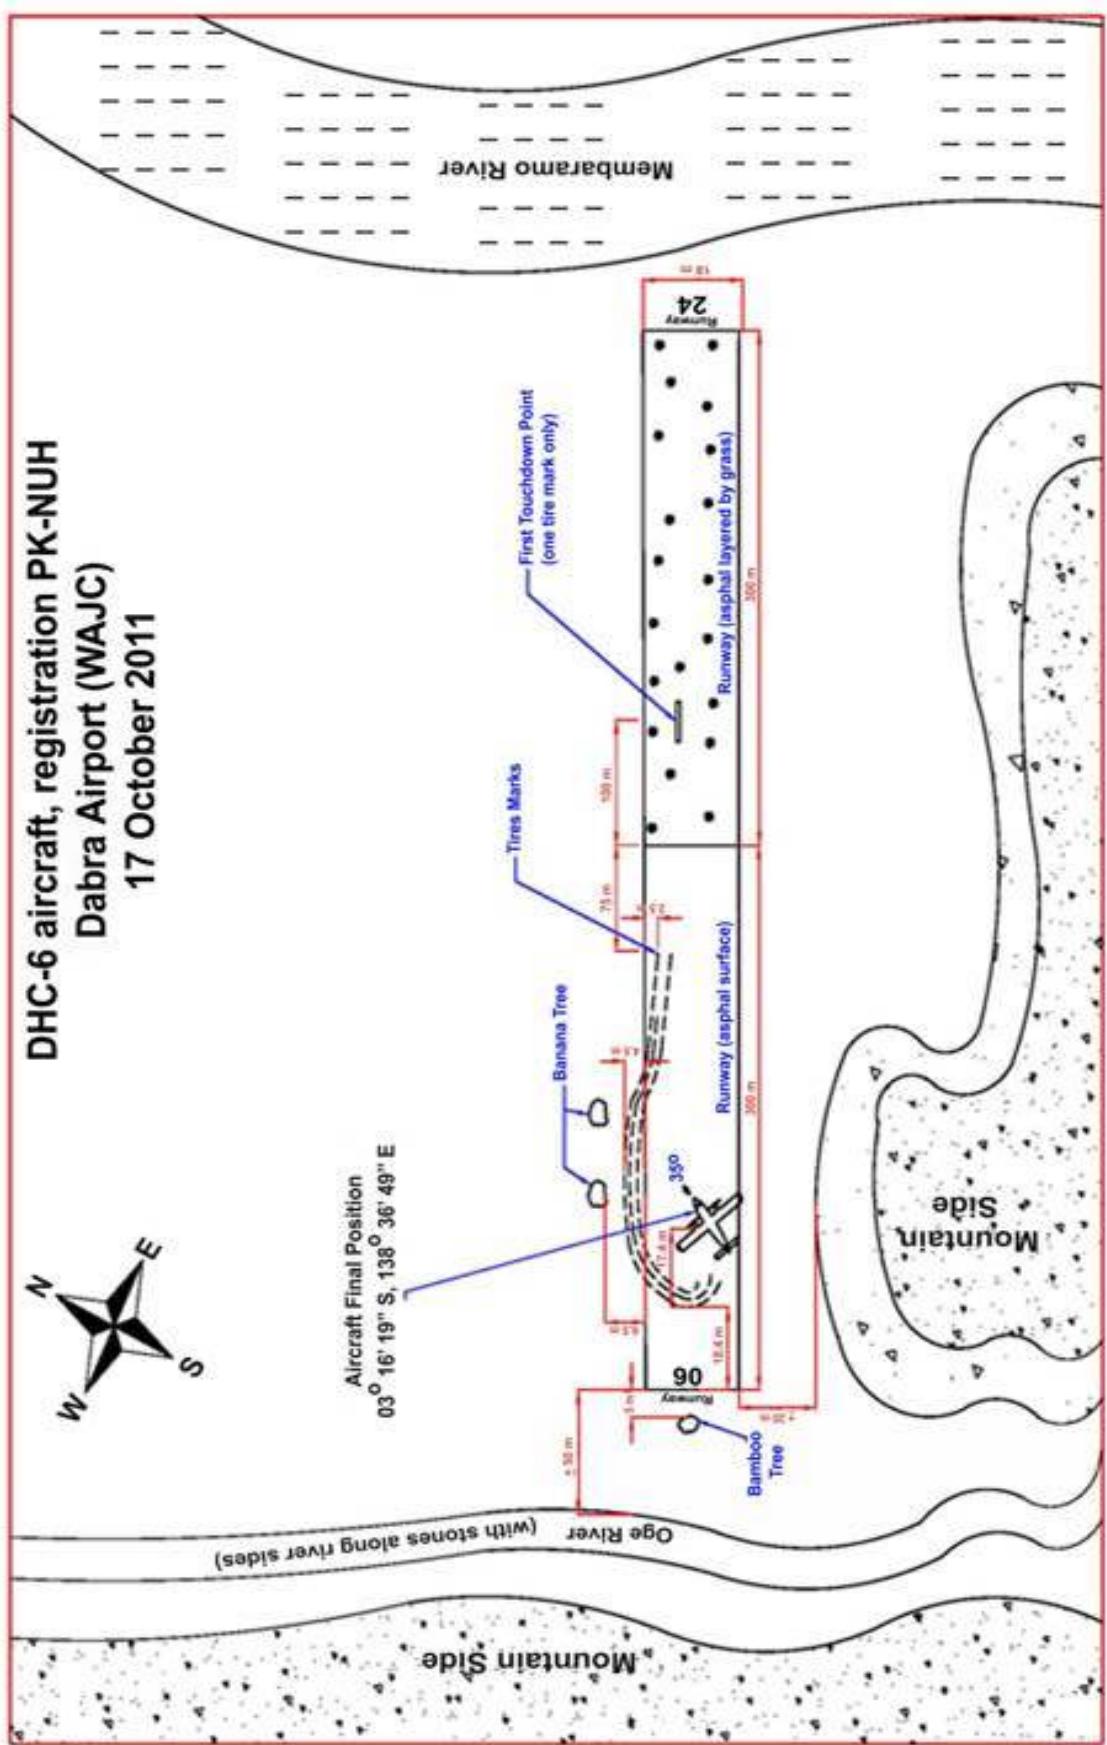
Figure 6. The Sketch of PK-NUH Final Position

The first main wheel tire mark was one main wheel on the runway about 200 metres and the second marks were about 375 metres from the beginning of the Runway 24, it indicated that the aircraft experienced bouncing during touchdown.

The following wheel mark indicated the aircraft veered to right of runway 24. The aircraft was out of the runway 24 and rolling on the right shoulder about 120 metres and the aircraft right wing hit banana trees 6.5 metres in the right of runway, and the PIC recovered the aircraft directed the aircraft entering into the runway and conducted a quick steep turning to the right and stop on the runway in the opposite direction.
