# Appendix 1

Fragmentation and other damage features of the fan of No.1 engine from G-OBME

BMA BOEING 737 - 400 G - OBME

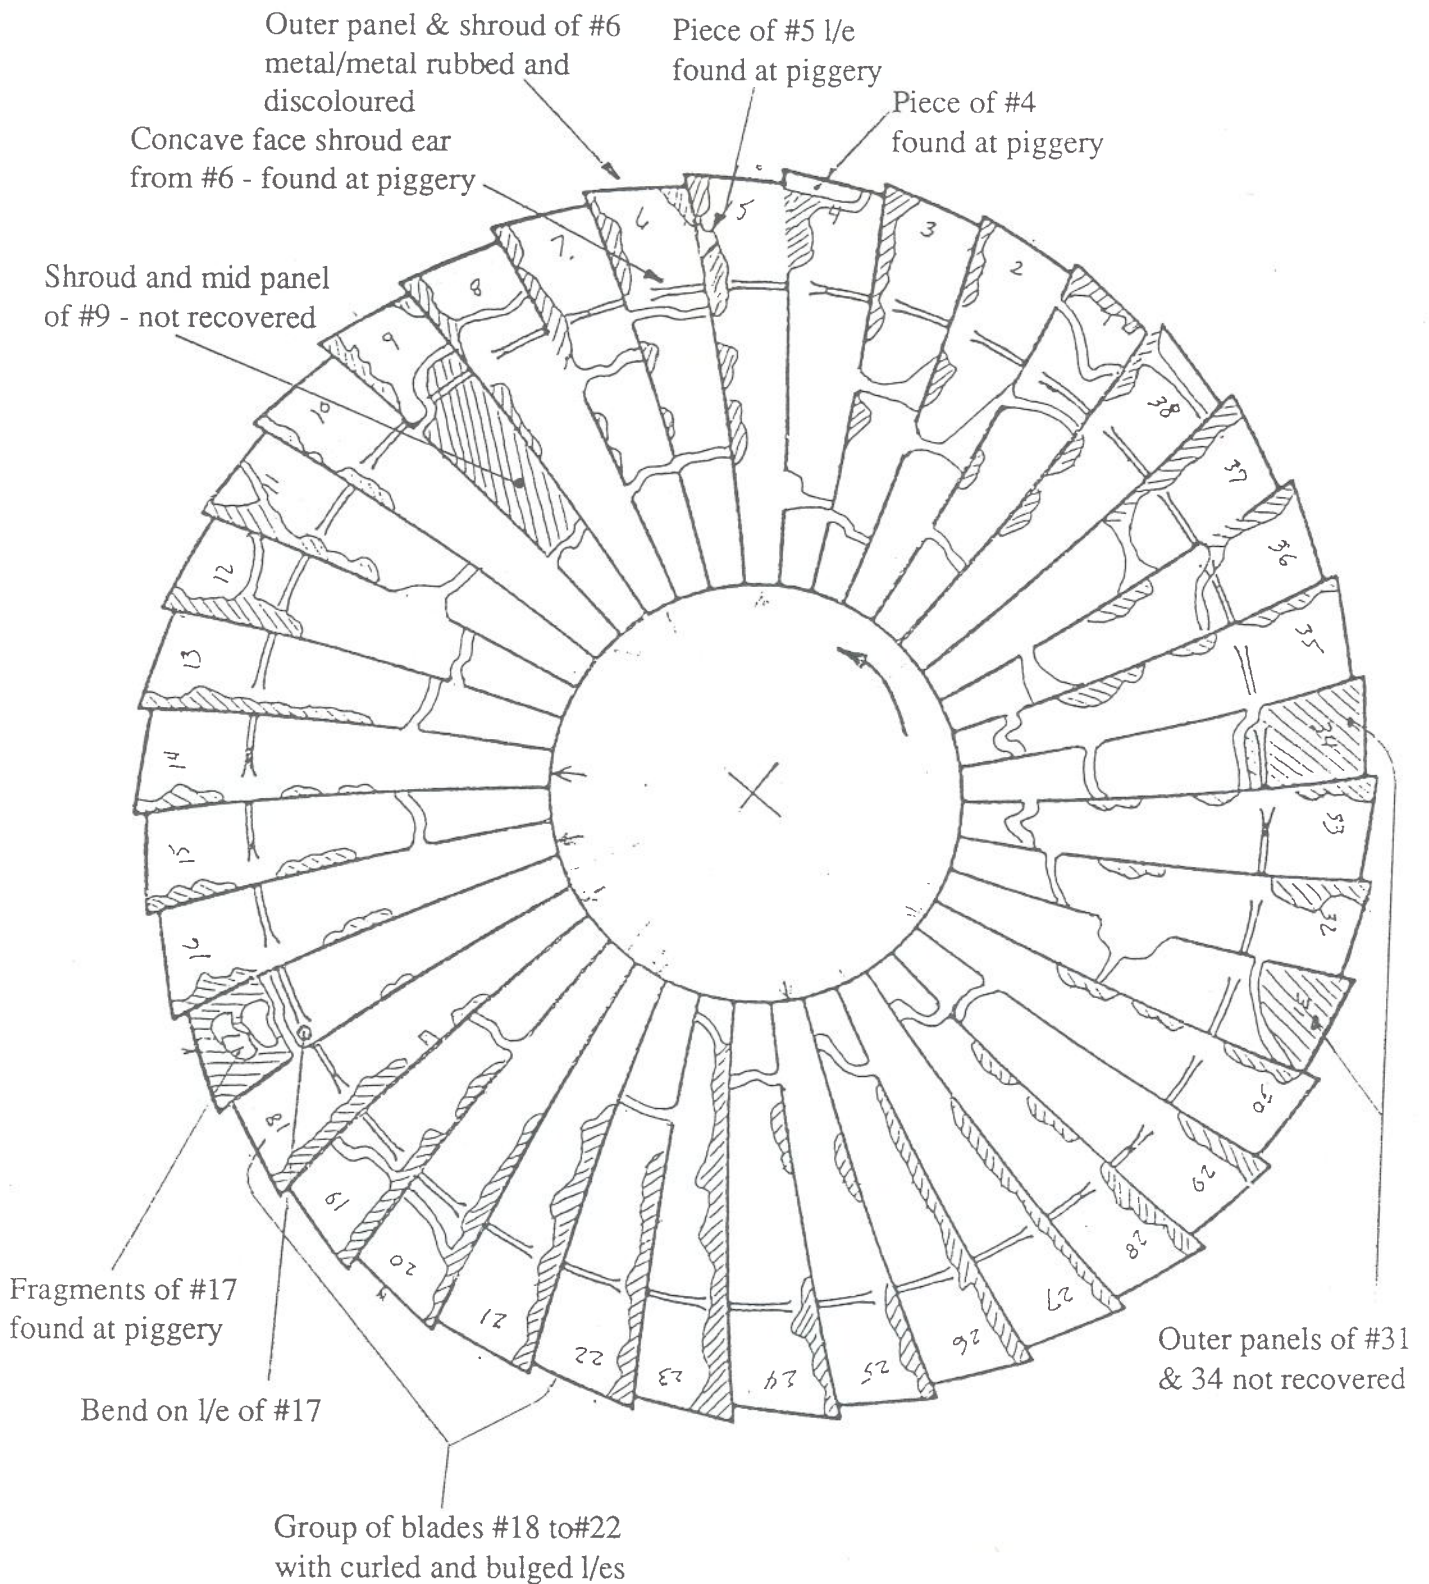
**Figure 3**

Microsection through the leading edge of blade 17 immediately below the plane of the fatigue crack.

This shows the even microstructure of the blade material as a whole and where the microstructure has been modified by high energy impacts.

The arrows point to the pressure (lower) and suction face impact facets where a shallow modified layer can be seen. The leading edge itself shows a much deeper bright modified layer.

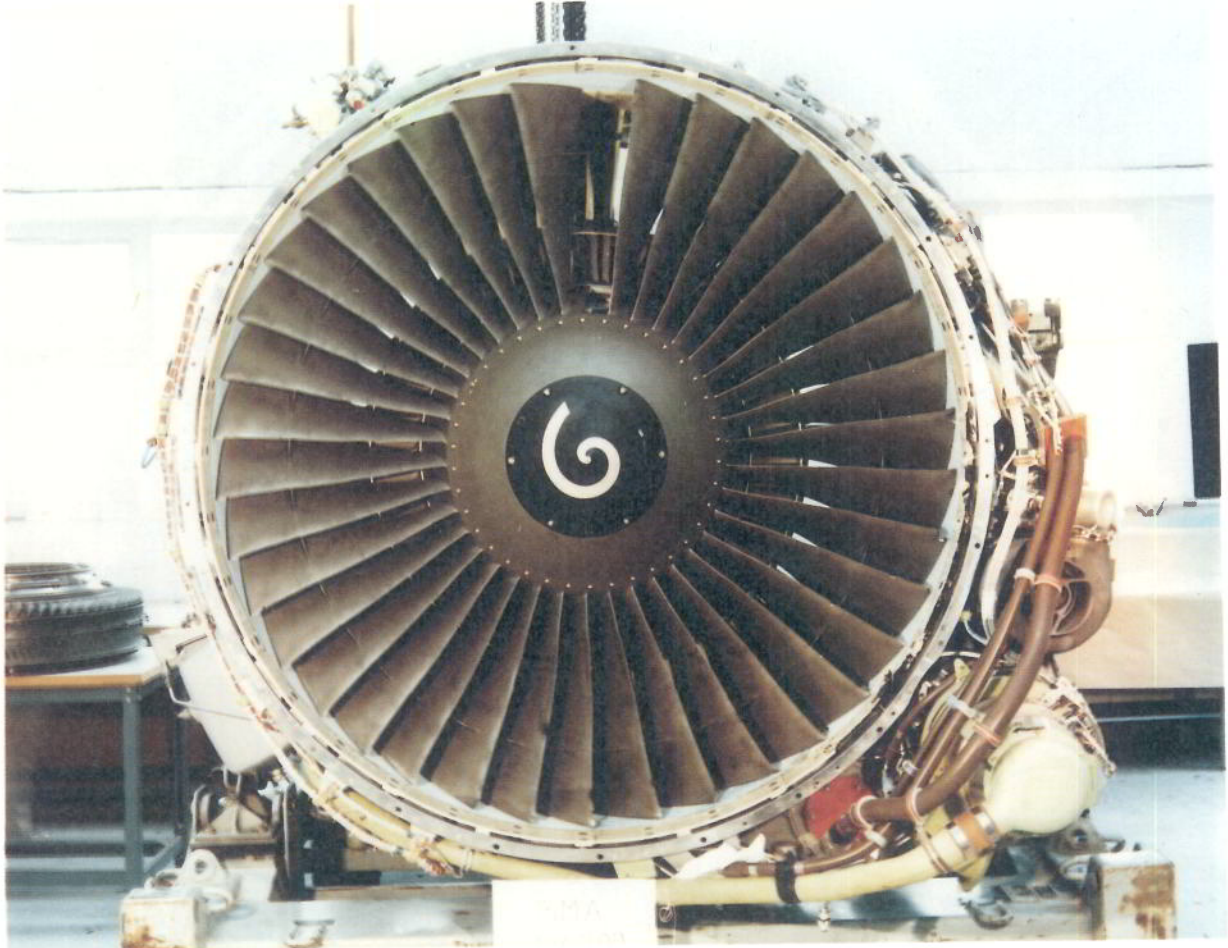
Figure 4(b)

View on front of fan of G-OBMG after in-flight fan blade outer panel separation showing the nearly total absence of leading edge damage on all the remaining blades.

The blade which suffered outer panel separation has been removed from the 12 o'clock position.

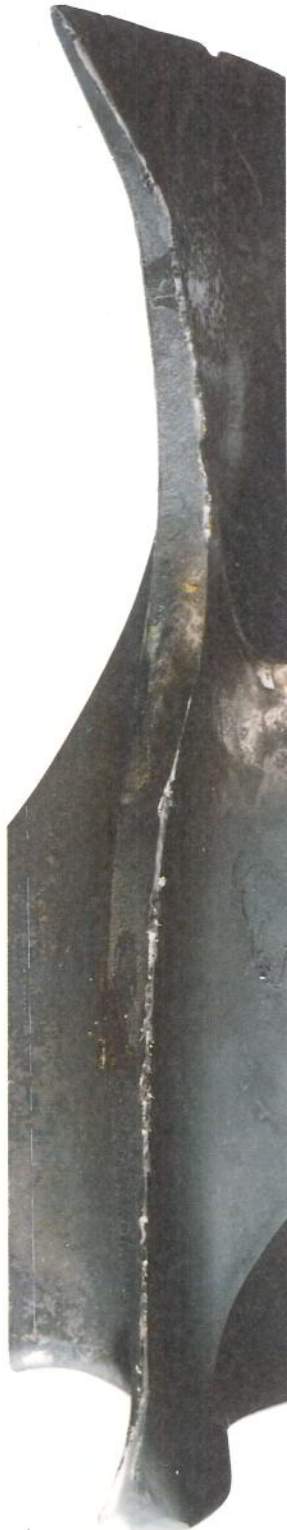
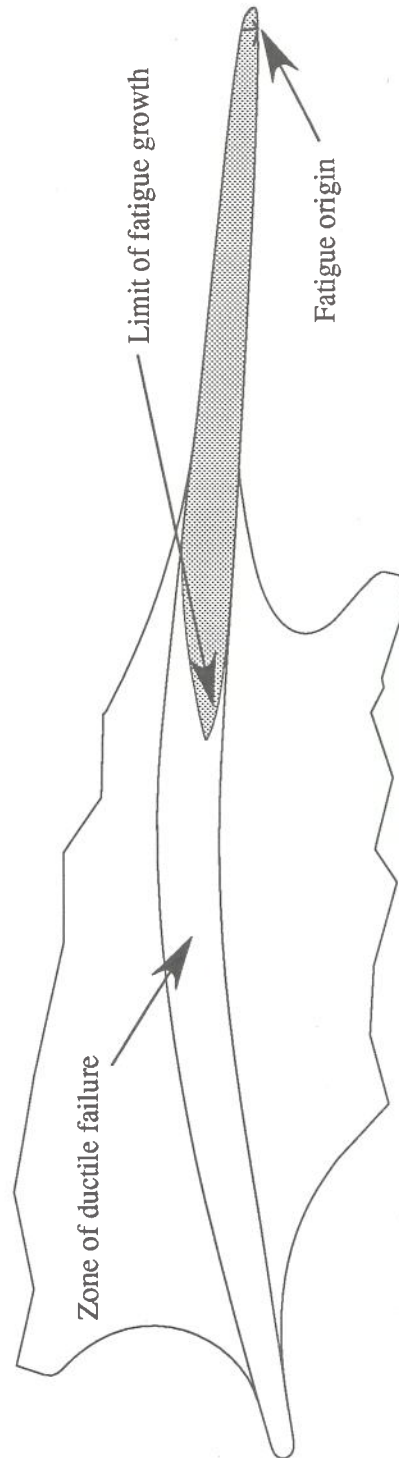
Features of fan blade fracture from G-OBME

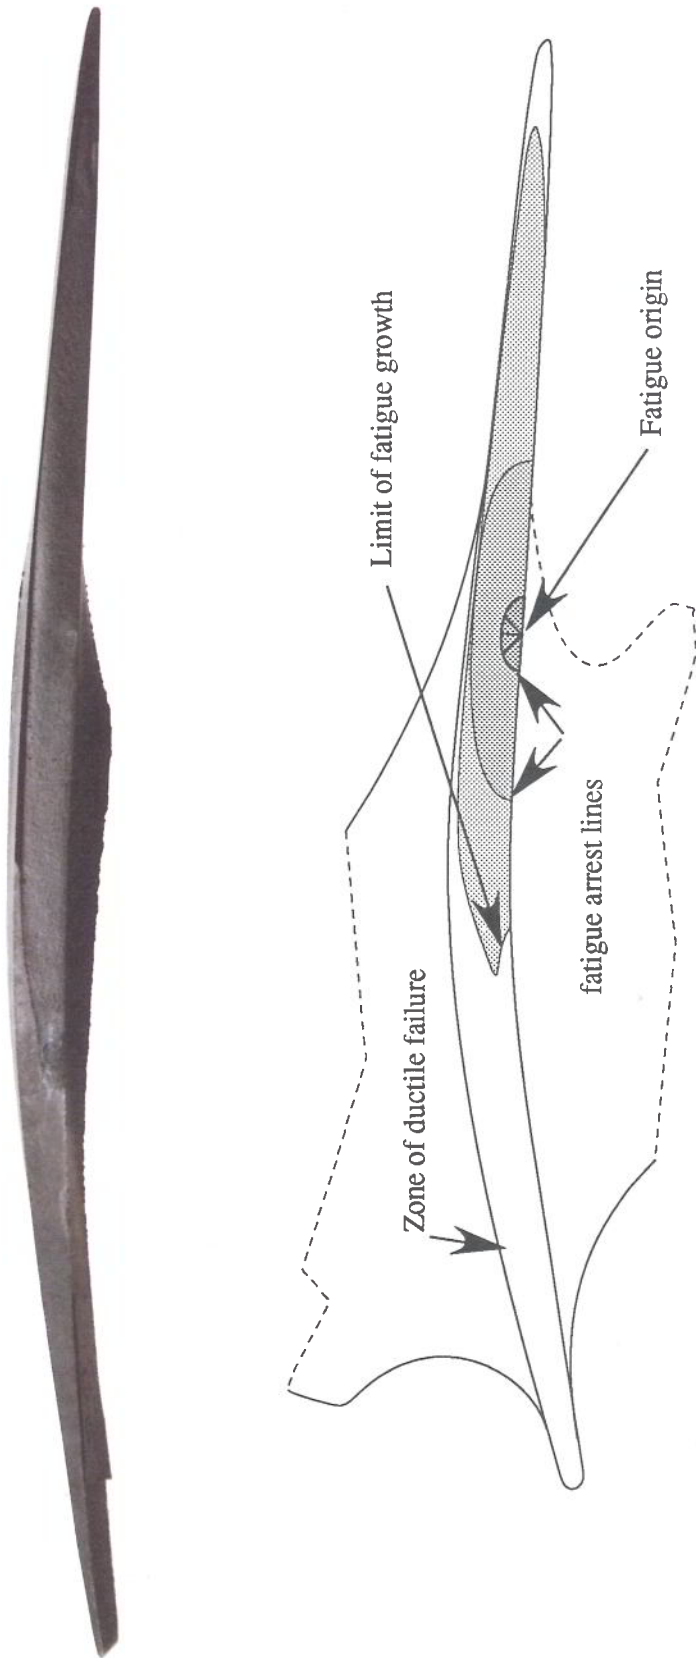
Features of fan blade fracture from G-BNNL

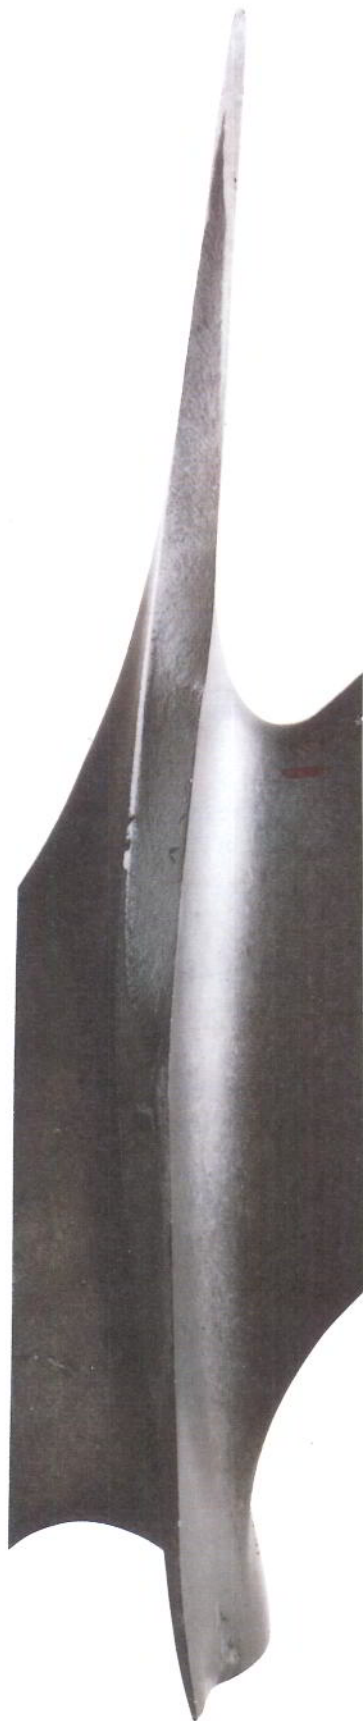
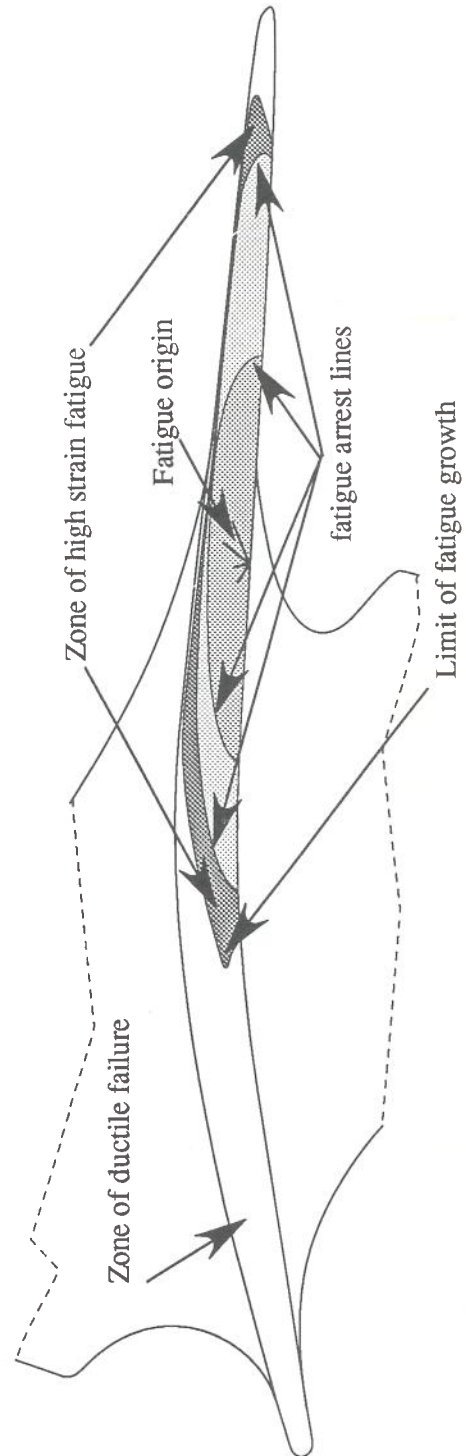
Features of fan blade fracture from G-OBMG

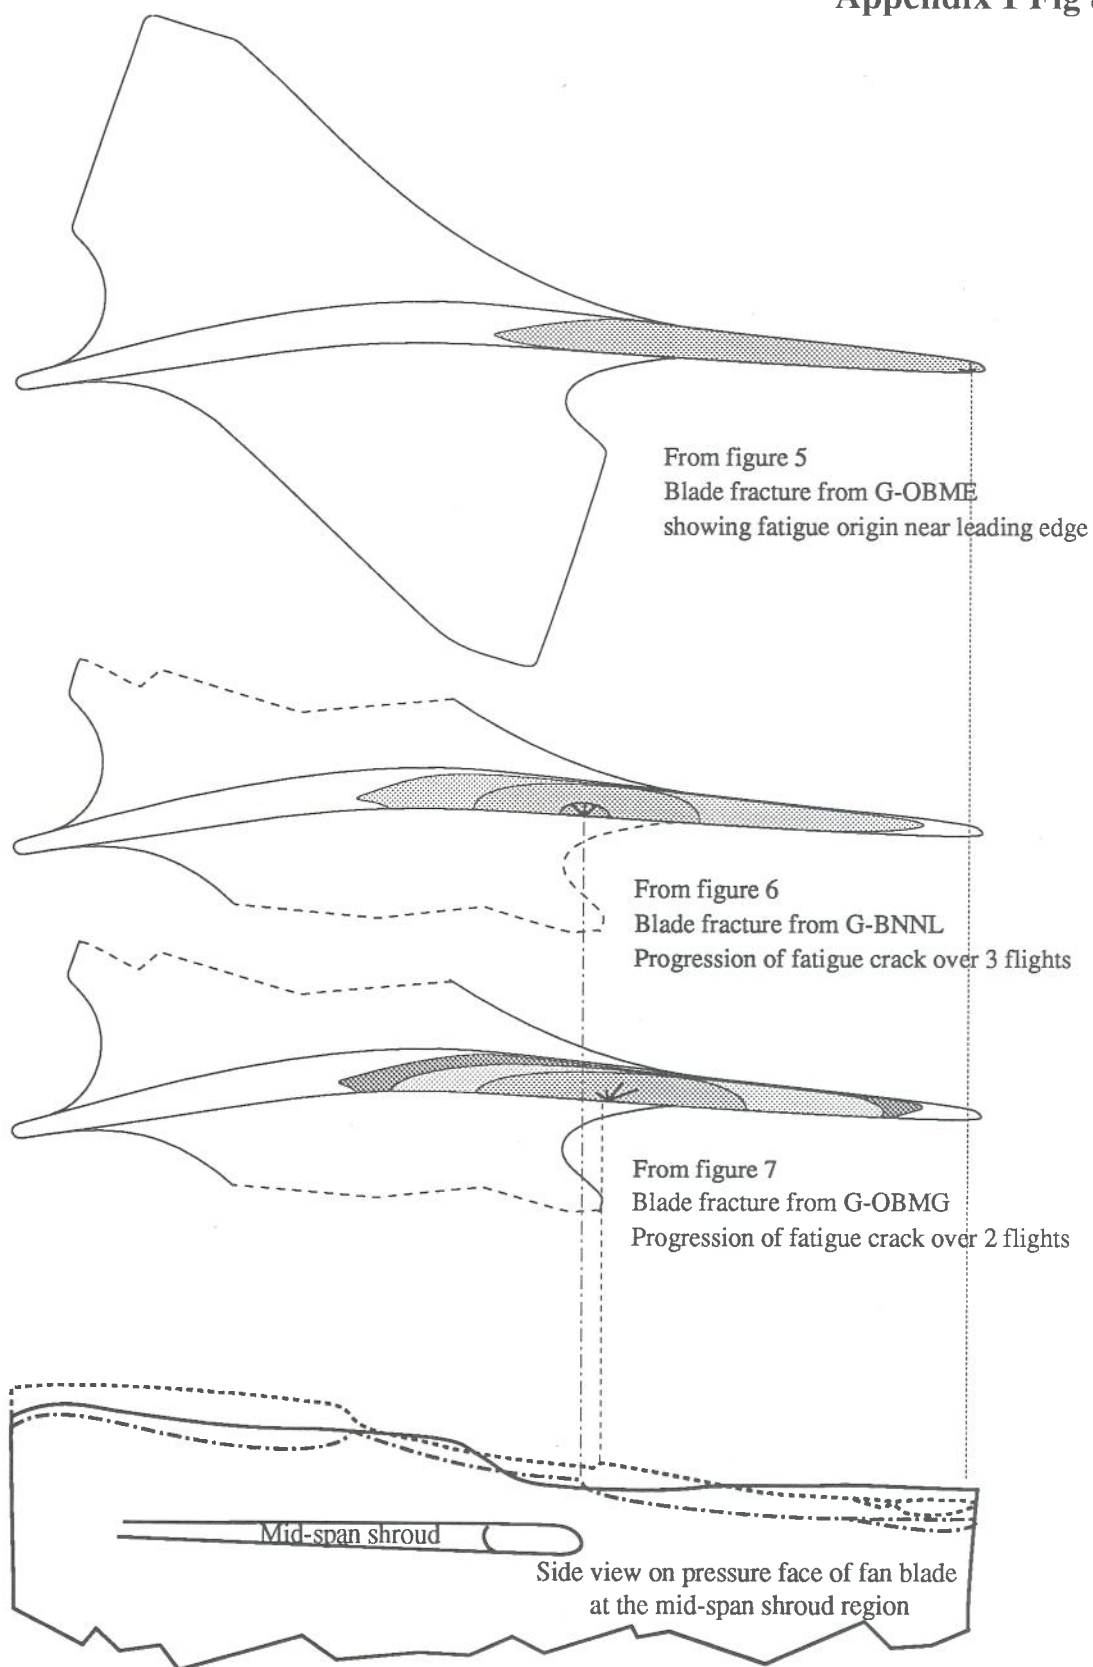
## Appendix 1 Fig 8

Comparison of fracture lines on 3 fan blades
