Loss of separation involving CASA C212-CC, VH-MQD, operating in the Richmond parachuting area and Boeing 737-7BX, VH-VBP

near Richmond Aerodrome, NSW | 5 November 2011

ATSB Transport Safety Report
Aviation Occurrence Investigation
AO-2011-142
Final – 16 December 2013

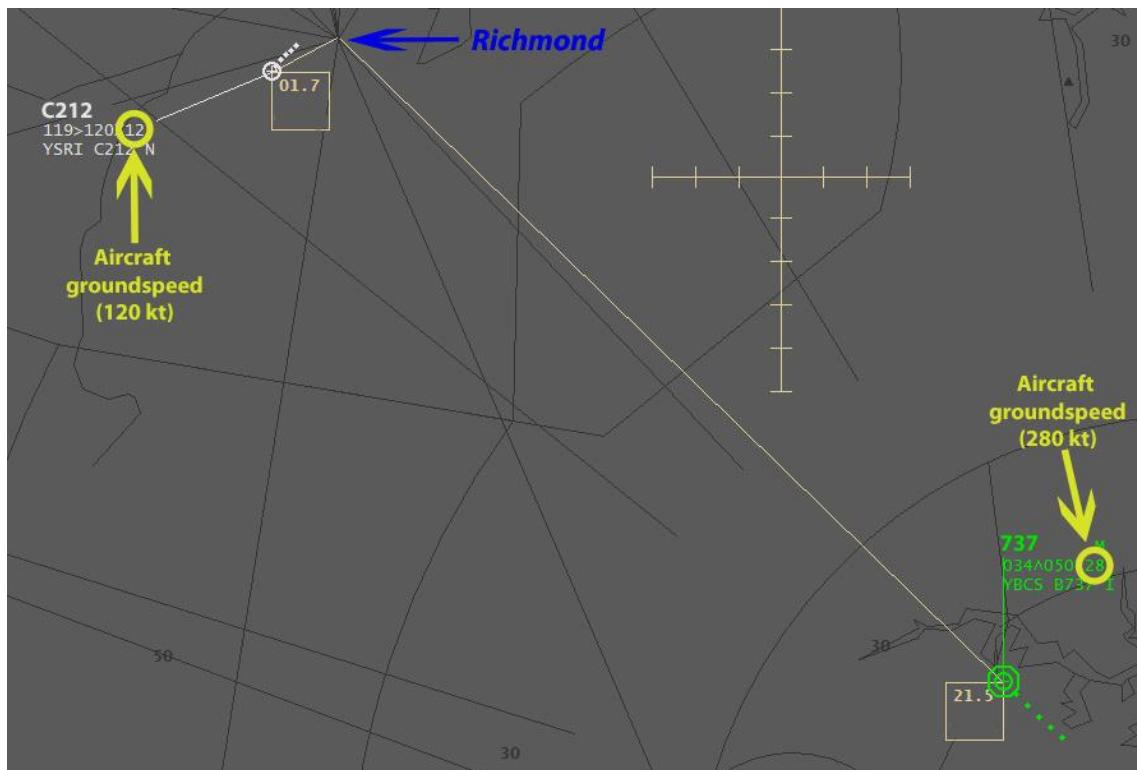
Figure 2: Aircraft positions at 1439:15

At 1439:15, the SDS trainee assigned the 737 a climb to 10,000 ft. At that time, the 737 was 21.5 NM (39.8 km) to the south-east of Richmond, passing through 3,400 ft with a groundspeed⁸ of 280 kt. The C212 was 1.7 NM (3.1 km) to the south-west of Richmond, maintaining 12,000 ft,⁹ with a groundspeed of 120 kt (Figure 2).

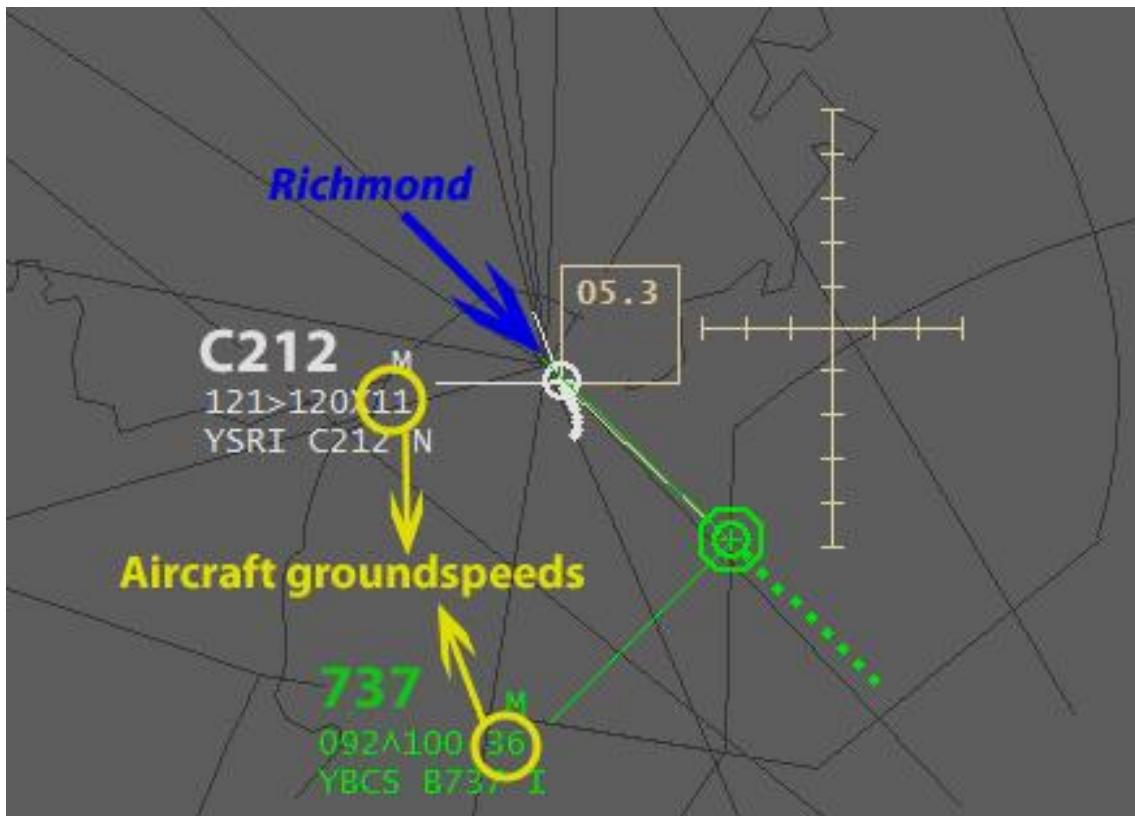
Figure 3: Aircraft positions at 1442:05

The SDS trainee instructed the 737 flight crew to contact the SAW controller at 1441:28, following that controller's system acceptance of the aircraft. The 737 flight crew first contacted the SAW controller at 1442:05, and was instructed by the SAW controller to stand by. At the time, the 737 was climbing through 9,200 ft, at a groundspeed of 360 kt, and 5.3 NM (9.8 km) from the C212. The C212 was maintaining 12,000 ft at a groundspeed of 110 kt and about 1 NM (1.85 km) south of Richmond tracking north-westerly (Figure 3).

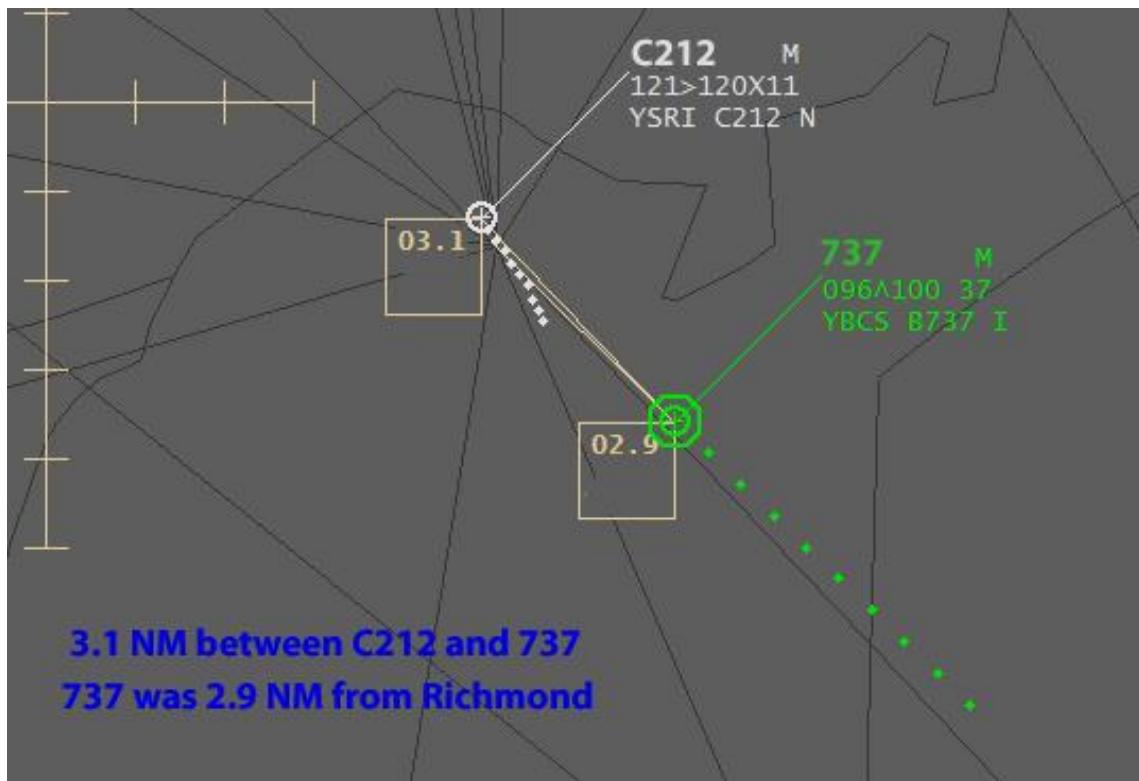
Figure 4: Aircraft positions at 1442:35

The SAW controller then asked the C212 flight crew for the 'status of the chutes'. Seven seconds later, after no response from the C212 flight crew, the SAW controller called again, to which the flight crew asked for the controller to repeat their request. The SAW controller again asked for a report on the 'status of the chutes', to which the flight crew responded with another request for the controller to repeat their query. The controller then asked 'are the chutes in the air?' to which the flight crew reported that the paratroopers were exiting the aircraft. At that time (1442:35), the 737 was 2.9 NM (5.4 km) to the south-east of Richmond, passing 9,600 ft on climb, with a groundspeed of 370 kt. The C212 was maintaining 12,000 ft, with a groundspeed of 110 kt, just to the north-west of Richmond and 3.1 NM (5.7 km) from the 737 (Figure 4).

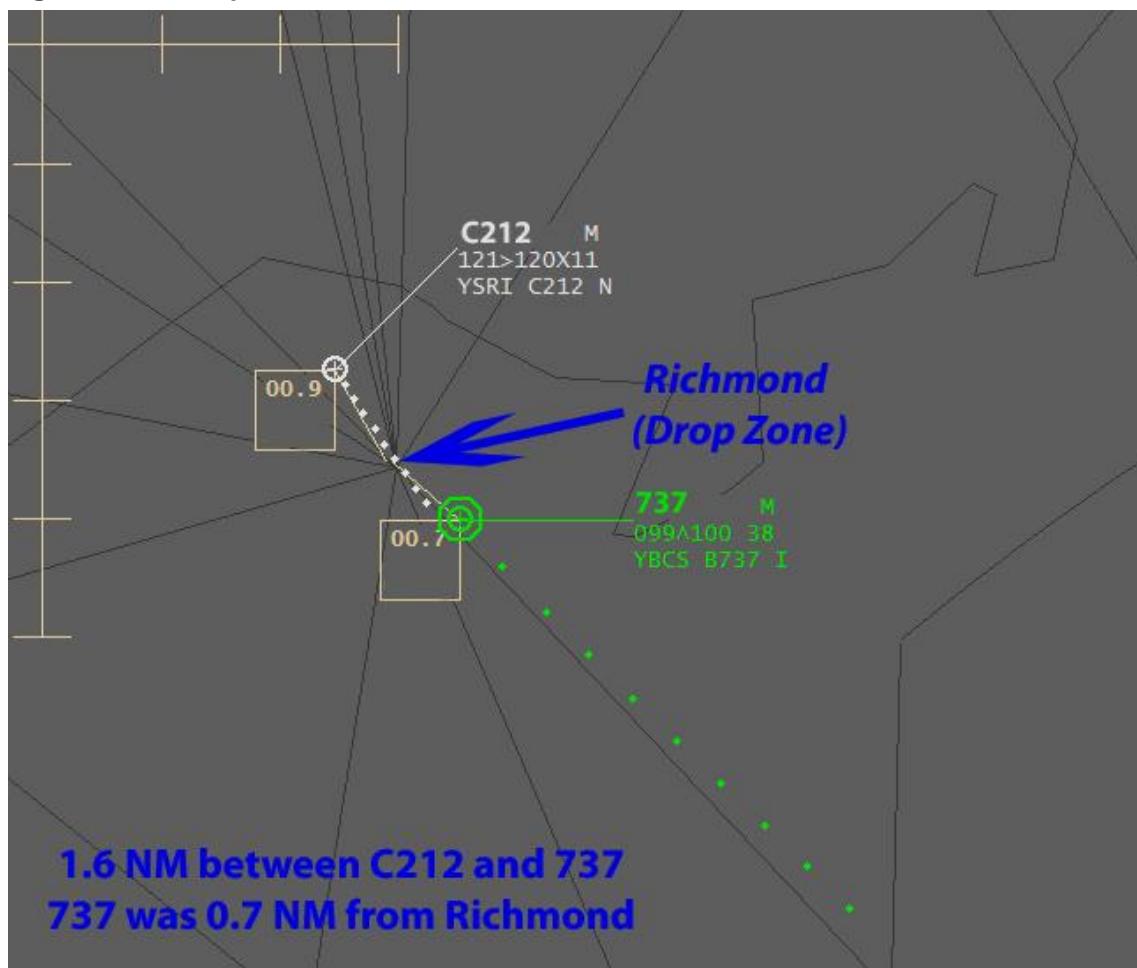
Figure 5: Aircraft positions at 1442:59

Directly after, at 1442:59, the SAW controller issued a traffic alert to the 737 flight crew that advised the C212's call sign and that 'chutes [were] in the air'. At that time, the C212 was maintaining 12,000 ft, with a groundspeed of 110 kt, 0.9 NM (1.7 km) north-west of Richmond and 1.6 NM (3.0 km) ahead of the 737. The 737 was 0.7 NM (1.3 km) south-east of Richmond (the 'drop zone'), passing 9,900 ft in the climb, at a groundspeed of 380 kt (Figure 5).

There was a LOS between the 737 and the Richmond parachute operations area (and paratroopers). The requisite separation standard was for controllers to apply a separation buffer of 1 NM (1.85 km) around a declared parachute operations area, which itself was defined as an area within 1 NM (1.85 km) radius of the dropdown zone or target (see the section titled *Air traffic control information – ATC parachuting procedures*). In this instance, the target was within Richmond and for the period that the 737 operated within 2 NM (3.7 km) of Richmond, there was a loss of separation.

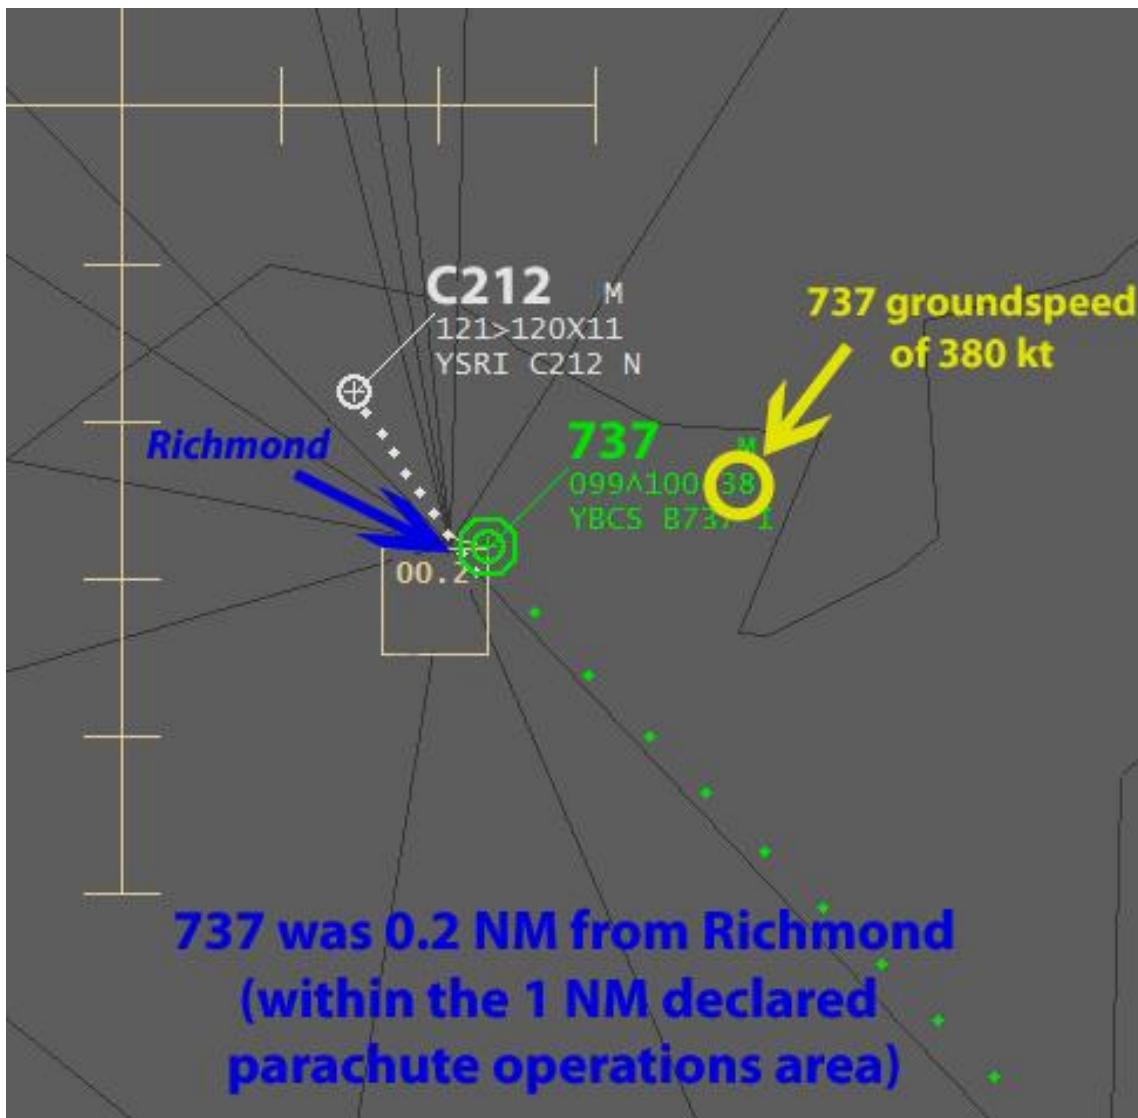
Figure 6: Aircraft positions at 1443:02

Separation between the 737 and the declared drop zone reduced to 0.2 NM (0.4 km) before the right turn that was initiated by the 737 flight crew took effect (Figure 6). At that time, the groundspeed of the 737 was 380 kt.

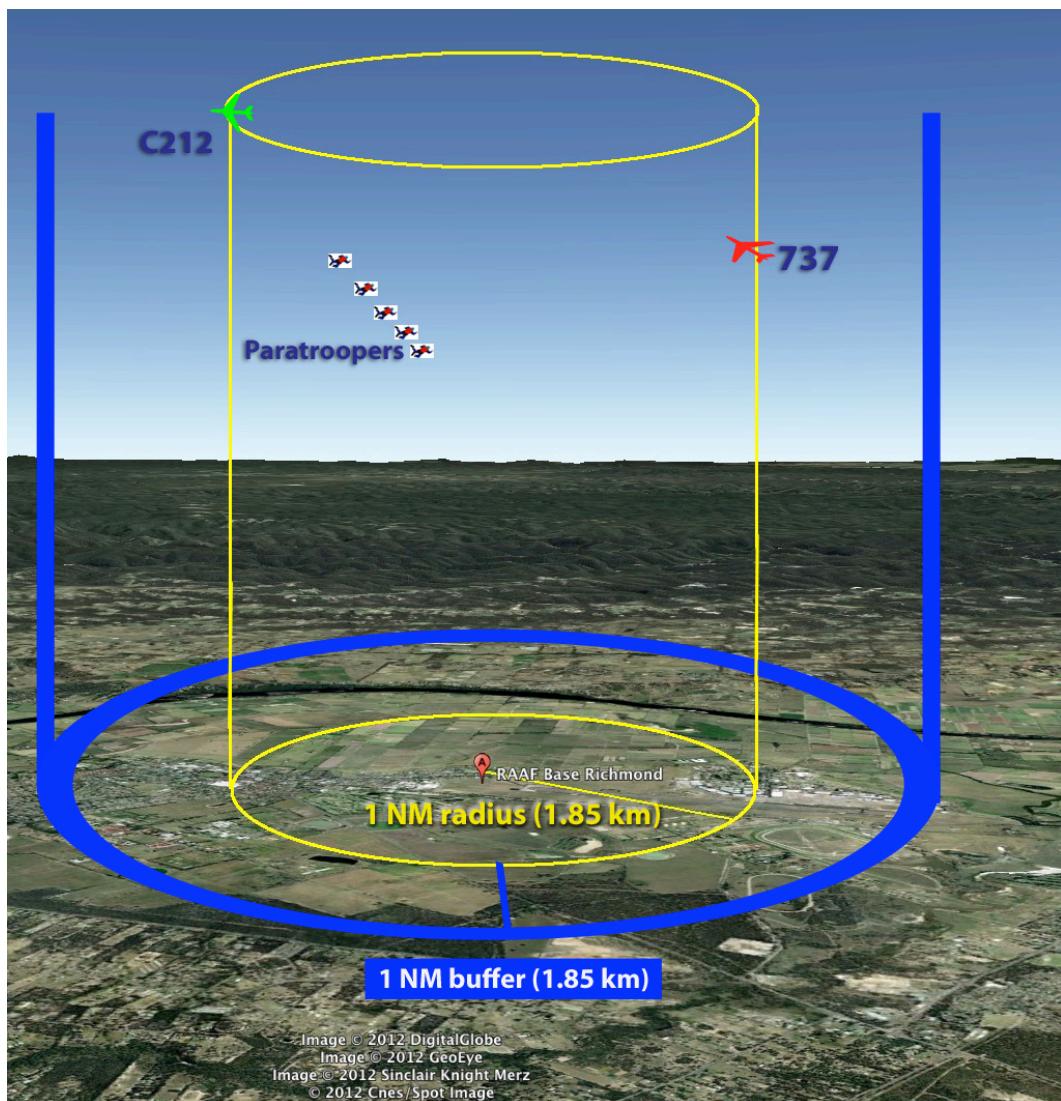
Figure 9: Illustration of the loss of separation

As defined in the Manual of Air Traffic Services (MATS), it was an air traffic control (ATC) responsibility to separate aircraft from the declared parachute drop area of 1 NM (1.85 km) radius from Richmond until receipt of advice that the drop was completed. That declared parachute drop area was from the altitude of the C212 to the ground. ATC were required to apply a 1 NM (1.85 km) buffer to that defined area (shown in blue in Figure 9). Should any aircraft have entered the 1 NM buffer, and then the column of reserved airspace below the C212 before a parachute drop had been completed, there was a loss of separation (LOS). This was the case when the 737 entered the 1 NM buffer zones, as ATC had not separated the aircraft from that area (Figure 9).
