# REPORT

Serious Incident which occurred on **20 December 2009**  
**In the cruise, FIR de Reims**  
**to Mc Donnell Douglas MD83**  
**registration F-GMLU**  
**operated by Blue Line**

# BEA

Inputting error, near stall at high altitude

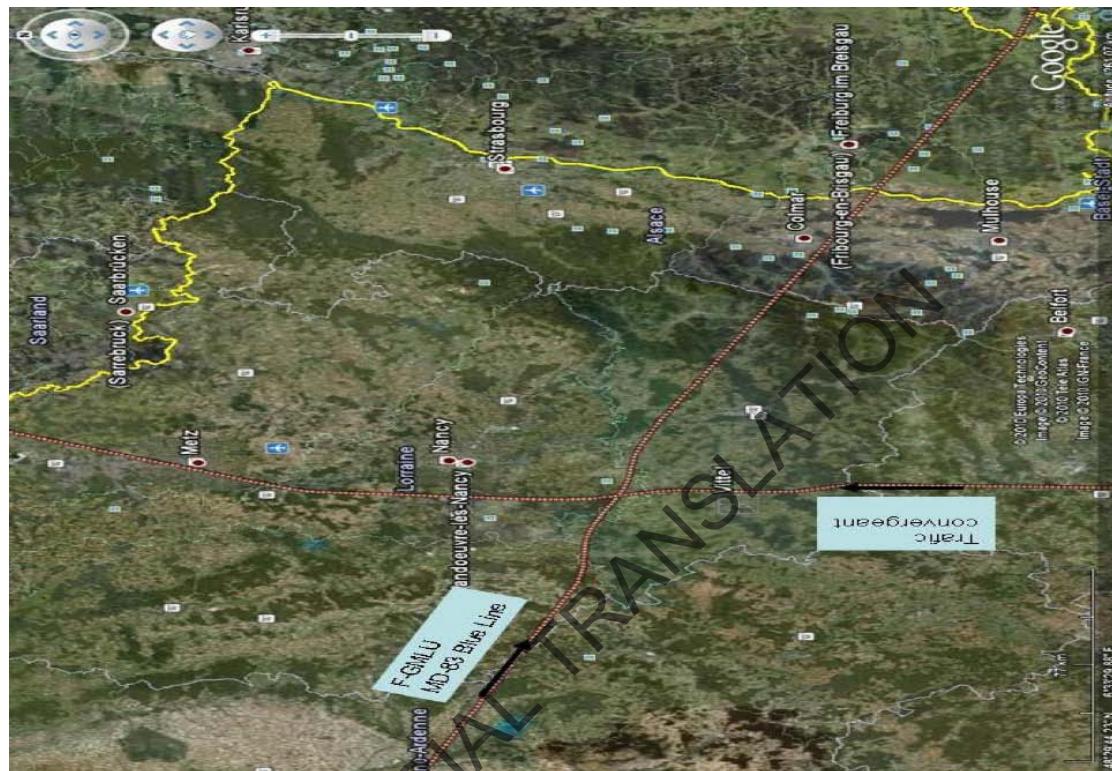
## ANNEX 1 TRACK

At 15.14.37, as the aircraft climbed to FL 300 at a Mach speed of 0.77, the controller asked the crew whether it could reach FL 370 within four minutes, in anticipation of a crossing aircraft (see path tracks in Annex 1). Having consulted the performances in the PMS, which indicated a minimum Mach speed of 0.59, i.e. 187 knots, the crew replied that it was indeed able to comply. The PF selected a climb speed of Mach 0.65 in order to maintain a margin of safety in relation to the maximum capabilities of the aircraft.

The radar tracks for the F-GMLU and the other aircraft have been calculated on the basis of the raw data from the Grand Ballon radar. At 15.21, the two aircraft were some 15 NM to the north of the town of Vittel.

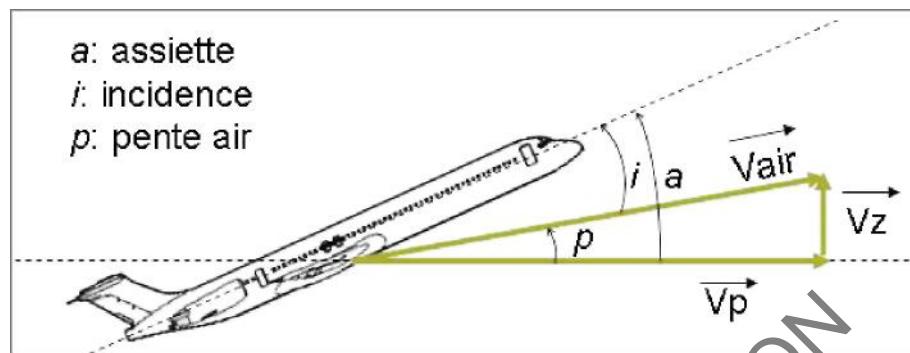
### CALCULATION OF ANGLE OF ATTACK

At 15.19.13 the aircraft came out of the turn, and the calculated angle of attack was 3° (see Annex 2), which started to increase.

At 15.20.42, the angle of attack peaked at 5.2°. The Mach number was 0.64. The ATHR mode displayed on the FMA changed to MACH ATL<sup>3</sup>, indicating that the thrust required to maintain Mach 0.65 was greater than maximum thrust.

At 15.21.03, the angle of attack was 6.1°<sup>5</sup>.

The angle of attack can be calculated on the basis of the following recorded parameters: altitude, CAS, pitch, TAT and Mach number.

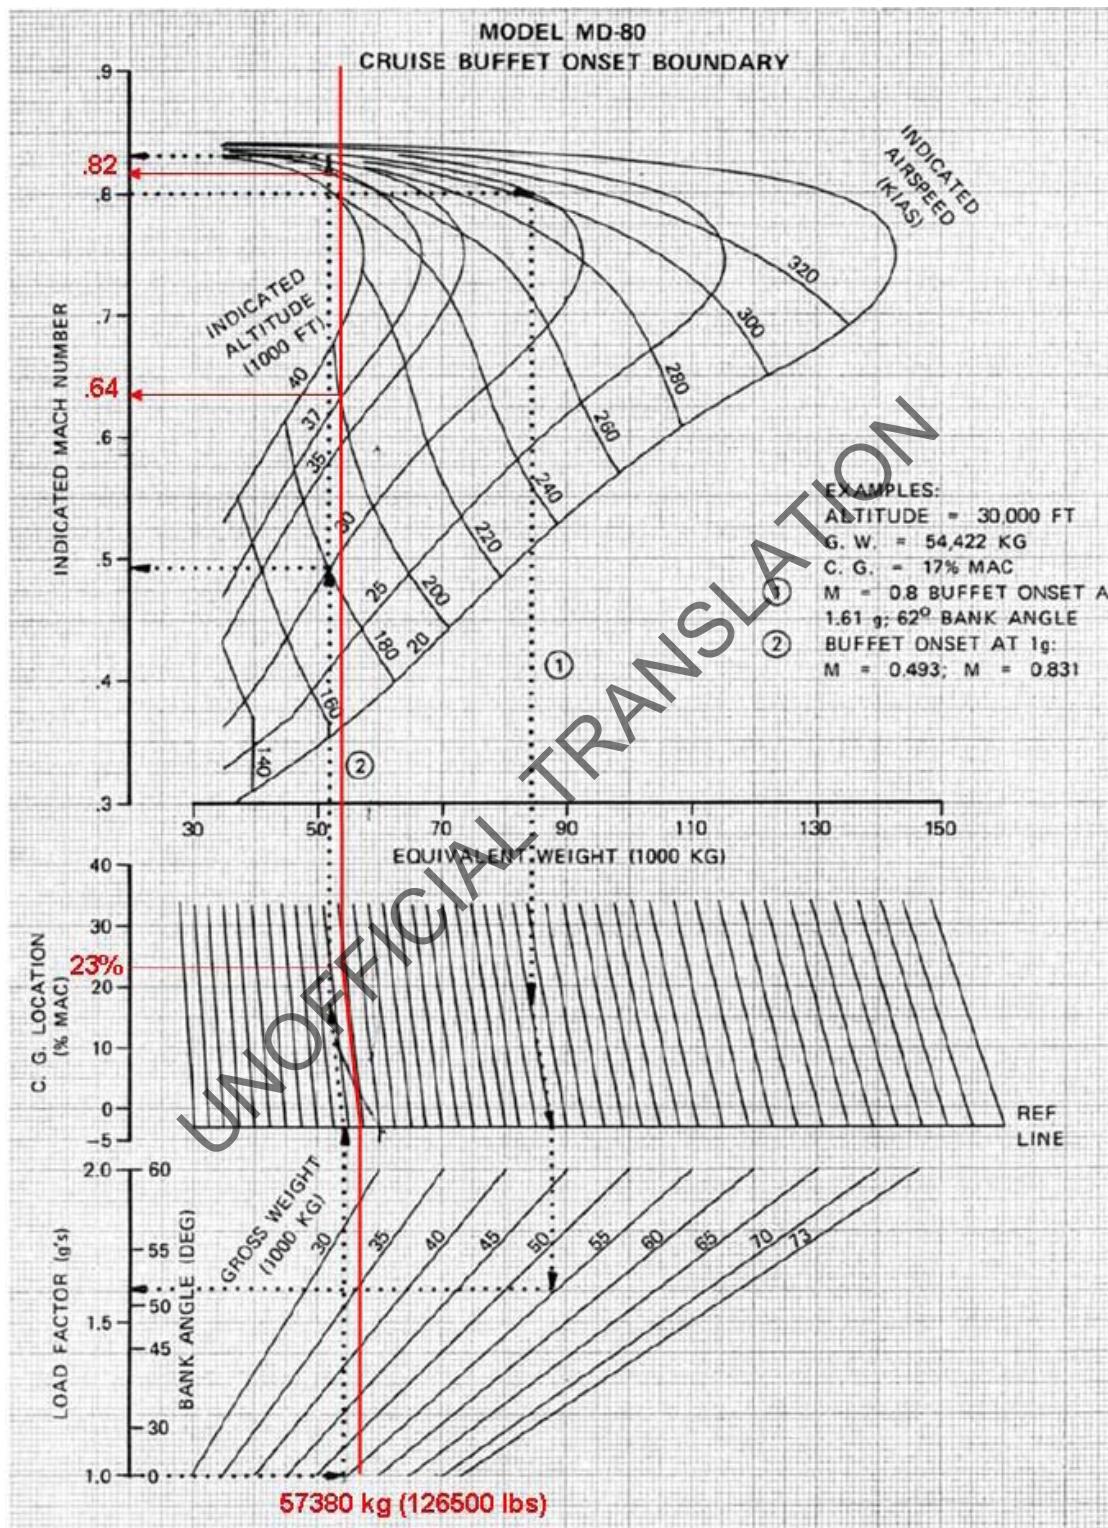
## FLIGHT ENVELOPE AT FL 370

The curve of the flight field extracted from the FCOM (see Annex 3) gives the Mach numbers for the onset of buffeting of 1g, for a weight of 126,500 lbs and a centre of gravity at 23% MAC:

- Mach buffet onset low = 0.64
- Mach buffet onset high = 0.82.

Engine thrust was limited by the thrust limit displayed on the TRP and did not allow the aircraft to climb while maintaining Mach 0.65. This meant that the Mach number reduced to 0.64 and the buffeting started.
