Investigation report

L2013-02

Serious Incident Involving Three Airliners in the Vicinity of Helsinki-Vantaa Airport on 6 February, 2013

G-EUUK	Airbus 320
OH-LKO	Embraer 190
OH-BLQ	Boeing 717

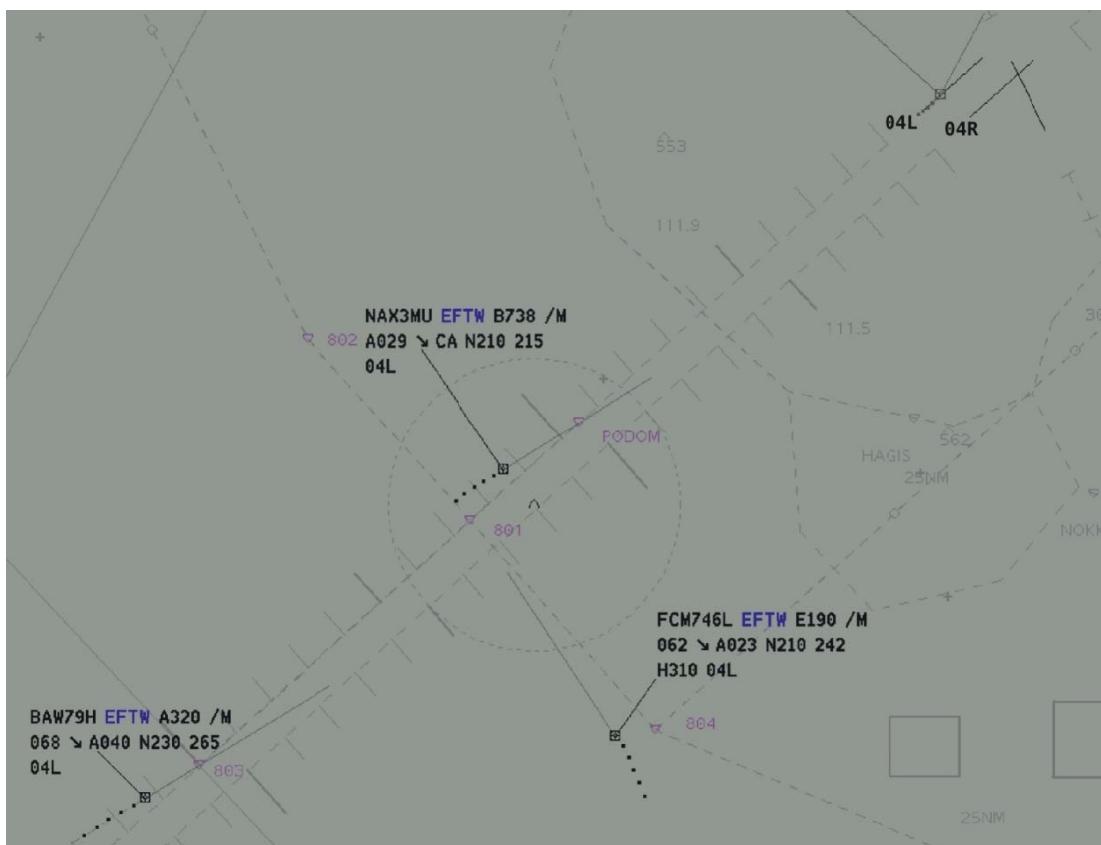
BAW79H, coming from the same direction, was trailing NAX3MU. Both aircraft had entered EFHK TMA from a direction which leads fairly straight to the approach course of RWY 04L. When BAW79H contacted ARR-E the distance from it to NAX3MU, flying ahead, was approximately 10 NM (18.5 km); there were still 24 NM (44.4 km) to go to the threshold. FCM746L was approaching from the south and ARR-E continued the radar vectoring that had been started by RAD-E, with the intention of merging FCM746L between NAX3MU and BAW79H (Figure 4).

Figure 4. NAX3MU and BAW79H are approaching from the southwest. The distance between them is 10 NM. FCM746L is approaching from the south, maintaining the heading 310 degrees. © Finavia, permission 4/590/2007.

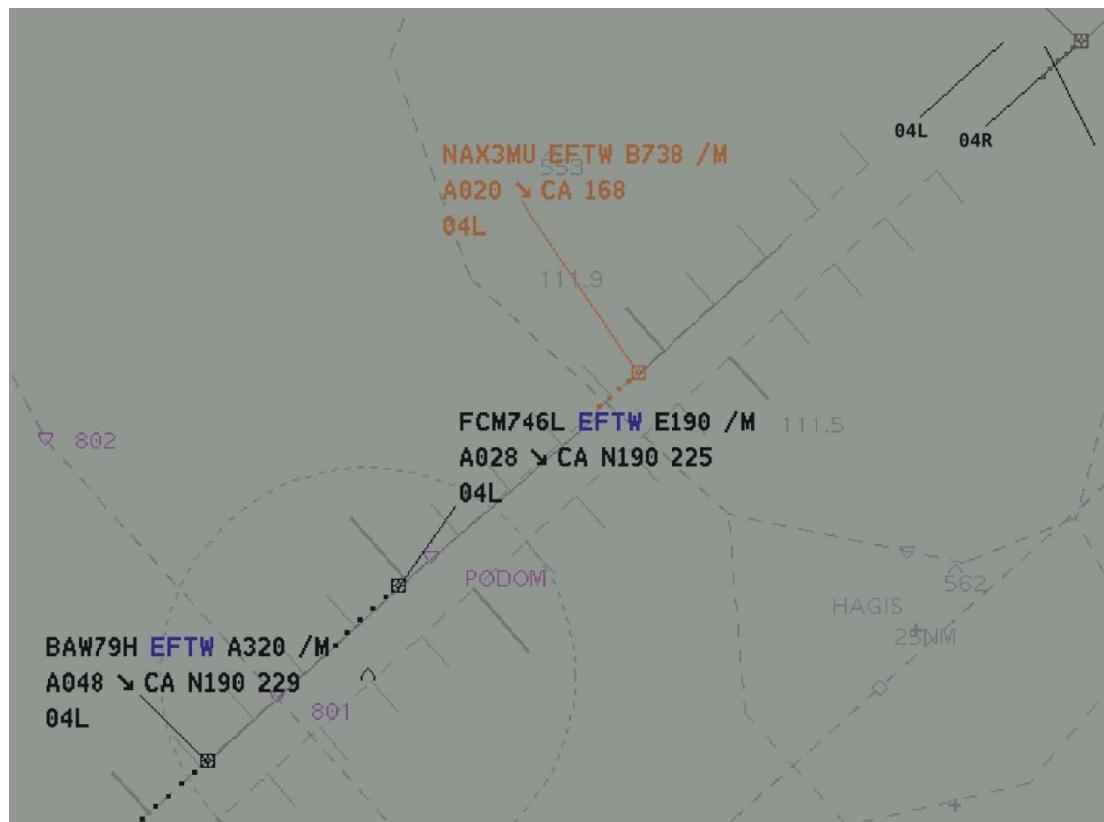
At 16:01:13 ARR-E issued an approach clearance to BAW79H and immediately thereafter to FCM746L. A moment later, as FCM746L was intercepting the final approach course the distance from it to NAX3MU, flying ahead, was 4.6 NM (8.5 km) and to BAW79H, trailing behind, 3.8 NM (7 km). Because of their diverging airspeeds the distances between the aircraft continued to decrease (Figure 5).

Figure 5. FCM746L intercepts the final approach course.

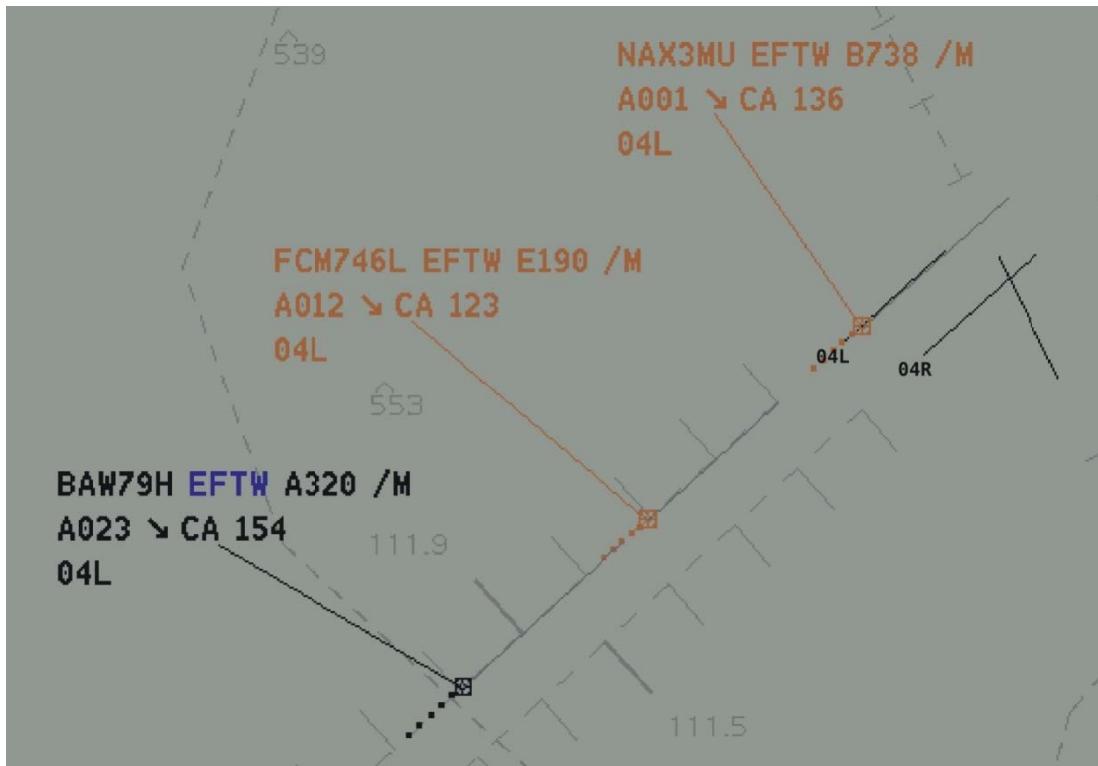
When BAW79H contacted ARR-E it was reducing its speed to 230 KT. ARR-E further reduced its speed to 210 KT, 190 KT, 180 KT, 170 KT, 160 KT and to minimum approach speed. At 16:04:50 BAW79H was 6 NM from the threshold of RWY 04L, and 2.9 NM from the preceding FCM746L (Figure 6).

Figure 6. The distance between BAW79H and FCM746L is 2.9 NM. NAX3MU is landing on RWY 04L. The brown colour of the radar labels indicates that ARR-E has transferred the aircraft to TWR-W and that TWR-W has assumed them.
 © Finavia, permission 4/590/2007.

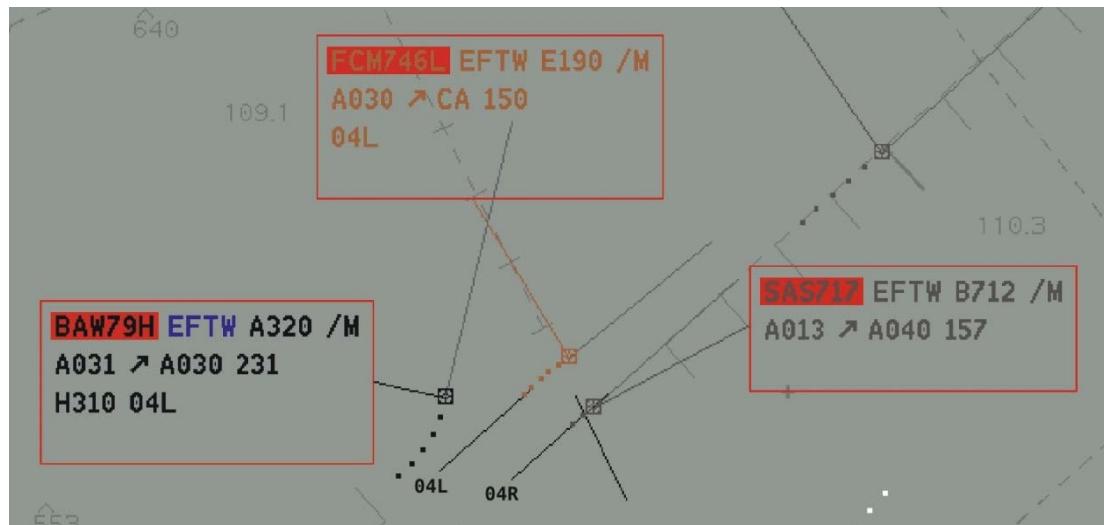
At 16:06:45 the radar system annunciated a Short Term Conflict Alert (STCA) relating to BAW79H and FCM746L as the distance between them at the time was 2 NM (3.7 km). The succeeding BAW79H was flying 80 KT faster, and there was no vertical separation between them. At 16:06:55 ARR-E told BAW79H to fly to heading 335.

At 16:07:08 TWR-W called ARR-E and informed it that FCM746L was going around, heading 040 degrees. TWR-W urged ARR-E to immediately turn BAW79H to the left, at which time ARR-E told BAW79H to continue turning to the left, heading 310 (Figure 7), and a moment later, to heading 280. The minimum distance between BAW79H and FCM746L was 1.5 NM (2.8 km), and at this time they were flying at the same altitude.

Figure 7. The distance between BAW79H and FCM746L is 1.5 NM. The red STCA alerts are illuminated. © Finavia, permission 4/590/2007.

Safety Investigation Authority, Finland recommends that Finavia Corporation augment the Helsinki-Vantaa ATC Ops Manual with an operational instruction in case of an STCA alert.

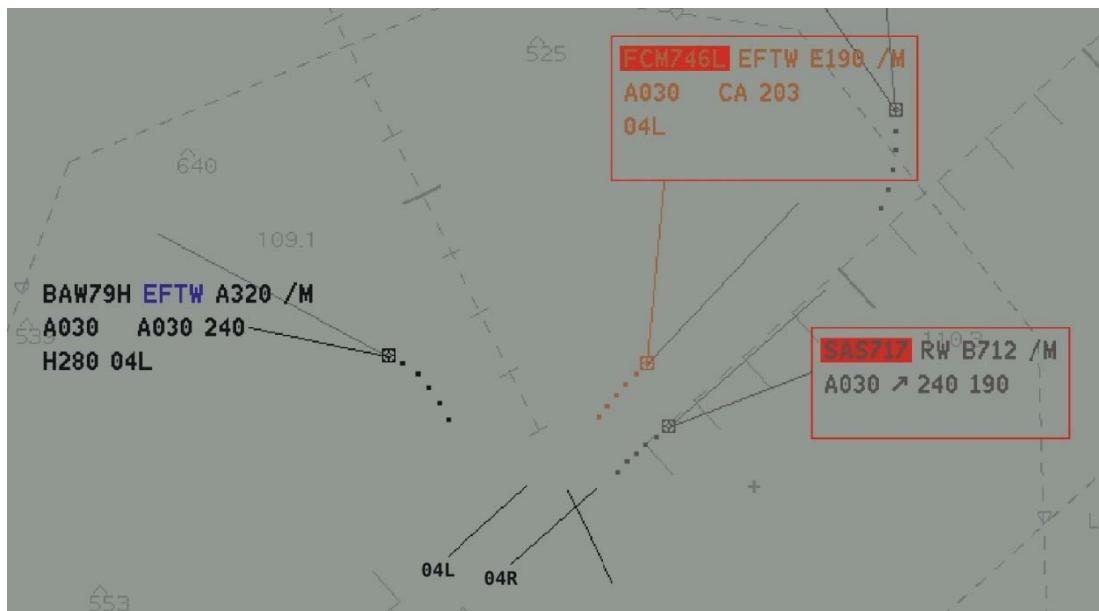
FCM746L, maintaining 040 degrees, reached 3000 ft soon after passing the threshold of RWY 04L. At 16:07:20 the radar system annunciated an STCA alert concerning FCM746L and SAS717 which had just departed from RWY 04R (Figure 7). The aircraft flew abreast of each other at the distance of 0.9 NM (1.7 km) for one minute and ten seconds. At 16:07:34 FCM746L requested TWR-W to confirm the heading 040 degrees, at which time TWR-W told it to contact ARR-E (Figure 8).

Figure 8. FCM746L and SAS717 flying abreast of each other at the same altitude. STCA alerts are illuminated. © Finavia, permission 4/590/2007.

At 16:07:50 FCM746L contacted ARR-E. After first issuing an approach clearance to another aircraft, at 16:08:01 ARR-E told FCM746L to immediately turn left heading 330. When FCM746L initiated the turn it was 3.5 NM (6.5 km) from the end of RWY 04L. The STCA alert remained on until SAS717 had climbed through 4000 ft.

Safety Investigation Authority, Finland recommends that Finavia Corporation specify and augment the instructions in the Helsinki ATC Ops Manual as regards missed approaches and non-standard go-around clearances.
