## Hard landing, inappropriate stopover maintenance procedure, take-off with a substantially damaged aeroplane

| <b>Aircraft</b> | Airbus A330-211 registered F-GZCB |
| <b>Operator</b> | Air France |
| <b>Place</b> | Caracas-Maiquetía Simón Bolívar Airport (Venezuela) |

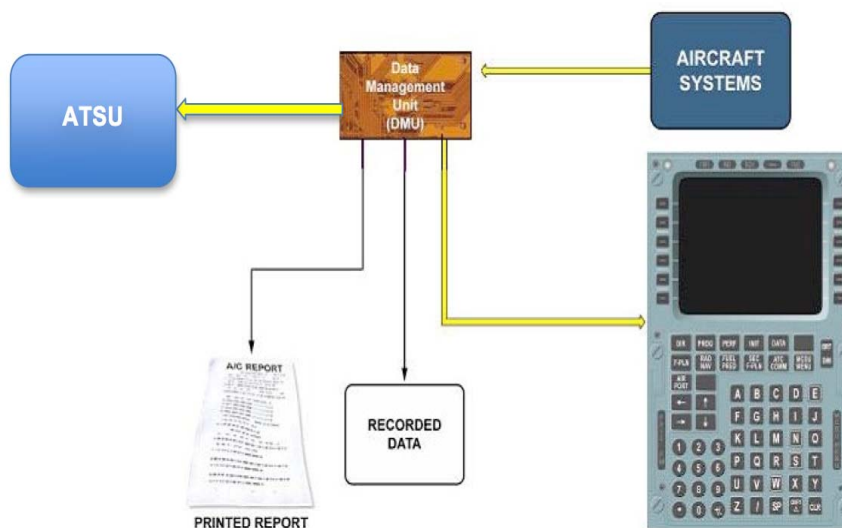
On 13 April, no R15 report relating to the hard landing had been received by the MCC. The last R15 found via the MCDU was dated 21 March 2011. An R15, generated by the DMU on 13 April, at 18 h 55 min 26 had been sent on 14 April at 21 h 14 min 02, or the day after the Paris - Caracas flight, at the beginning of the breakdown action. It is likely that the R15 associated with the last flight was not available at the time of the technicians' operations.

- ☐ The DMU did not issue a R15 report immediately after the hard landing, yet the conditions to generate it were met;
- ☐ No R15 report associated with the last flight was available on the page of the ACMS menu of the MCDU.

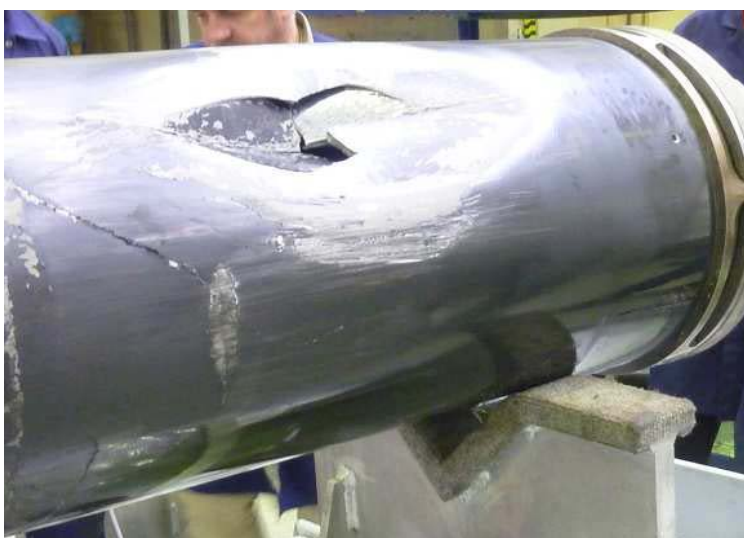
The landing gear was examined in two stages. The first examination carried out in an approved workshop enabled the absence of hydraulic fluid to be noted as well as internal fractures on the body of the fixed unit (Upper Piston). Further examinations, including in particular the characterisation of the fractures, were carried out at the manufacturer's. The examinations showed that the fractures were the result of abnormally high stress.

The incipient failure did not show any pre-weakening. Its characteristic fracture surfaces indicated that it was sudden. However the presence of an end mark was noted about twenty centimetres from the source of the fracture, indicating the development and propagation of the crack in two stages.

This mark corresponded to the end of the cracking during the immobilisation of the aeroplane on the tarmac, on arrival of the flight from Paris.

The final fracture was a result of deterioration of the landing gear which may have occurred either during taxiing to take-off on the return flight or during landing of the same flight.

The violent impact of the landing gear during the hard landing caused an excessive local increase in the damping hydraulic pressure in the lower part of the mechanism leading to constraints greater than the materials' resistance. There was excessive compression of the static piston, subsequently limiting its movement. This damage prevented the full operation of the landing gear retraction sequence.
