ATSB TRANSPORT SAFETY REPORT
Aviation Occurrence Investigation AO-2008-033
Final

**Operational non-compliance
Perth Airport, WA
9 May 2008
PK-GEF
Boeing Company 737-8CX**

Report No.	Publication date	No. of pages	ISBN
AO-2008-033	30 June 2009	33	978-1-921602-82-5

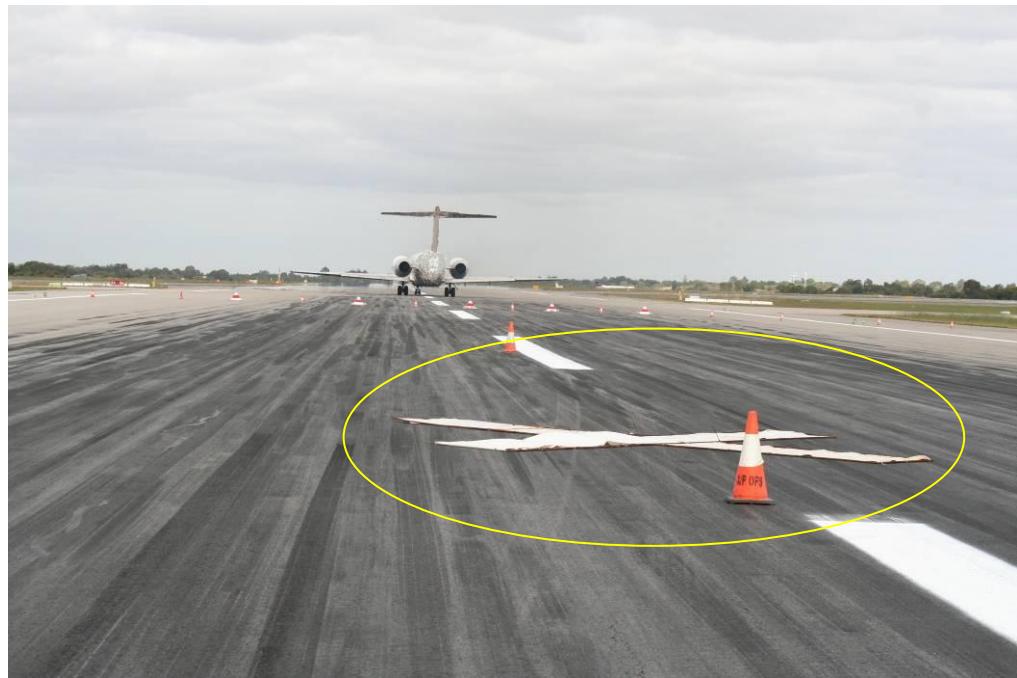
Figure 1: Runway 21 works area looking south. Note the 6m cross (circled)

The flight crew recalled that, during the first approach and subsequent go-around, they did not see the closed runway crosses and that, on the second approach, they saw the closed runway crosses 'too late'.

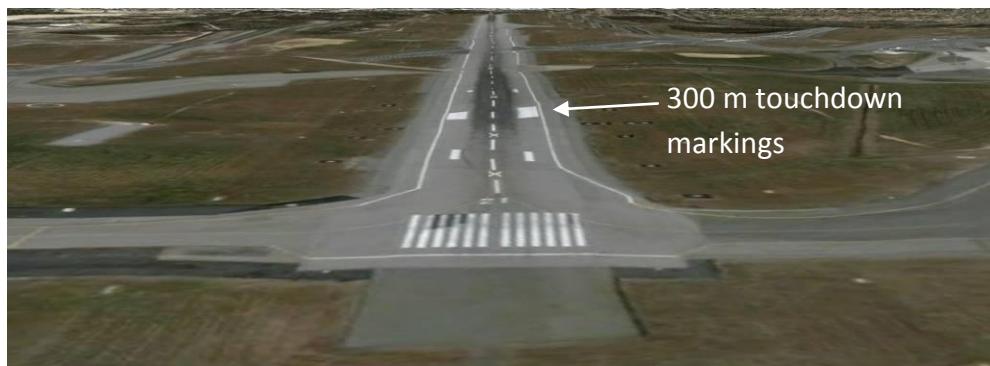
Simulated views of the 6 m and 36 m closed runway markings are at Figures 8 and 9 respectively. Those markings are indicative of the final approach to a runway as viewed by the flight crew just prior to touchdown. Note the 300 m touchdown marking as normally used by this type of aircraft.

Figure 8: Closed runway 21 markings (6 m) as used at the time of the incident

The use of the 6 m closed runway markings in lieu of the recommended 36 m markings increased the risk of a flight crew conducting a visual approach to the permanent threshold/touchdown area.

During the development of this draft report, the ATSB met with CASA officers to discuss the possible safety benefits of the use of the International Civil Aviation Organization (ICAO)-recommended 36 m closed runway markings in Australia when the affected permanent threshold and touchdown markings were not required to be obscured.

In response to that meeting and the Directly Involved Party process (see Appendix C) CASA advised that, ‘any changes to runway marking standards will be subject to mandatory consultation with industry. The proposal for the use of the International Civil Aviation Organization (ICAO) recommended 36 m closed runway markings will be incorporated into the Part 139 amendment work program.’

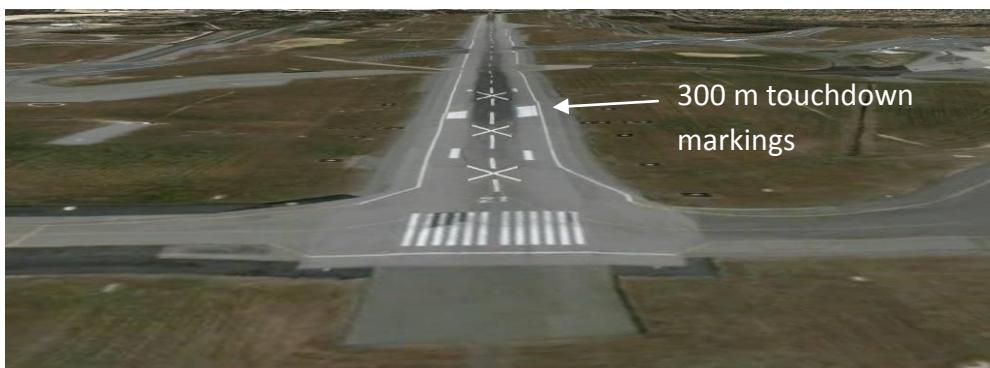
Figure 9: 36 m closed runway markings
