## ATSB Investigation: 200501819 - Airbus A340, ZS-SLA

### Summary

At 0803 Western Standard Time on 24 April 2005, an Airbus Industrie A340-212 (Airbus) aircraft, registered ZS-SLA, with a crew of 11 and 219 passengers, landed short of the displaced threshold on runway 21 at Perth Airport, Western Australia. The aircraft was on a scheduled flight from Johannesburg, South Africa. The pilot in command was the handling pilot for the approach and landing at Perth.

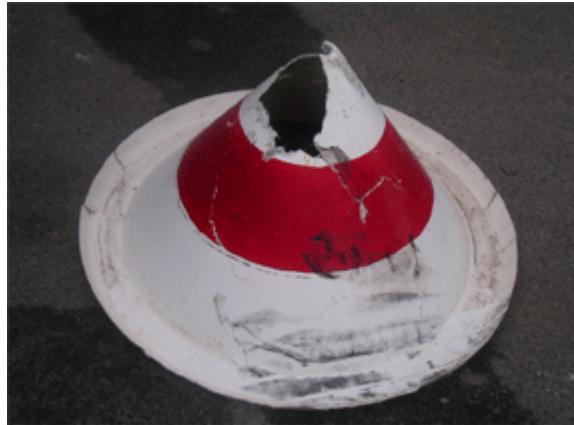
The aircraft ran over one of the red and white cone-shaped unserviceability markers during the landing (see figure 1). However, the aircraft was undamaged, and there was no other damage.

**Figure 1: Damaged cone-shaped boundary marker**

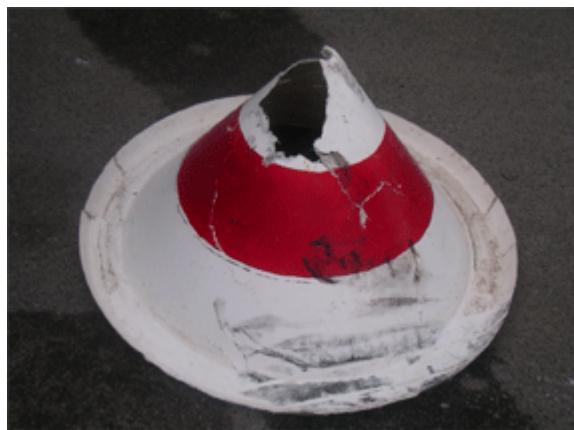
The aircraft ran over one of the red and white cone-shaped unserviceability markers during the landing (see figure 1). However, the aircraft was undamaged, and there was no other damage.

**Figure 1: Damaged cone-shaped boundary marker**

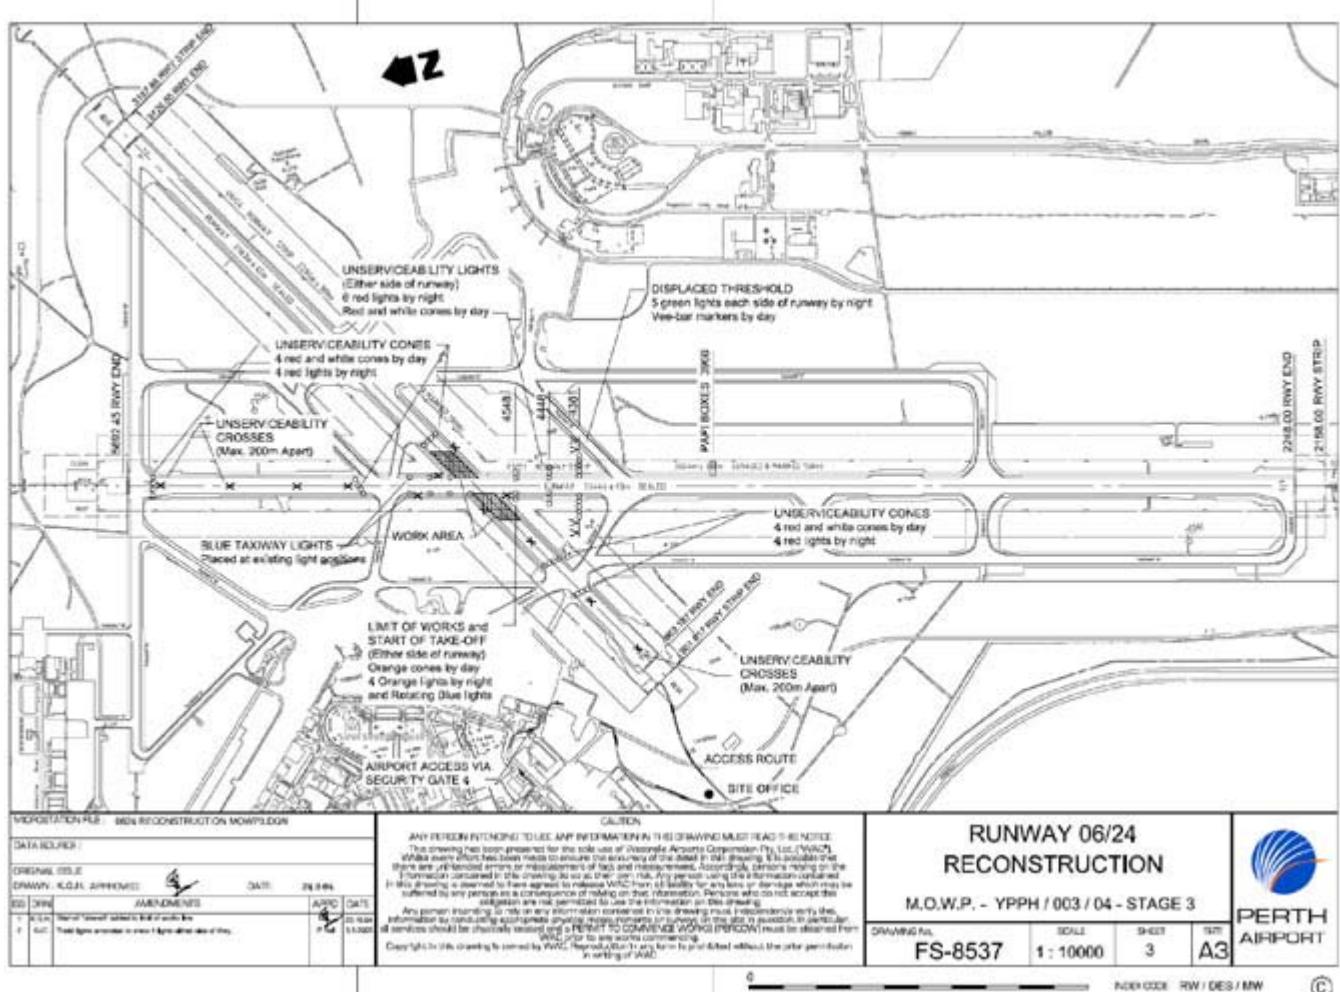
## Appendix A: Stage 3 works at Perth Airport

The MOWP provided information that Stage 3 works included reconstruction of the runway 03/21 intersection. The Stage 3 works were scheduled between 0130 and 0930 on each programmed workday. During the Stage 3 work periods, the threshold of runway 21 was displaced 1,331 m to the south, and the glidepath component of the runway 21 instrument landing system was not available. A temporary precision approach path indicator (PAPI) was also installed on the eastern side of runway 21 to provide visual guidance for a 3-degree approach to the touchdown zone for the displaced threshold. The temporary PAPI was 395 m to the south of the runway 21 displaced threshold. Refer to Appendix A for a diagram of the displaced threshold arrangements for Stage 3 of the works.
