Lateral runway excursion during landing roll, nose landing gear collapse

Aircraft	Airbus A300-B4 registered EI-EAC
Date and time	16 November 2012 at 4 h 25 UTC ⁽¹⁾
Operator	Air Contractors
Place	Bratislava Airport (Slovakia)
Type of flight	International public cargo transport
Persons on board	Captain (PF) ; Copilot (PNF) ; Flight Engineer
Consequences and damage	Aeroplane severely damaged

This is a courtesy translation by the BEA of the Final Report on the Safety Investigation. As accurate as the translation may be, the original text in French is the work of reference.

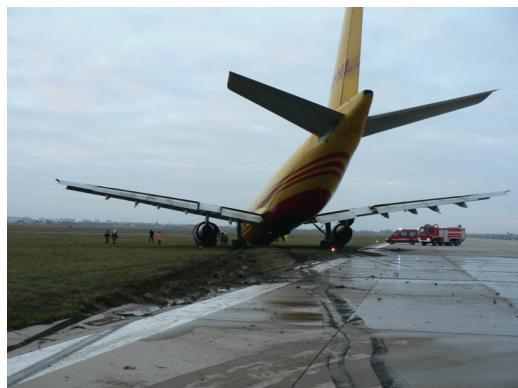
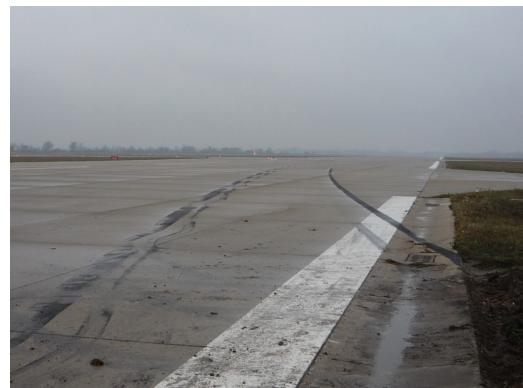
On the runway, a continuous line of rubber from the nose gear tyres was observed. It began on the runway centreline (point 04 on the illustration below) then veered towards the left as far as the edge of the runway. On the last part of the path, another tyre mark from the left rear tyre (tyre n°5) on the left main landing gear was also observed.

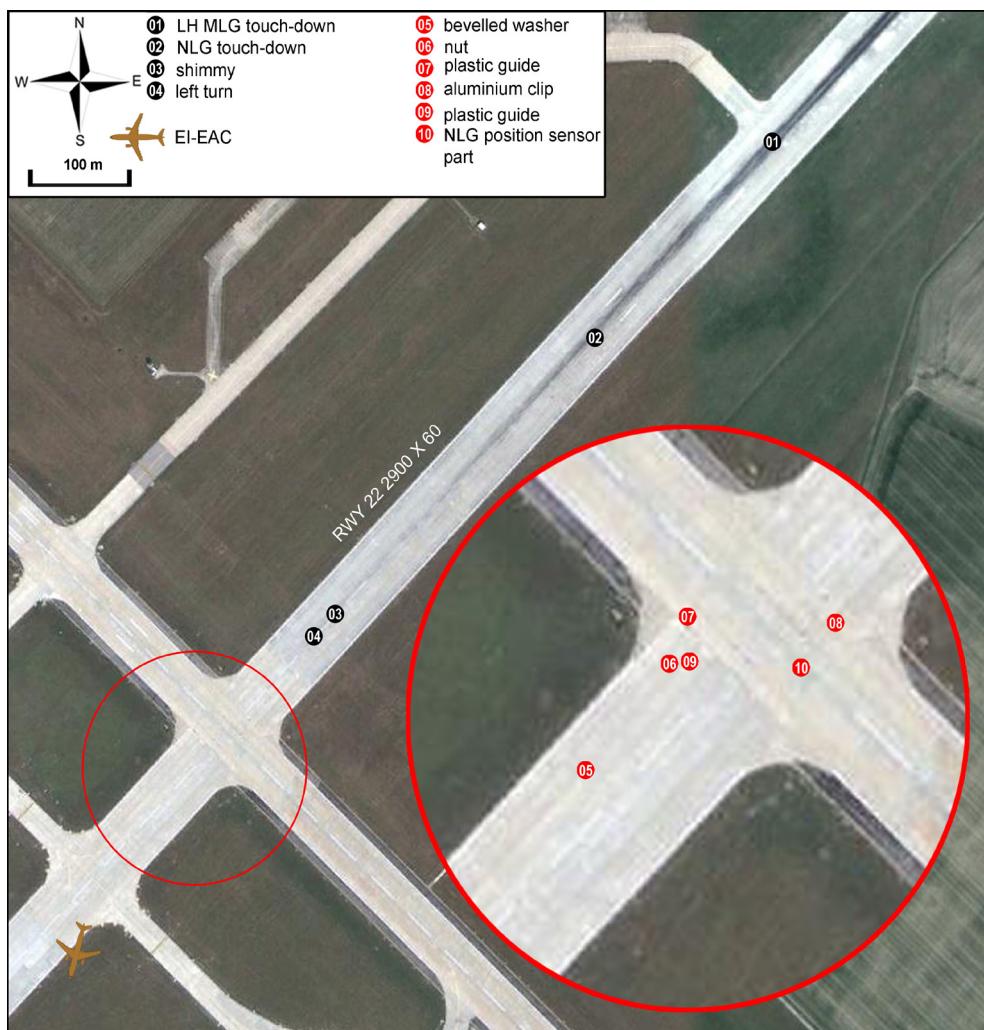
On the runway, parts of the nose gear were found at the beginning of the marks made by the nose gear tyres. Among them was the shock strut apex pin (see list of parts referenced in red on the illustration below).

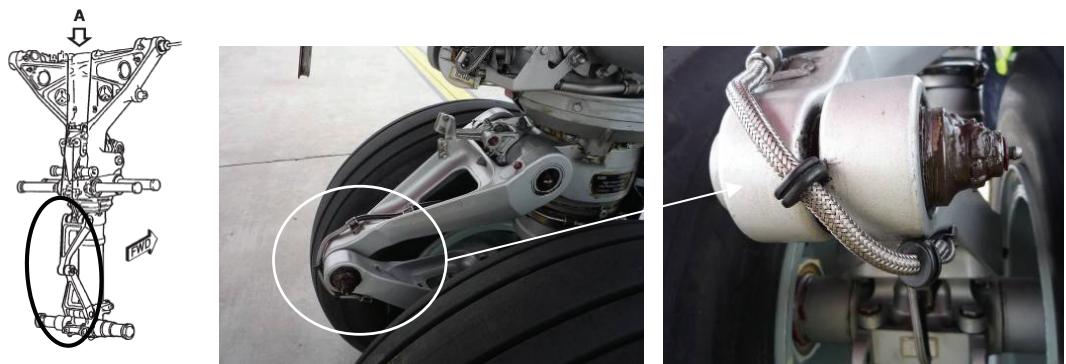
Diagram and photos (side and face views) of the NLG torque link assembly on the A300-B4

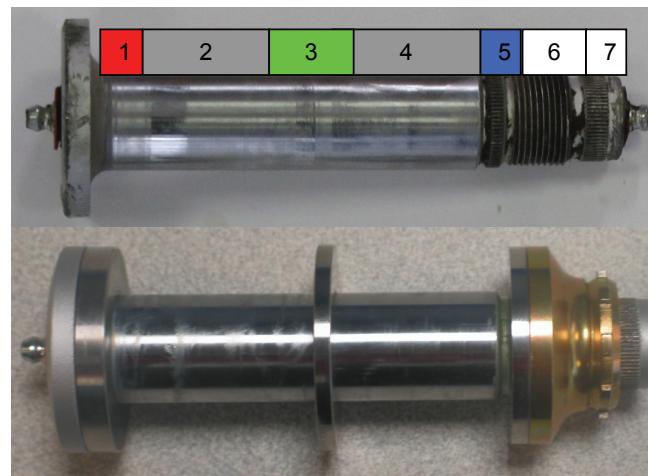
Apex pin without the torsion link arms

Liaison between the two arms of the torque link is ensured by an apex pin whose end has, successively, grooves, a thread and then more grooves. On this pin the following parts are installed:

1. a bevelled washer (P/N C59853-1),
2. the upper arm bearing,
3. a washer, (P/N C64066-1),
4. the lower arm bearing,
5. a grooved washer (P/N SL40374)
6. a crenelated nut,
7. a washer lock (P/N SL61WTM22P)

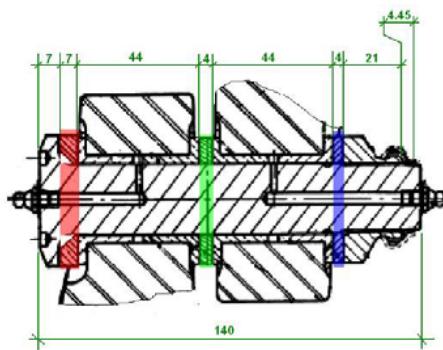
Dimensions

Dimensional analysis of the nominal installation showed that the total length of the assembled element was 140 mm. Once the last washer lock is positioned, the shaft projects by 4.5 mm. 0.5 mm of grooves are visible on the shaft.

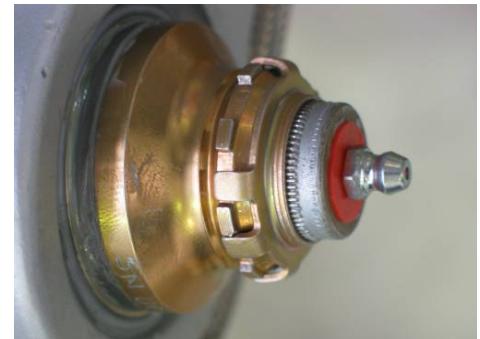
Photo of the end of the shaft with 0.5 mm of grooves visible after the washer lock.

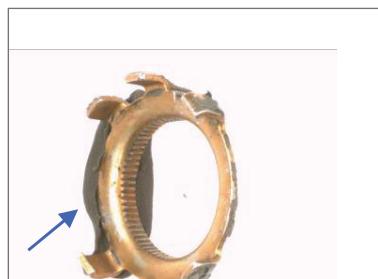
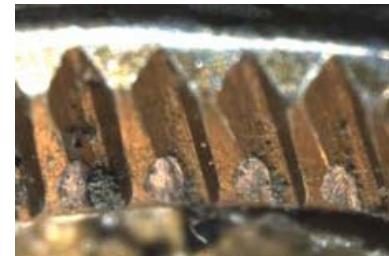
- Contamination (grease and dust) on the inner side of the shaft head. This seemed to indicate that it was not in contact with the grooved side of the washer (red);
- Circular marks around the fillet. This seemed to indicate the presence of a washer blocked against the fillet;

- The shaft thread in good condition. This seemed to indicate that the nut was not torn off but unscrewed in service. At the end of the last grooves on the shaft, damage was observed;
- The damage to the inner extremities of all of the grooves on the washer lock (n°7).

The examinations showed that the washer lock was not completely engaged on the last series of grooves on the shaft.

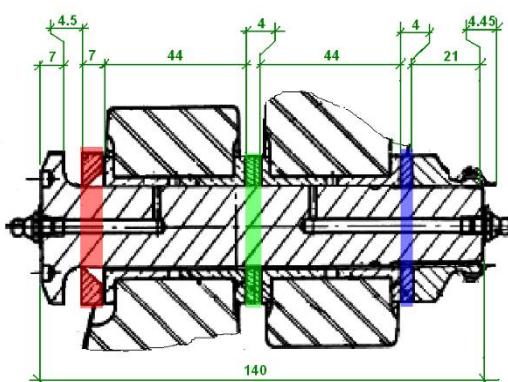
<p>1st incorrect assembly:</p> <p>The bevelled washer in red in the diagram is installed the wrong way round. In this position, the washer is no longer in direct contact with the shaft head because of the presence of the fillet between the shat and the shaft head.</p>

In both cases, play of 4.5 mm appears between the shaft head and the first washer installed. This gap makes complete engagement of the key washer on the grooves impossible at the other end of the shaft. The grooves on the washer lock are engaged over less than 1 mm on the shaft grooves, instead of the nominal 4.45 mm.

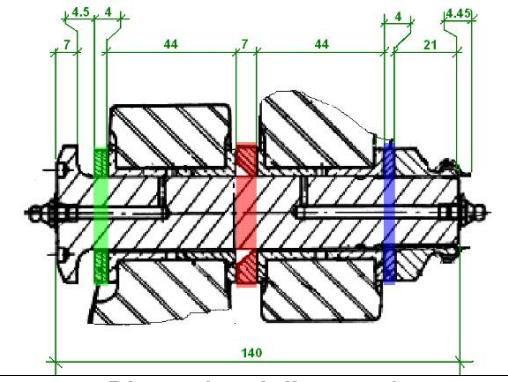
<p>Dimensional diagram 2</p>

<p>Dimensional diagram 1</p>
<p>2nd incorrect assembly:</p> <p>In case of inversion of the red and green washers, play is also visible between the shaft head and the badly positioned washer, also because of the fillet.</p>

In the case of the second assembly, the greater thickness of the n°1 washer (7 mm instead of 4.2 or 4.4 mm) introduces an additional difficulty during insertion of the centre hinge. Abnormally high effort is necessary to align the bearings of the two arms of the torque links and insert the hinge completely. The second assembly scenario is consequently more difficult to perform than the first.

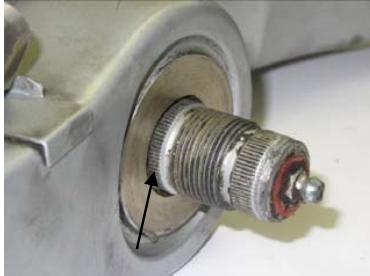
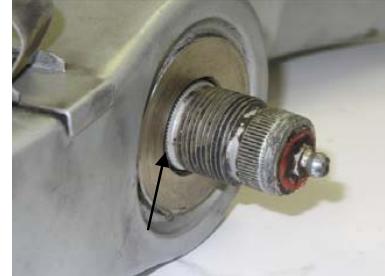
Step 2

The shaft grooves appear. The grooved washer engages in the first grooves. Once in place this washer is prevented from rotating.	The shaft grooves no longer appear. The grooved washer can no longer engage in the shaft grooves. This washer can then rotate freely.
Step 3

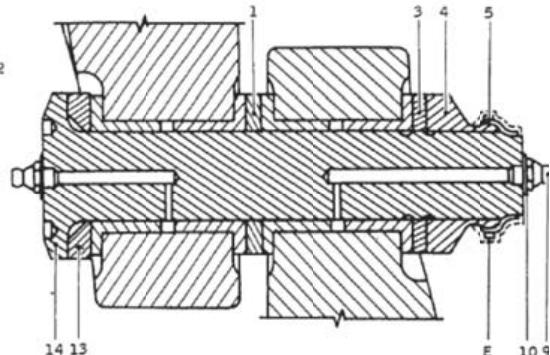
Extract from AMM 32-21-15 p. Block 401

The assembly diagram used in the AMM 32-21-15 p. Block 401 « Nose gear torque Links – Removal/Installation » gives exact details of the position and the shape of each washer. However the text associated with the diagram does not specify the order for installation and does not inform the operator of the need to install the first washer with its bevelled side in contact with the shaft head. It states:

- During disassembly, keep the washers (3), (1) and (13) (diagram below).
- During re-assembly, re-install the washers and refer to the AMM 32-21-15 p. Block 801 « Nose gear torque Links – Approved repairs » in order to measure the play between the two torque link arms :

Following the accident, Airbus provided all Airbus A300/A300-600/A310/AST customers with recommendations on the maintenance of nose gear steering torque link assembly (Operators Information Transmission - OIT ref 999.0014/13 dated 3 April 2013). This publication draws operators' attention to the importance of correct assembly of the washers on the nose gear torque link centre hinge. It was stated that a warning would be added to the AMM 32-21-15 p. Block 401 « Nose gear torque Links – Removal/Installation » during its next revision.
