# Report

**Serious incident** on **29 June 2010**  
**near Basel-Mulhouse (68) airport**  
between the **Airbus A319** registered **HB-JZQ**  
operated by **easyJet Switzerland**  
and the **Airbus A319** registered **F-GRHA**  
operated by **Air France**

Bureau d'Enquêtes et d'Analyses  
pour la sécurité de l'aviation civile

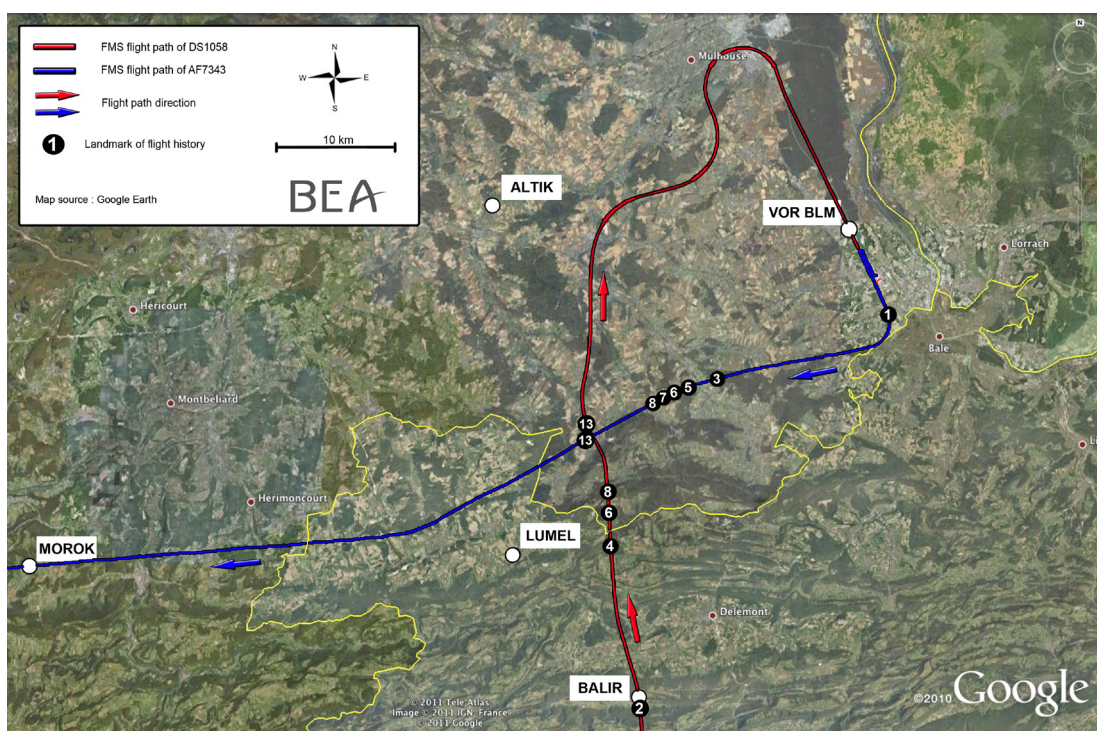
At 17 h 26, AF7343 took off from Basel Mulhouse runway 15 to follow a departure via waypoint LUMEL 5T bound for Paris Orly. The Captain was the PNF. At 17 h 27 min 40 **(1)**, the approach controller requested a climb to FL110. The crew read back and selected FL110 on the control panel (FCU)<sup>(3)</sup>.

At 17 h 28 min 46 **(2)**, the crew of DS1058 called out they were above waypoint BALIR and requested a visual approach. The controller requested they descend to FL110, refused the visual approach and asked if they could reach waypoint ALTIK. The crew indicated they needed to alter their heading 10° to the right to avoid a thunderstorm cell. The controller cleared them to do so and requested that they call back when they could fly direct to waypoint ALTIK.

At 17 h 30 min 01 **(3)**, the crew of AF7343 requested permission to set their heading to 230° to the left to avoid a thunderstorm cell. The controller cleared them to do so and requested that they call back when they could fly direct to waypoint MOROK.

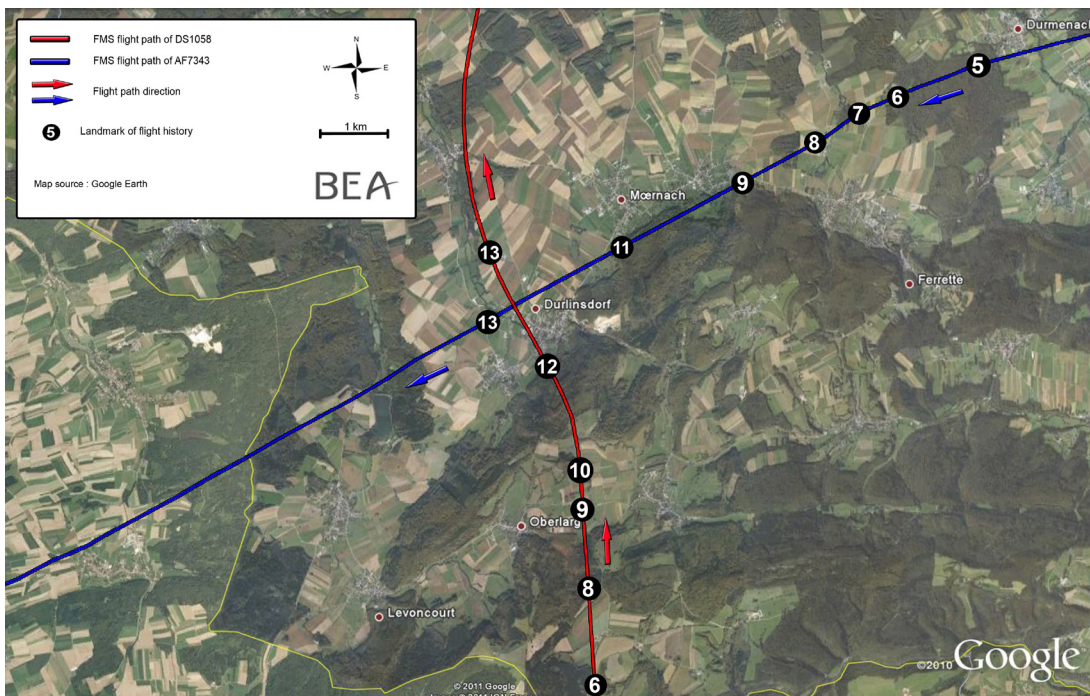
At 17 h 30 min 37 (8), whereas AF7343 reached a flight level of approximately 10,750 ft in a climb, a corrective resolution advisory (RA) "*maintain vertical speed, crossing maintain*" was triggered, inviting the crew to maintain a minimum vertical speed evaluated to be 1,500 ft/min. The PF applied a nose-up input, changing the attitude from 2.1° to 6.7°. The PNF called out "TCAS climb" to the controller.

At the same time, aboard DS1058, the preventive RA "*monitor vertical speed*" was triggered, prompting the crew not to climb. The PF briefly applied a nose-up input while the AP was disengaged; the attitude changed from 2.8° to 5.3°. The FDs were kept triggered, the auto-thrust (ATHR) was disengaged and the thrust levers were moved forward. Approximately two seconds after the first action, the PF applied a nose-down input; the attitude changed from 5.3 to -5.6° and the vertical load factor reached -0.19 g.

At 17 h 30 min 45 (9), the altitude of DS1058 reaches a maximum of approximately 11,050 ft. The thrust levers were moved to the IDLE detent. The ATHR was disengaged. A corrective RA "*descend, crossing descend*" was temporarily recorded for 1 to 2 seconds, then the corrective RA "*climb climb now*" was triggered. The PF applied a nose-up input and started a turn to the left at a bank angle of about 30°.

The attitude increased from  $-5.6^{\circ}$  to  $13.8^{\circ}$  and the heading decreased from  $355^{\circ}$  to  $329^{\circ}$ . Simultaneously, the corrective RA *"descend descend now"* was triggered aboard AF7343. The PF applied a nose-down input, the attitude changed from  $6.7^{\circ}$  to  $-5.3^{\circ}$ .

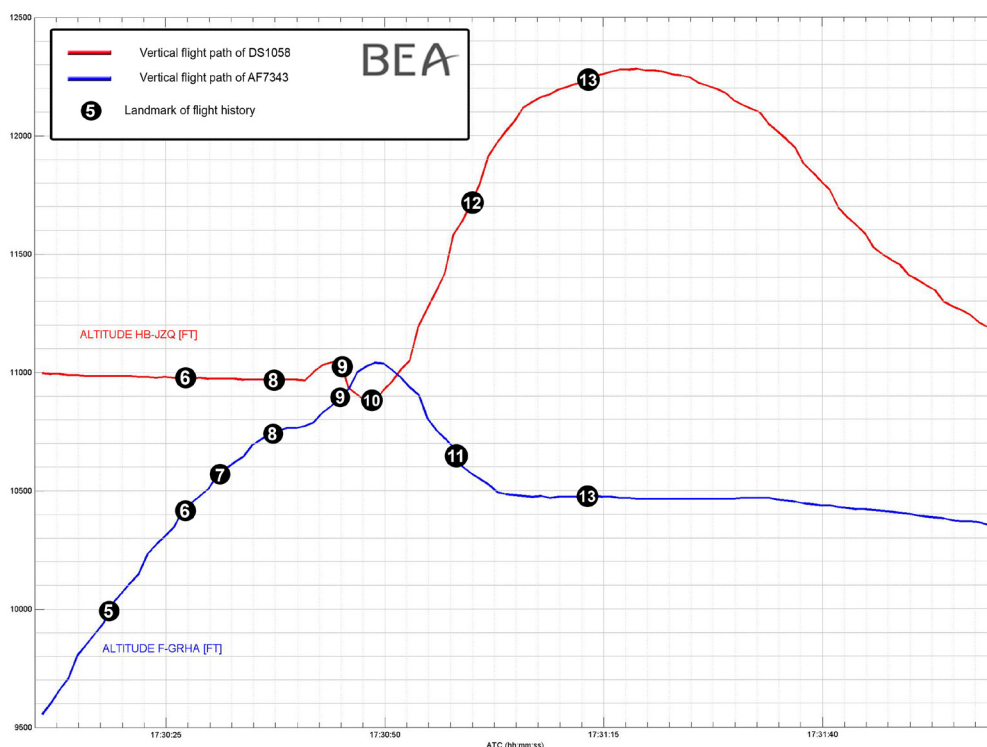
The operational instructions in the case of procedural control indicate: *"the departure for waypoint LUMEL is separate from all the holding areas EXCEPT WAYPOINT BALIR."* Therefore there was loss of separation.

The risk of a mid-air collision is characterized by the dual triggering of the TCAS and of the STCA.

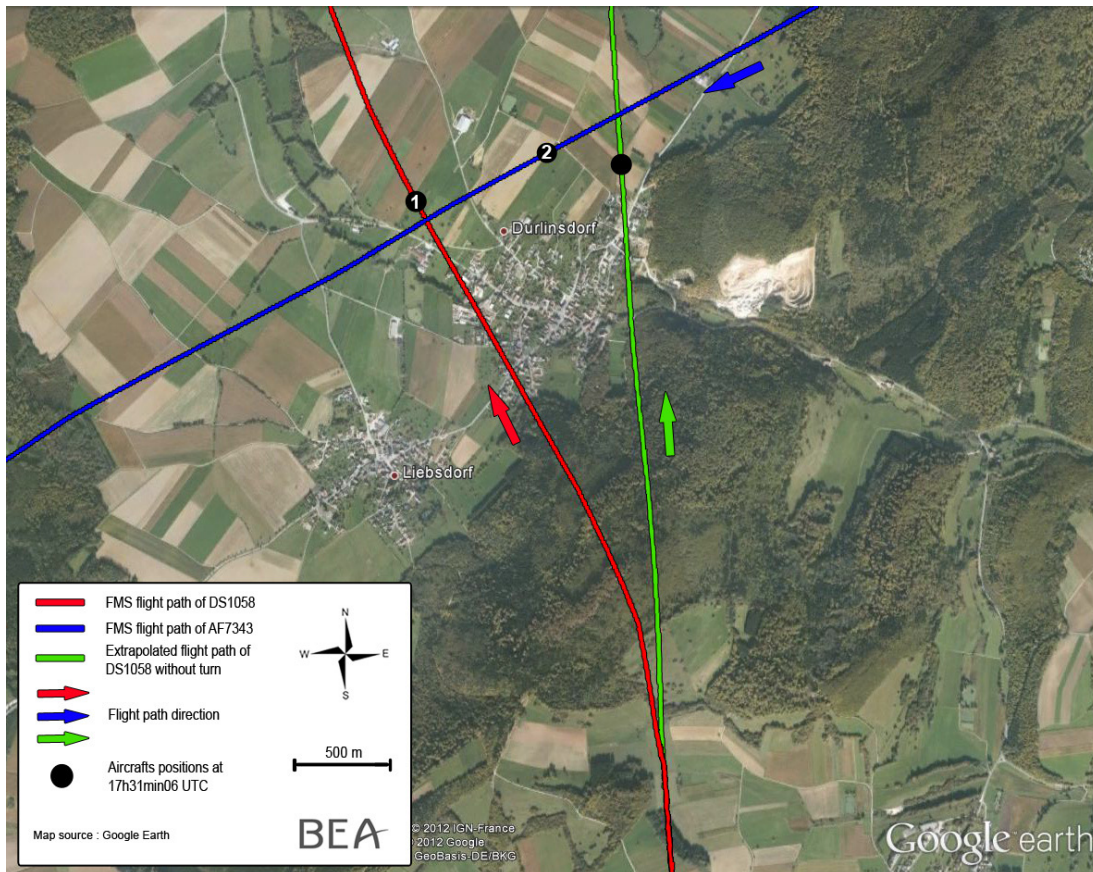
Analysis of the flight paths showed that the turn by the pilot of DS1058 made his aeroplane pass in front of AF7343 and not behind it, as it would have done if it had kept a straight path.

The positions of the aeroplanes shown on this diagram do not correspond to the point in time at which the minimum angular separation occurred. At that time (i.e. two seconds later), the distance between points 1 and 2 was smaller. In turning left, therefore, DS1058 did not increase the separation with AF7343.
