**Accident on 4 March 2013**  
**just after takeoff from Annemasse (France)**  
**to the Beechcraft Premier 1A**  
**registered VP-CAZ**

Bureau d'Enquêtes et d'Analyses  
pour la sécurité de l'aviation civile

## Stall after takeoff in icing conditions, collision with the ground, fire

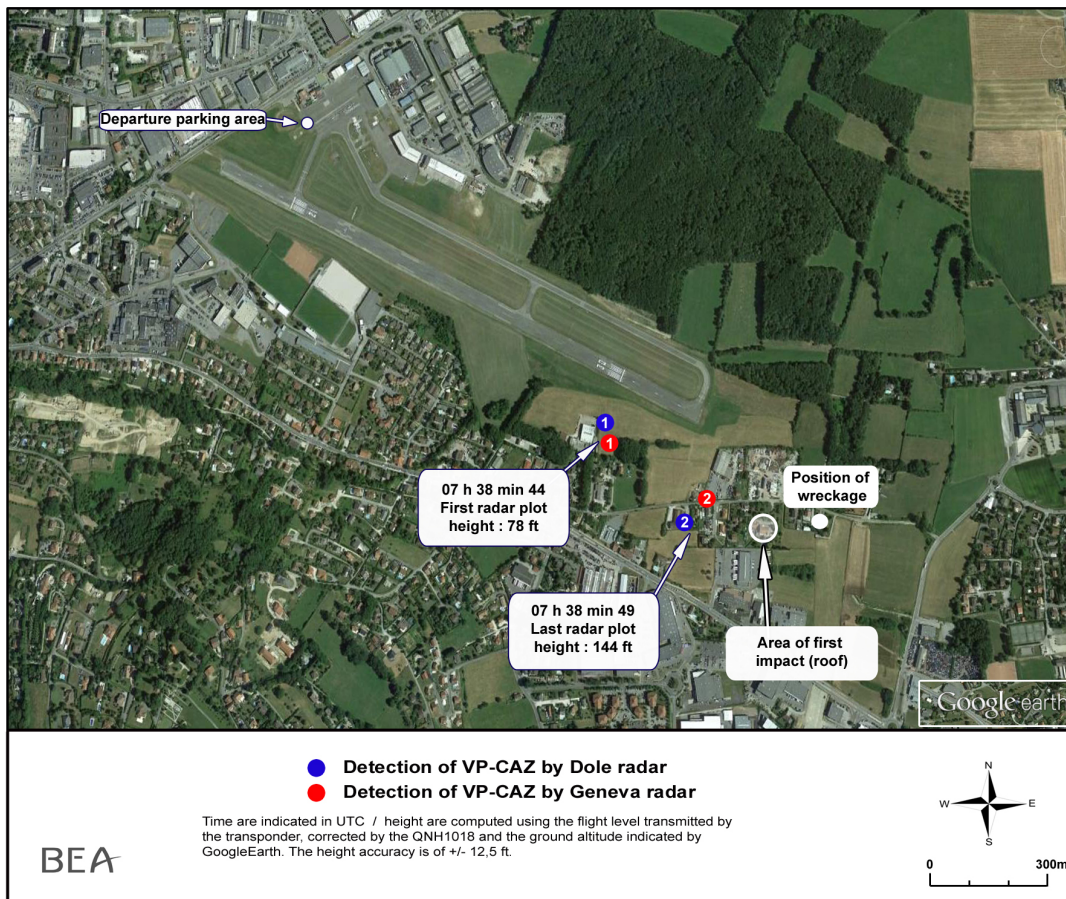
At 07 h 38 min 52, the main landing gear struck the roof of a first house. The aeroplane then collided with the ground. During the impact sequence, the three landing gears and the left wing separated from the rest of the aeroplane. The aeroplane slid along the ground for a distance of about 100 m before colliding with a garden shed, a wall and some trees in the garden of a second house. The aeroplane caught fire and came to a stop.

Figure 1 - Radar plots and position of the wreckage

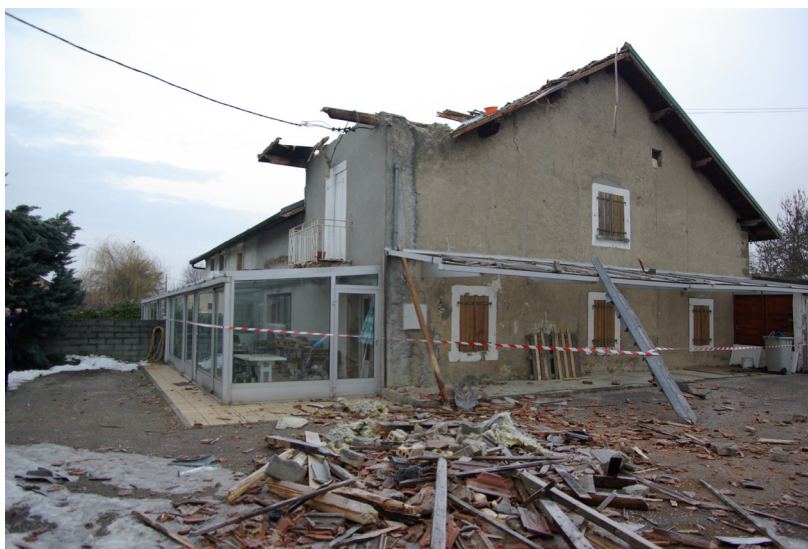
The aeroplane struck the roof of a house about 500 m from the threshold of Annemasse runway 30, and then struck trees located 10 to 20 m further. The damaged section of the roof was located about 5 m up. The person inside the house at the time of the accident was not injured.

Figure 2 - Damage to the house

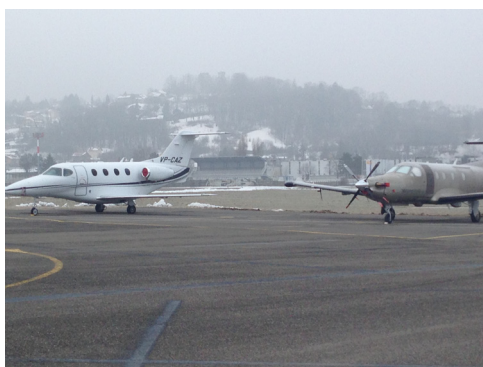
A photo of the aerodrome taken about 50 minutes before the accident shows the presence of low stratus, as well as snow on the ground.

Figure 4 – Photo taken on the morning of the accident at the aerodrome

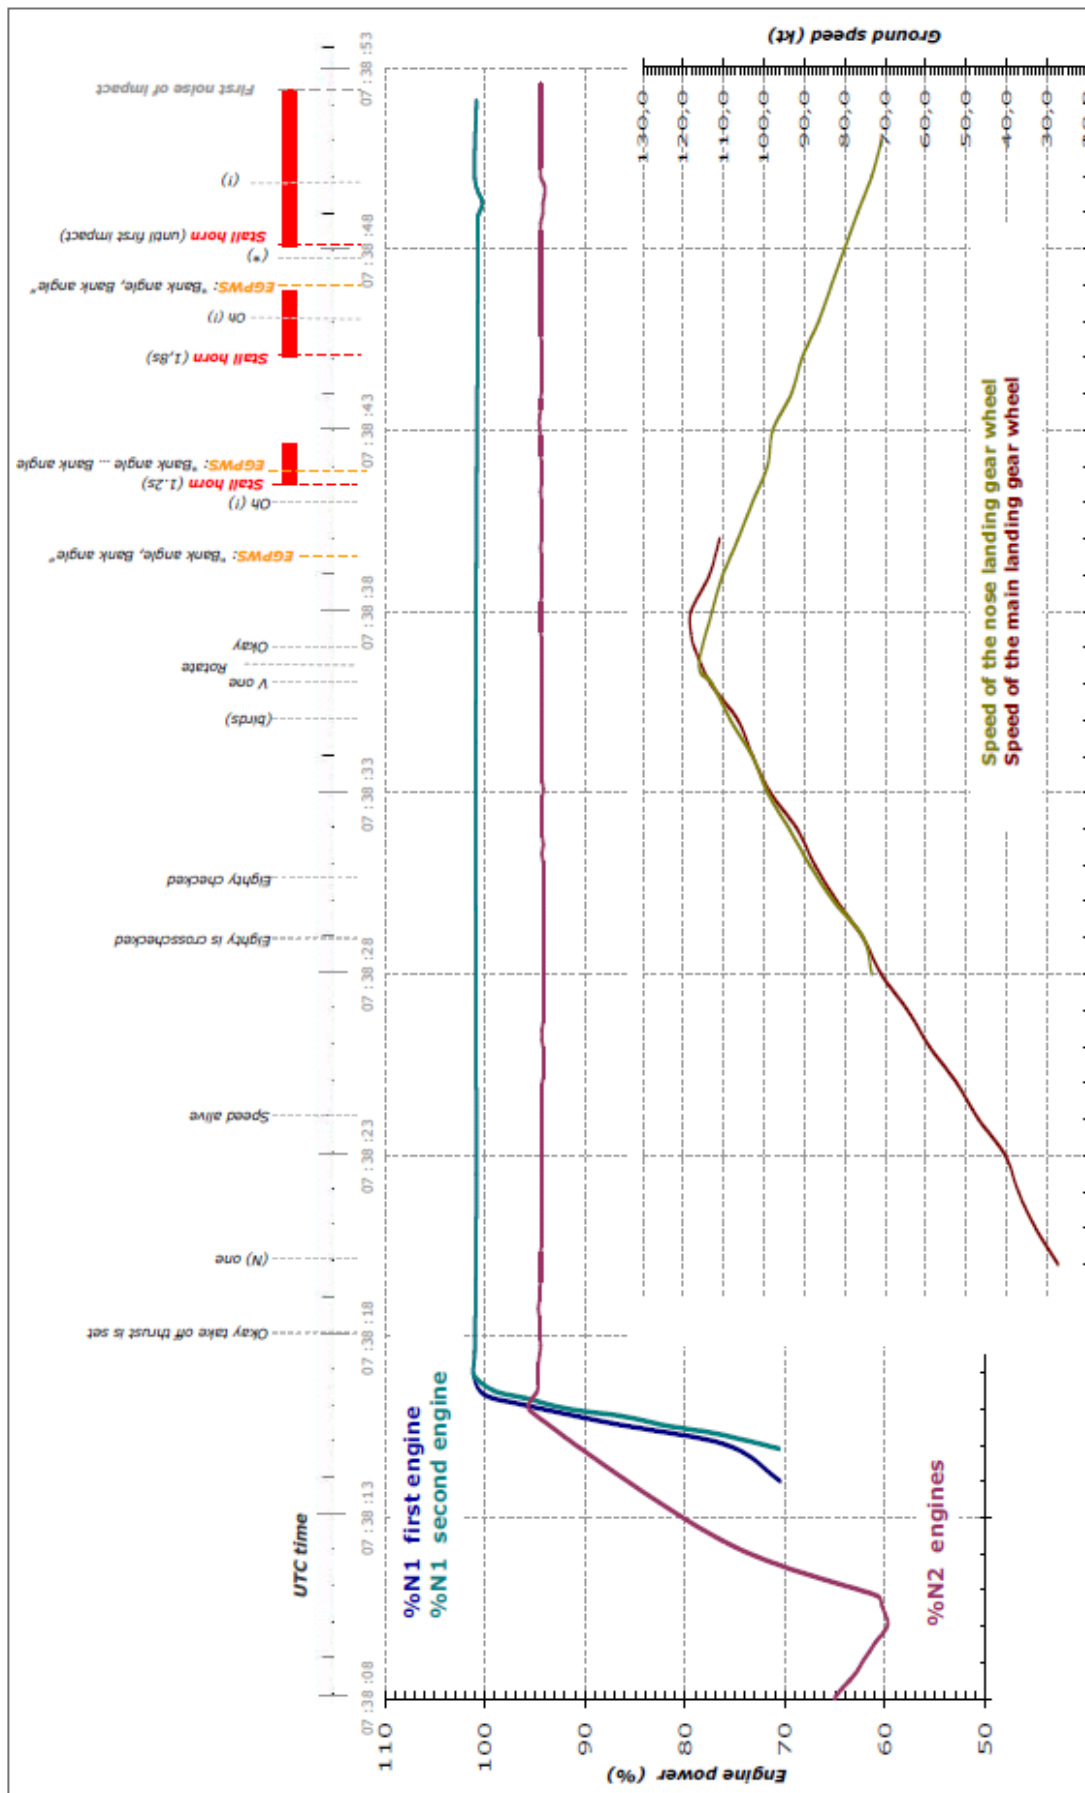
Spectral analysis of the recording made it possible to determine the rotation speeds of the rotating parts of both engines, of the nose landing gear wheel and the main landing gear wheels. It was possible to deduce from this the various speeds of each engine (N1 and N2), as well as the wheel rotation speeds, and therefore a ground speed during taxiing.

Figure 5 – Summary of data from the CVR

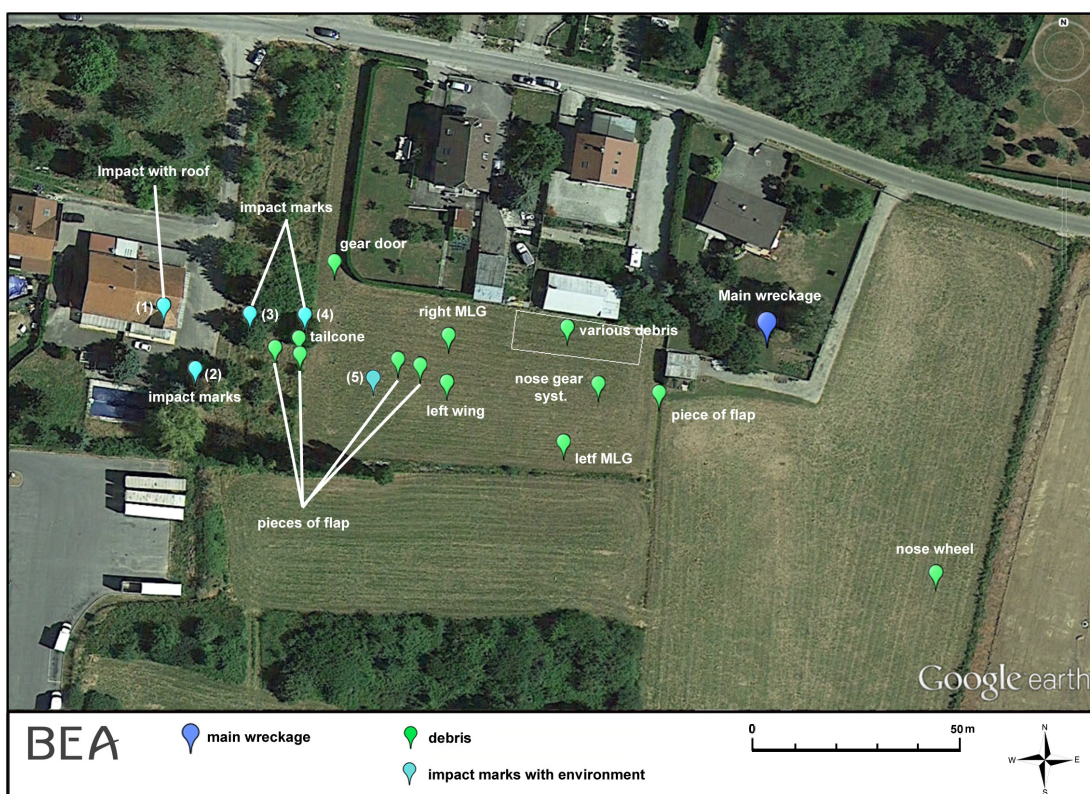
Initial impact of the aeroplane with the roof of another individual's house was observed about 150 m to the west of the main wreckage.

- ❑ the left wing, which showed marks of the same colour as that of the roof tiles of the first damaged house. Marks of fire (soot) were observed on this wing, at fracture level;
- ❑ the left main landing gear, on which pieces of wooden structure and deposits the colour of tiles were found.

The first major mark of impact with the ground was observed in the field, 20 m from its western edge, over about 15 m. It showed a slight curve to the left (in the direction of the flight path). The right main landing gear was found at the end of this mark.

A second mark, less spread out but deeper, was observed to the left of the previous mark.

Figure 6 - Distribution of main debris

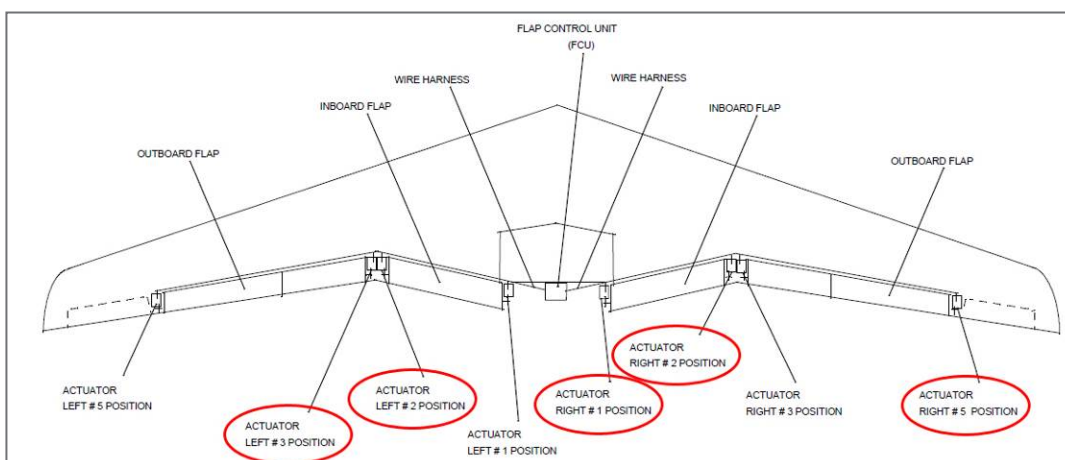
Among the eight flap actuators, six were recovered and examined. The positioning of five of them was identified (circled on the figure below).

Figure 7 - Position of the flap actuators found at the site

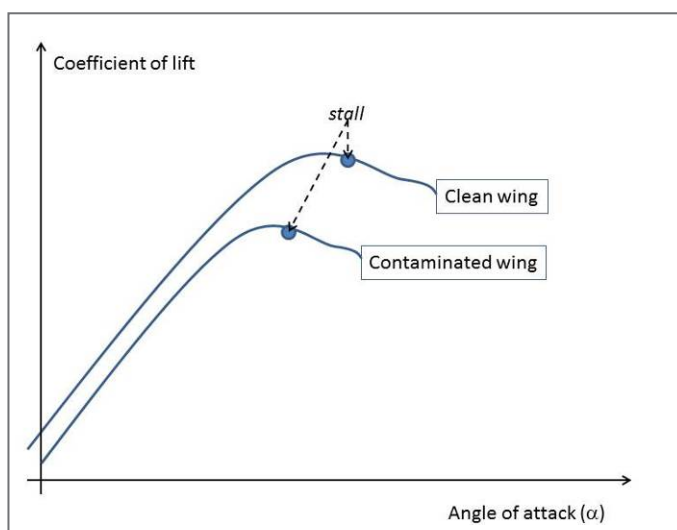
The deposit of frozen contaminants on the wing, even a small quantity, makes its surface rough. This roughness modifies the airflow locally and causes airflow to separate from the wing surface. The wing aerodynamic characteristics may in this way become significantly degraded. A decrease is observed specifically in:

- ❑ Lift for a given angle of attack;
- ❑ Maximum lift;
- ❑ The angle of attack at which the stall appears.

In these conditions, the true stall angle of attack may be much lower than the thresholds allowed for the stall warning calibrated for a “clean” wing.

Figure 8 - Effects of contamination on lift

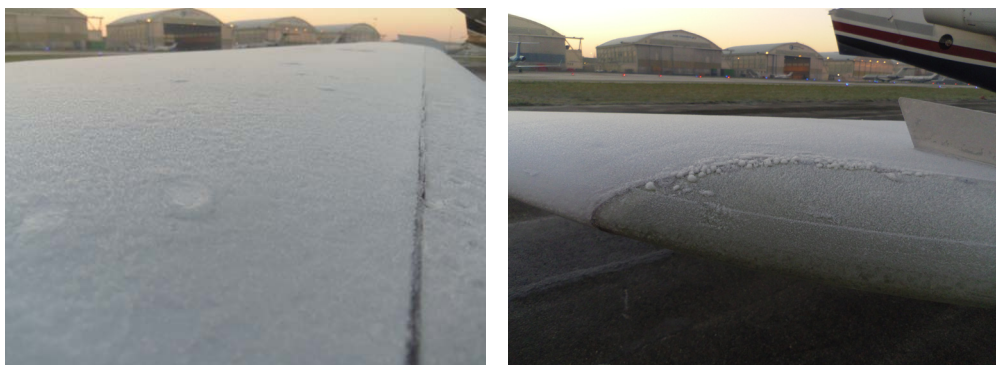
For this, a visual and/or hands on surface check must be carried out by the captain. It is intended to detect the presence of roughness on the surfaces or different sensations to those of the skin of the aircraft, in particular on critical surfaces such as the wings and the horizontal stabiliser. The wings photographed below are those of a Beechcraft Premier 1A which had parked all night outside at Le Bourget airport in meteorological conditions similar to those that prevailed at Annemasse on 4 March 2013. Rime ice, showing roughness in several places, had been deposited over the whole wing surface, without any previous precipitation.

Figure 9 - Roughness on a wing contaminated by frost
