**AIRCRAFT ACCIDENT INVESTIGATION BUREAU**

**INVESTIGATION REPORT ON**

**ACCIDENT TO THE B737-MAX8 REG. ET-AVJ OPERATED  
BY  
ETHIOPIAN AIRLINES**

Report No. AI-01/19  
Pub, Date December 23, 2022

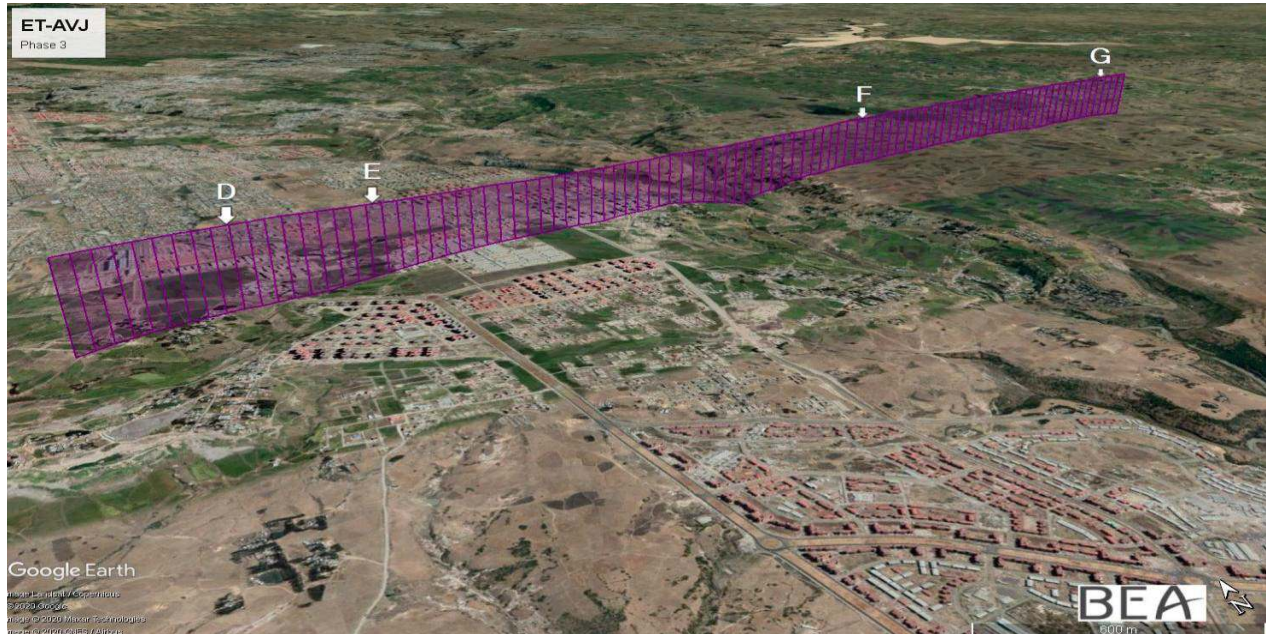
FIGURE3: PHASE 3 FROM A/P DISCONNECT TO STABILIZER TRIM CUTOUT

As a result of the erroneous LH AOA value and the increasing airspeed, SMYDC 1 computed LH minimum operational speed and LH stick shaker speed greater than VMO (340Kt) without any alert or invalidity detection.

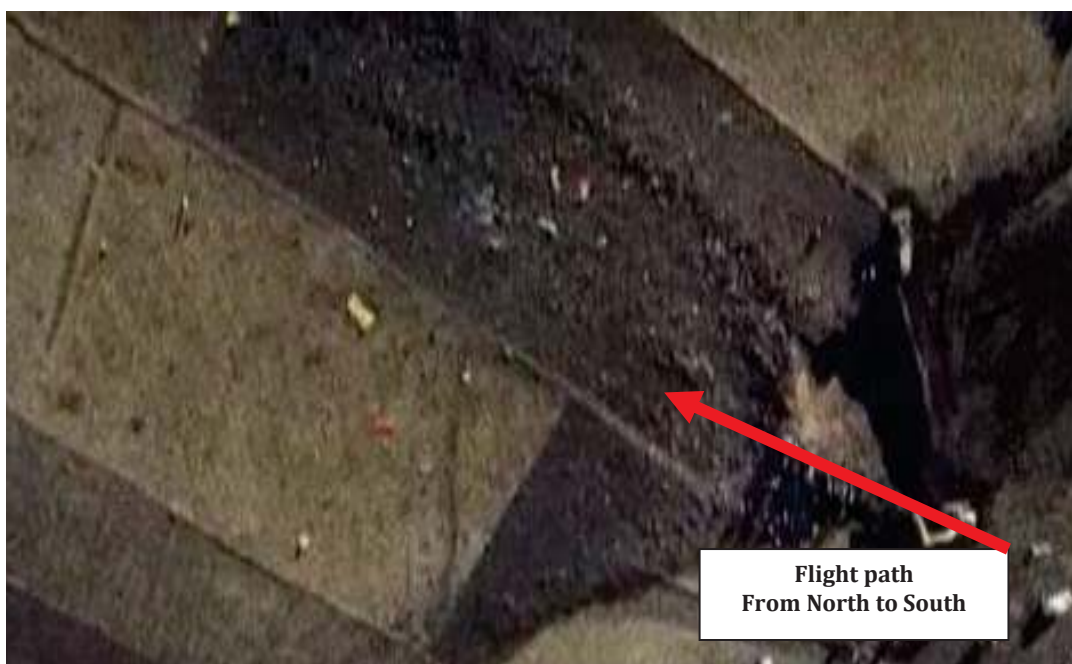
FIGURE 40: TOP VIEW OF THE CRATER

The Airplane impacted terrain at a farm field and created a crater approximately 10 meters deep (last Airplane part found) with a hole of about 28 meters width and 40 meters length. Most of the wreckage was found buried in the ground; small fragments of the Airplane were found scattered around the site in an area about 200 meters wide and 300 meters long. Damages to the Airplane were consistent with a high energy impact.

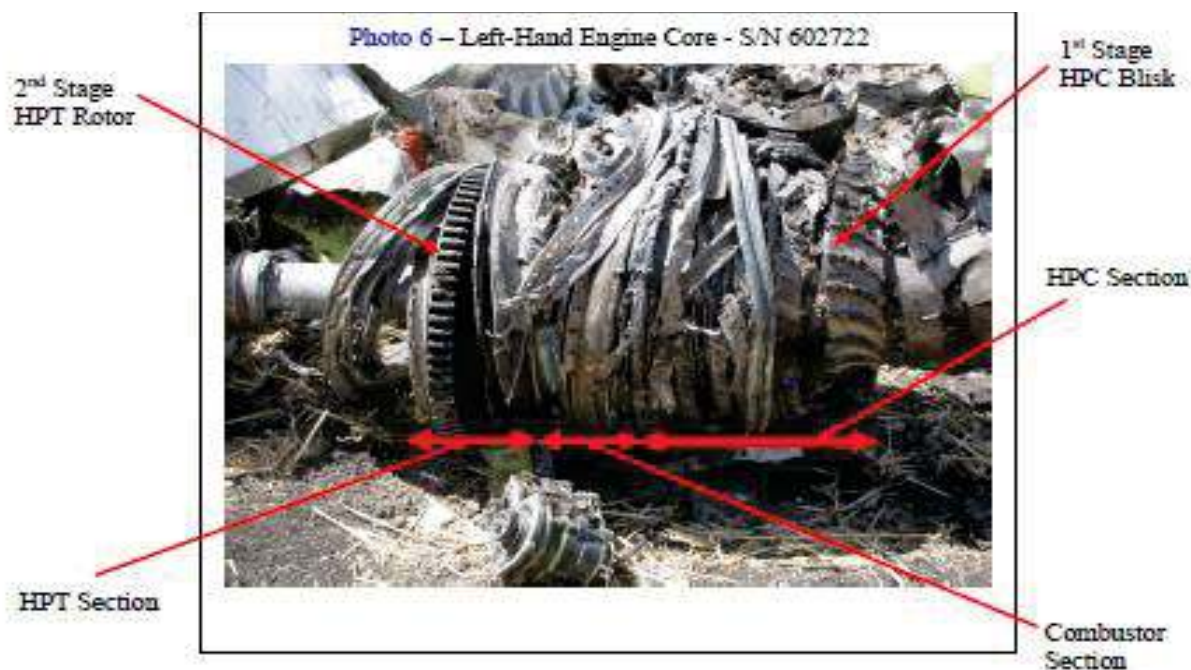
FIGURE 43: LEFT HAND ENGINE SECTION

The left engine core was recovered from the site and examined by the group. The engine was reportedly recovered at a depth of approximately 10 to 15 meters depth on the left side of the excavation site. The predominant feature of the deformation of the entire remaining core was axial deformation.

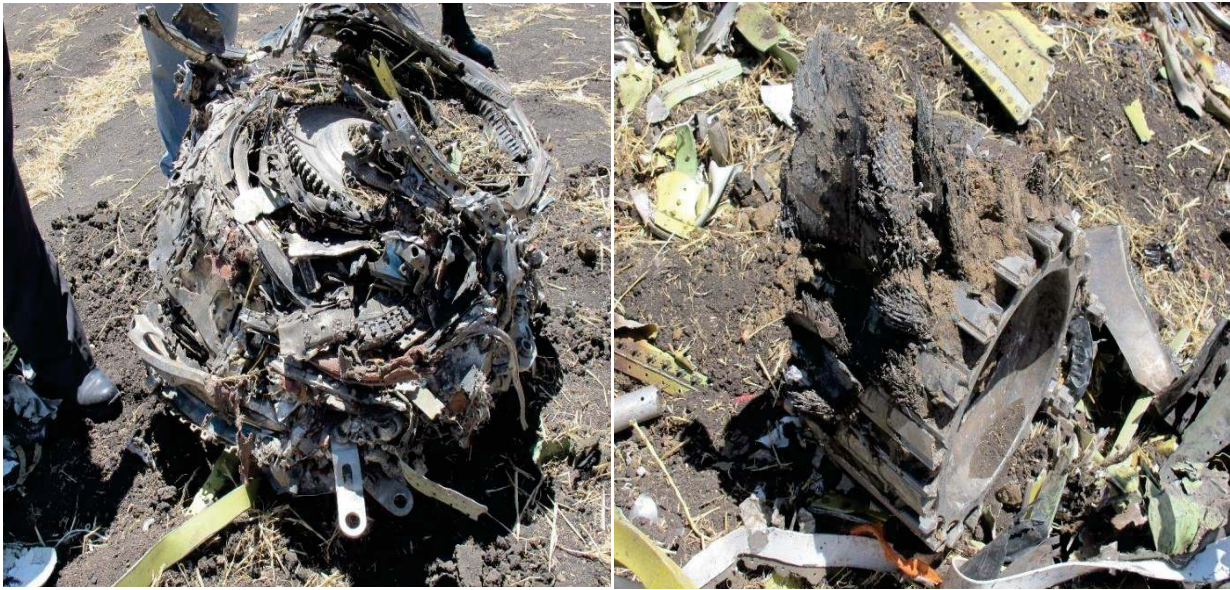
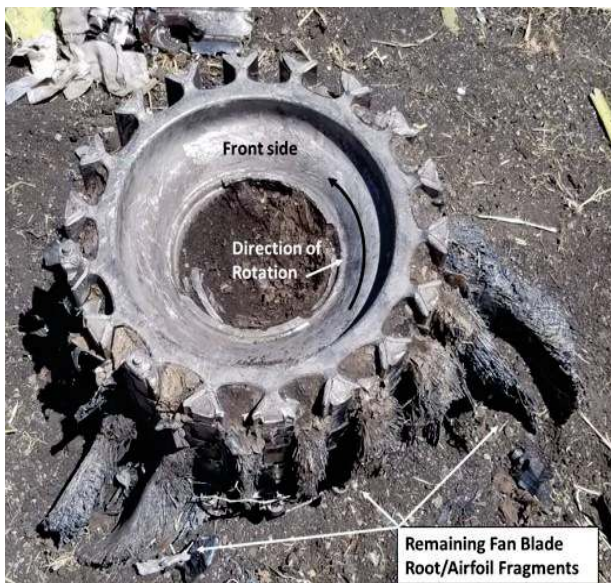
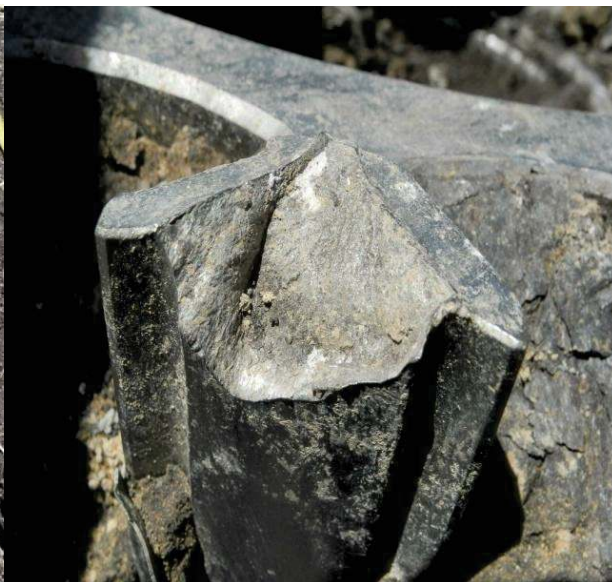
FIGURE 44: R/H ENGINE - S/N 602695 - CORE      FIGURE 45: - R/H ENGINE - S/N 602695 - FAN DISK

The predominant feature of the deformation of the entire remaining core was axial deformation.

FIGURE46: R/H ENGINE - S/N 602695 - FAN DISK      FIGURE47: R/H ENGINE - S/N 602695 - RETENTION LUGS - FRACTURED

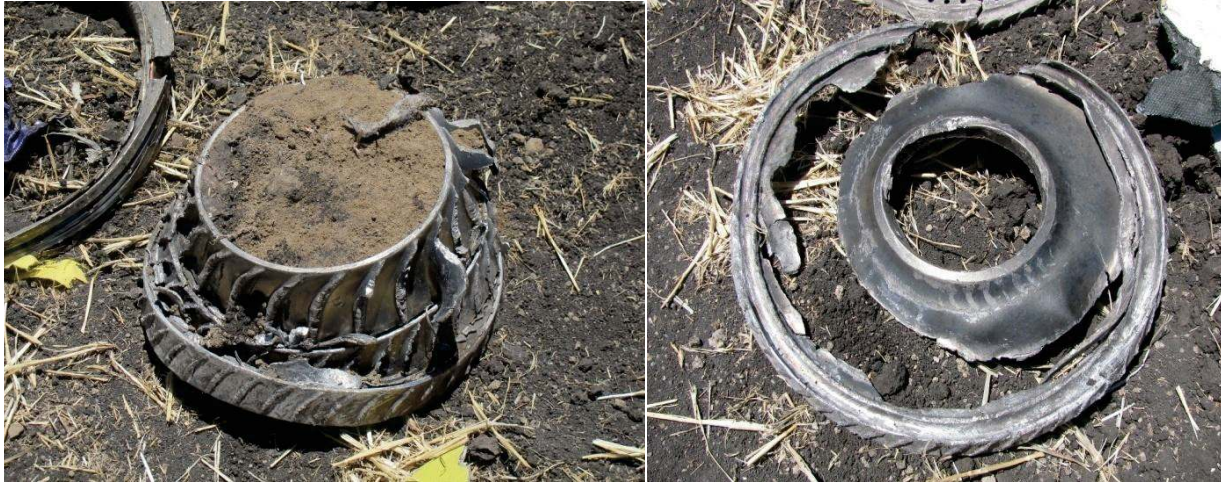
FIGURE 48: - R/H ENGINE - S/N 602695 - HPC STAGES 1 TO 3 FIGURES 49:- R/H ENGINE - S/N 602695 - HPC STAGE 7

6<sup>th</sup>, and the 8<sup>th</sup> to 10<sup>th</sup> stages were not found. The 5<sup>th</sup> stage was found separately, and it was also missing its airfoils. The 7<sup>th</sup> stage web was fractured circumferentially. The stator sections could not be identified.

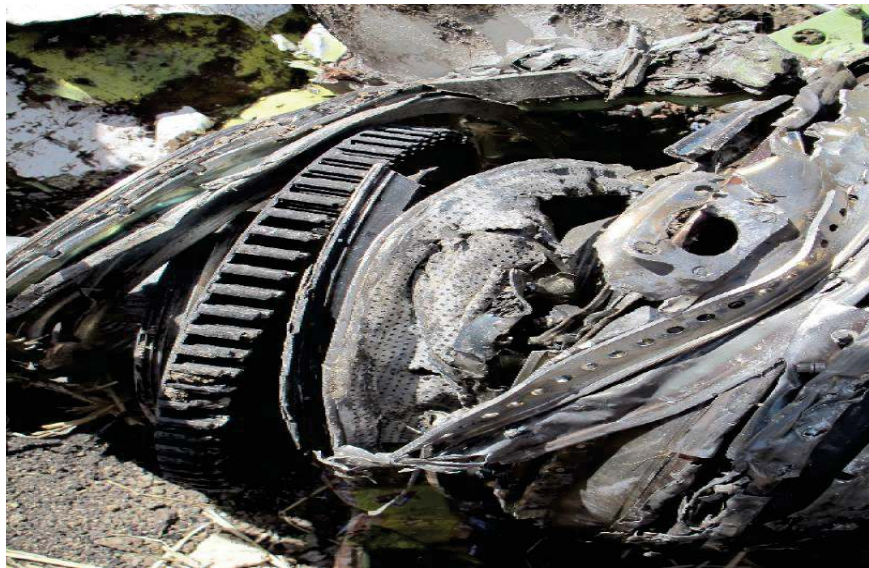
FIGURE 50: COMBUSTOR CRASHED

The combustor was severely crushed and most of it was missing into pieces.

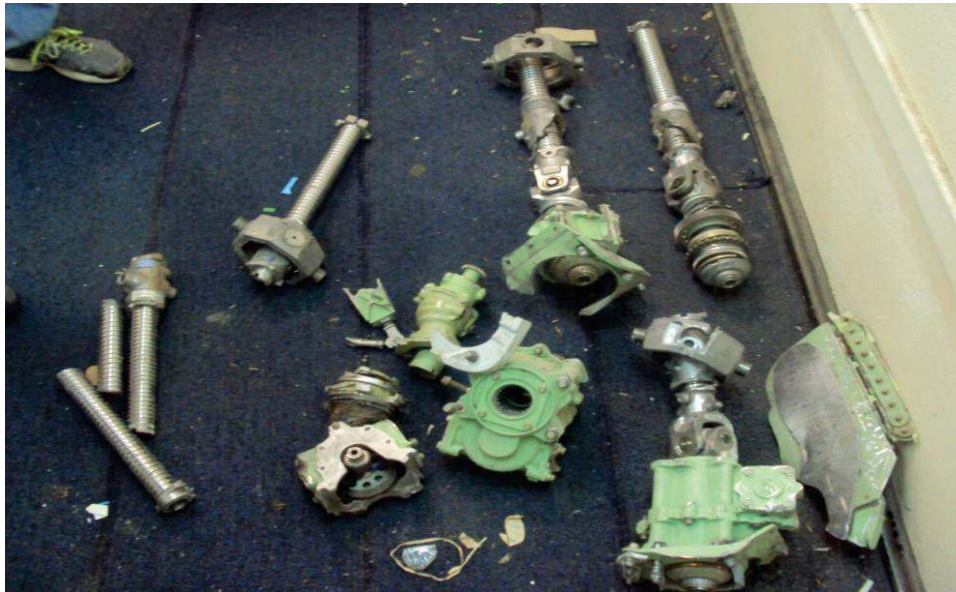
FIGURE56: TRAILING EDGE FLAP TRANSMISSIONS AND BALL SCREWS

During the examination of the wreckage pile located at the Addis Ababa airport EAIB store, the Airworthiness group identified a total of 4 (including the ones identified at the impact site) trailing edge flap transmissions (there are 8 total); three of these had the ball nut and gimbal still attached.

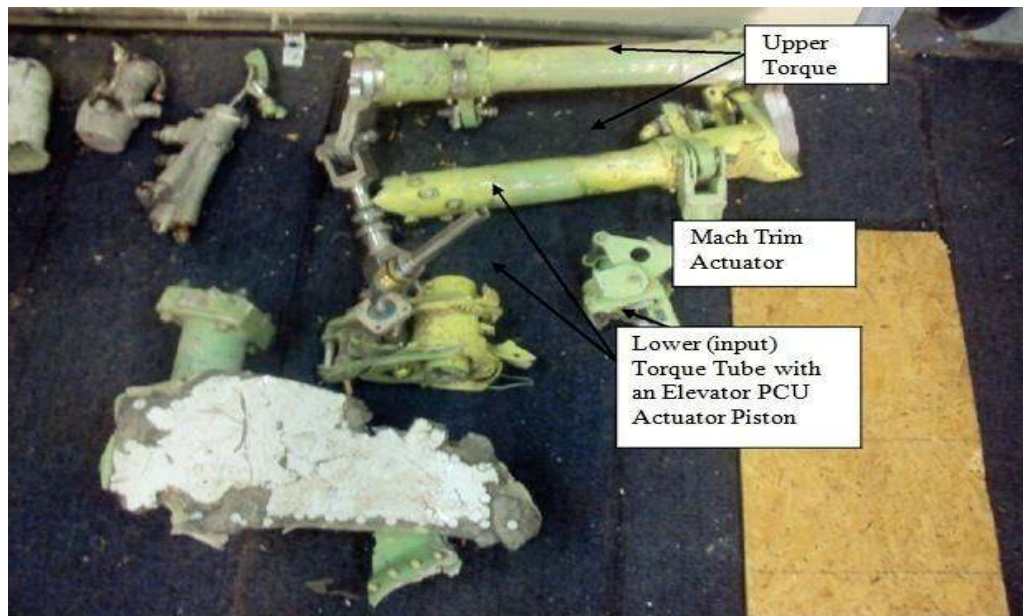
FIGURE64: ELEVATOR PCU ACTUATOR PISTON

The Airworthiness group located components from the elevator control system within the wreckage pile located at the Addis Ababa airport property.

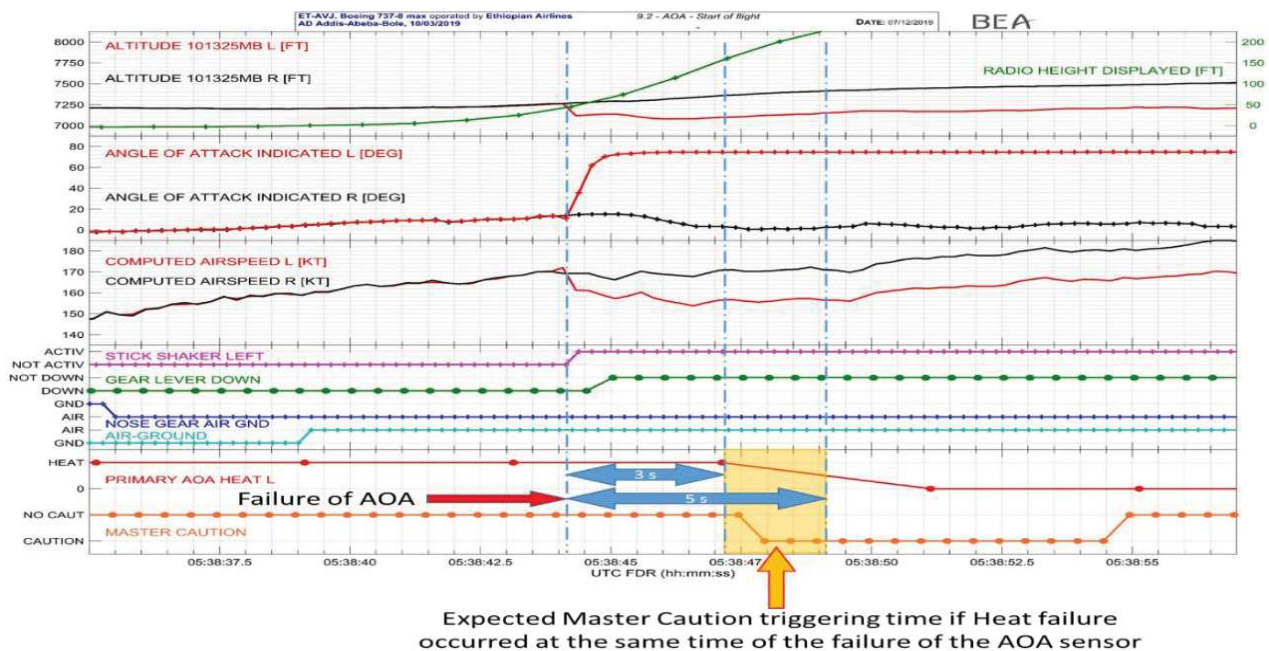
FIGURE 67: AOA VALUES DURING THE BEGINNING OF THE FLIGHT

From the CVR transcript, at 5 h 42 min 48 s, the Captain requested the recall of the master caution. At that time, master caution had only triggered once. Following the master caution recall, the crew exchanged “Master Caution Anti Ice” and “Left Alpha Vane”.

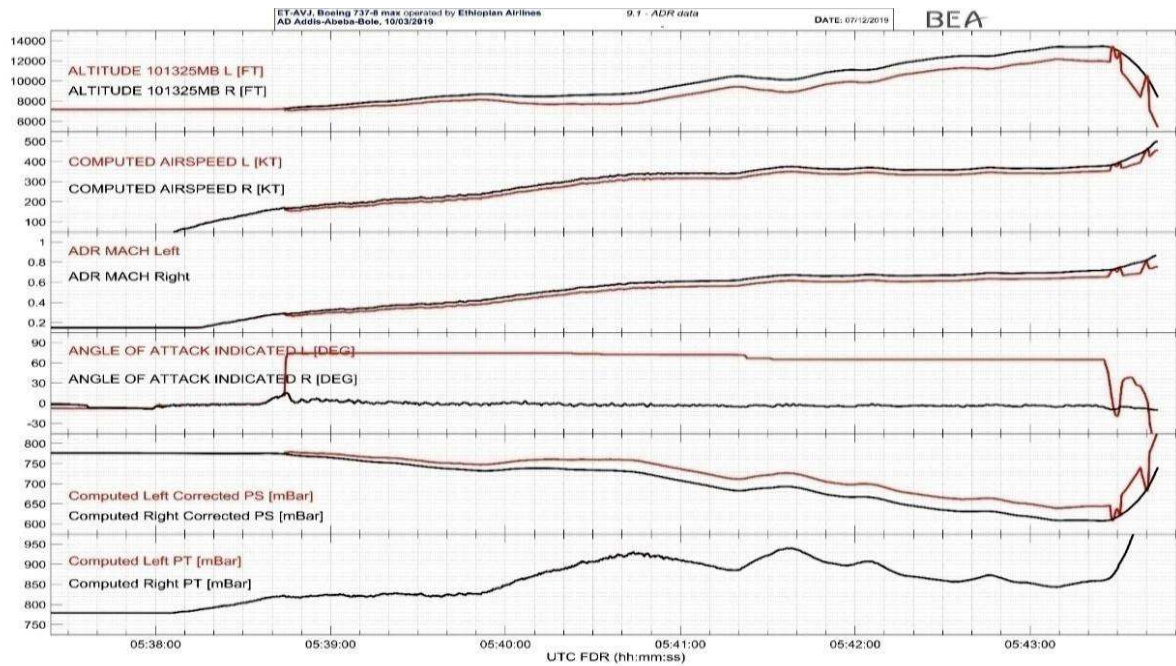
FIGURE 68: AIR DATA PARAMETERS

During the flight of the event, the left and right recorded altitude values, the recorded CAS values and the recorded Mach numbers diverged after LH and RH AOA values divergence.

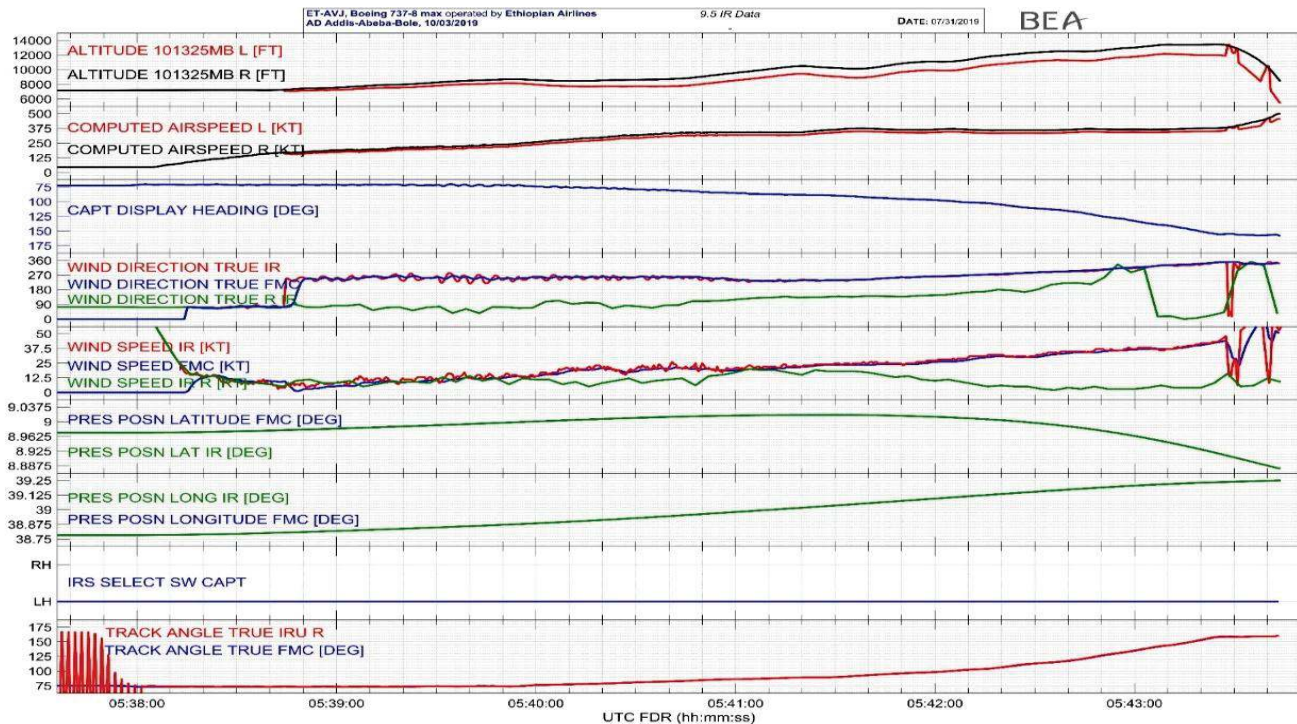
FIGURE70: IMPACT OF AOA FAILURE ON THE WIND COMPUTED VALUES

Most of the recorded IRS parameters did not show any variation following the AOA failure. On the contrary, the computed wind, on the left side, was clearly affected by that failure.

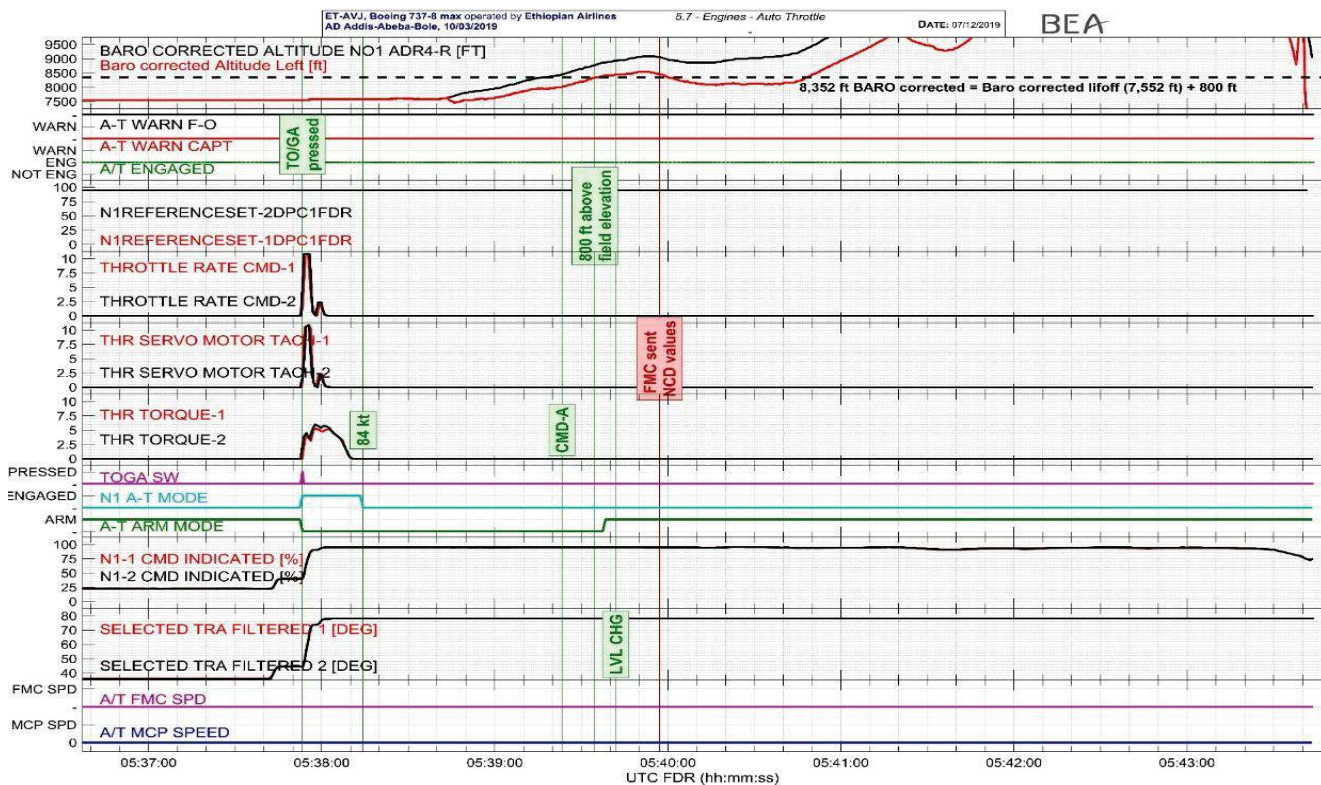
FIGURE 73: AUTO THROTTLE BEHAVIOR DURING THE FLIGHT OF THE EVENT

automatic reduction to climb thrust did not occur because the LH and RH TAS diverged by more than 25Kt before the FMC sensed that the Airplane had reached the thrust reduction altitude.

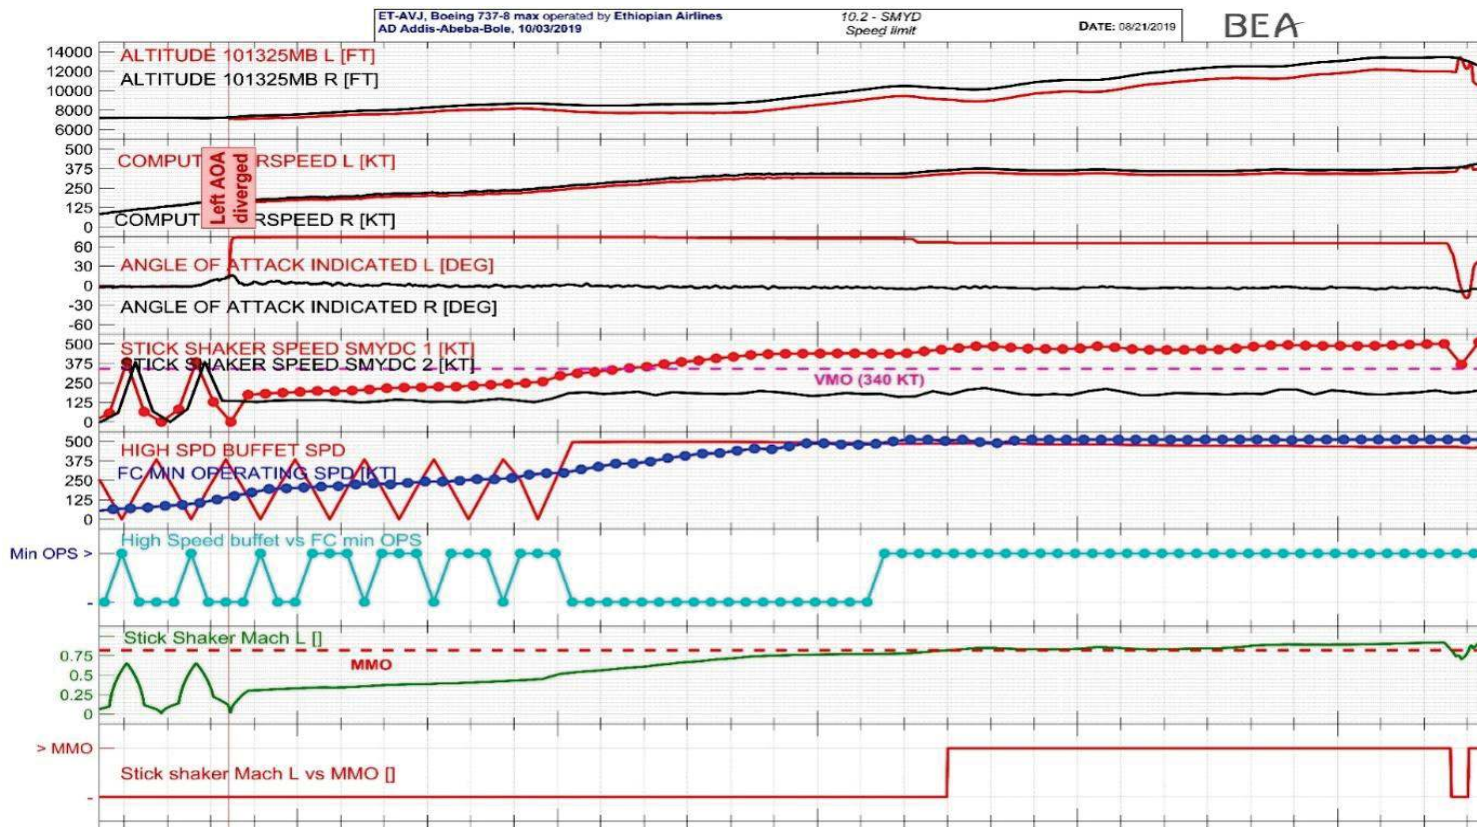
FIGURE 75: SMYD COMPUTED SPEEDS LIMITS

At 5 h 41 min 17 s, SMYDC1 computed FC minimum operational speed values greater than High speed buffet speed values. Both values were computed by the same computer SMYDC 1.

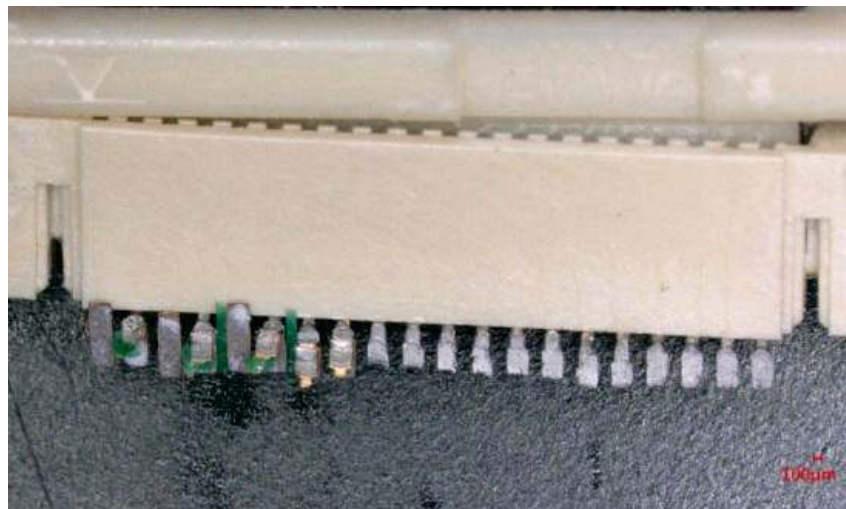
Figure5: Pads and pieces of PCB material on the connector pins

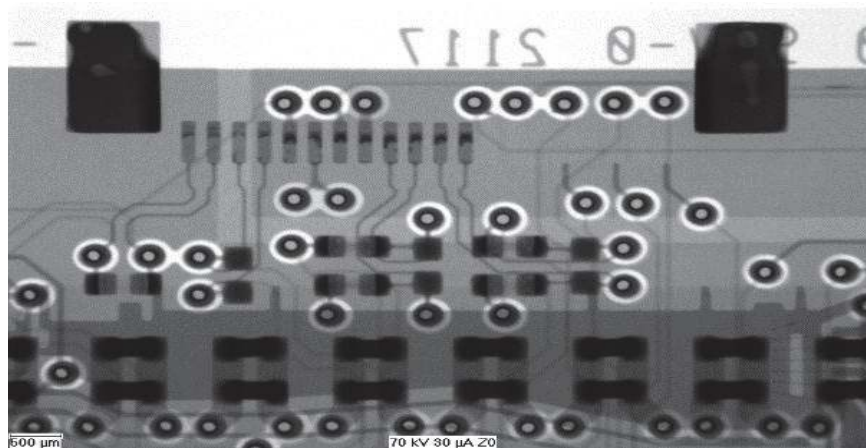
FIGURE 6: X-RAY EXAMINATION OF THE FDR MEMORY BOARD SHOWING THE 8 MISSING PADS
