SERIOUS INCIDENT

Aircraft Type and Registration:	Boeing 787-9, G-ZBKF	
No & Type of Engines:	2 Rolls-Royce Trent 1000-J2 turbofan engines	
Year of Manufacture:	2016 (Serial no: 38622)	
Date & Time (UTC):	1 October 2020 at 0800 hrs	
Location:	En route to London Heathrow Airport	
Type of Flight:	Commercial Air Transport (Passenger)	
Persons on Board:	Crew - 10	Passengers - 53
Injuries:	Crew - None	Passengers - None
Nature of Damage:	No aircraft damage	
Commander's Licence:	Airline Transport Pilot's Licence	
Commander's Age:	49 years	
Commander's Flying Experience:	21,200 hours (of which 2,092 were on type) Last 90 days - 111 hours Last 28 days - 35 hours	
Information Source:	AAIB Field Investigation

Synopsis

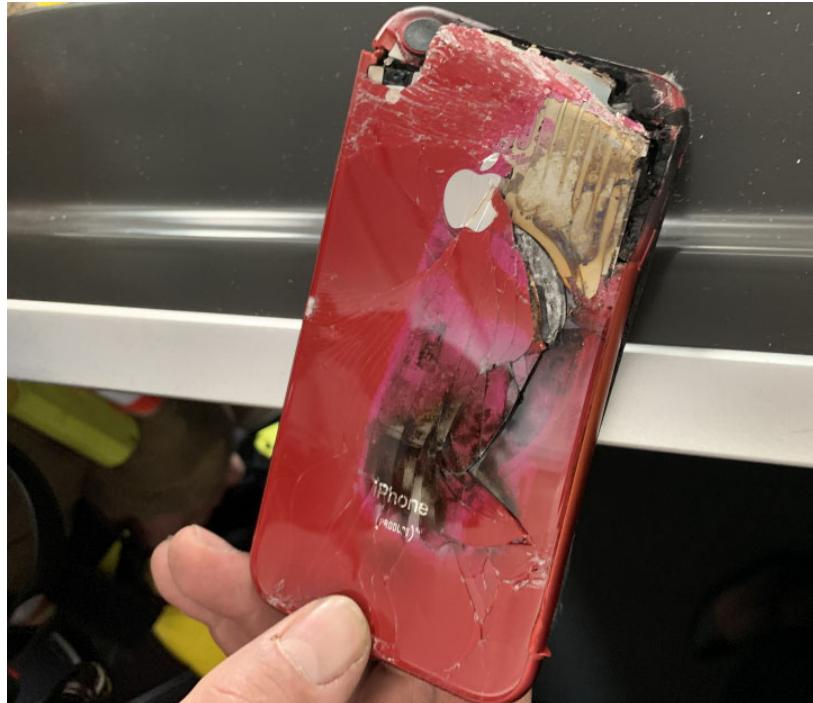
After landing the fire service boarded the aircraft and removed the device from the seat (Figure 1). There was no damage to the aircraft.

Figure 1
Mobile phone retrieved by the fire service after landing

A passenger's mobile phone became trapped in the seat mechanism and was crushed when the seat was adjusted. This damaged the battery, generating flames, smoke and fumes. The cabin crew were able to extinguish the fire using their existing procedures.

It is recommended that the Civil Aviation Authority require that passenger seats in commercial air transport aircraft are designed to minimise the chance of portable electronic devices becoming crushed in mechanisms.
