Runway Incursion (RI)

Serious Incident Investigation Final Report

**Air Cargo Global Boeing 747-400SF,
OM-ACB and Hong Kong Airlines
Airbus A330-343, B-LNS at
Hong Kong International Airport
22 September 2017**

02-2021

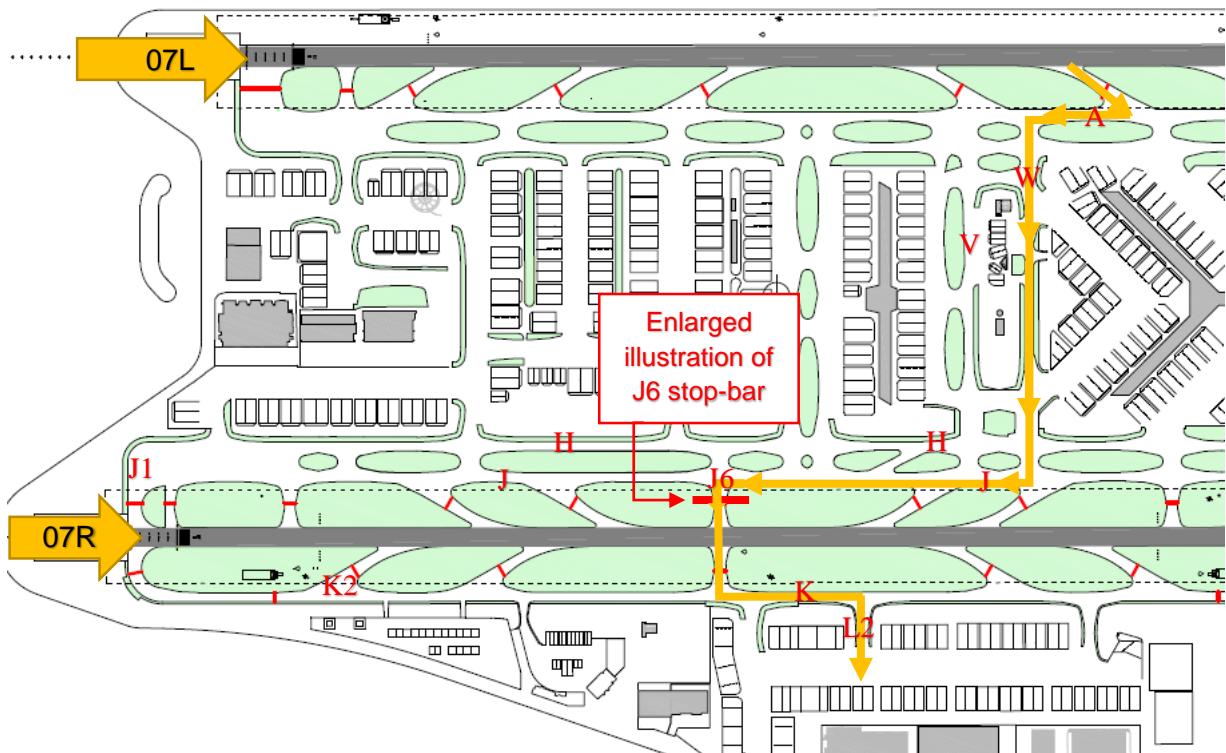
1.1.4. At 08:48:41 after vacating RWY07L, the Pilot Monitoring of Aircraft 1 contacted GMC and the instructor, who had momentarily taken over control from the trainee, issued progressive taxiing instructions to Aircraft 1 to taxi via Taxiway A, W, J to J6 holding point which was on the north side of RWY07R. (See Figure 1 for depiction of the taxi route assigned to Aircraft 1)

Figure 1: Taxi route of Aircraft 1 depicted on Hong Kong International Airport Chart

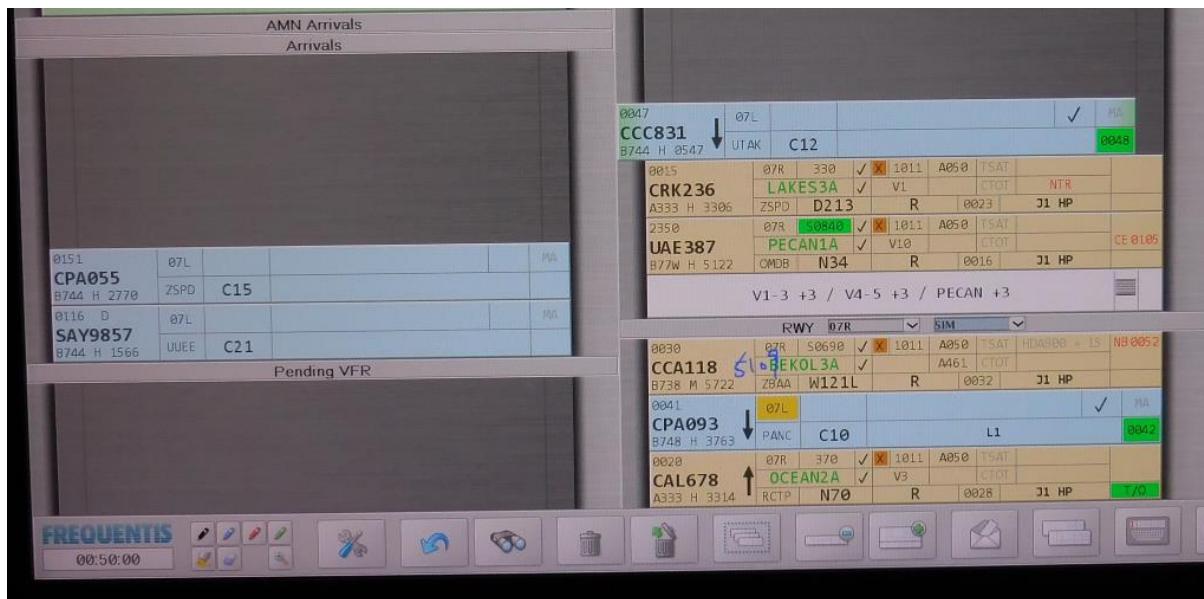
2.2.7.2. The fact that this earlier arrival followed ATC instructions and crossed RWY07R via J6 onto Taxiways K and L1 without any incident indicated that there had been close coordination between GMC and AMS. (See Figure 3 for the actual traffic situation at UTC 00:50:00 (Local Time 08:50:00) as illustrated by the TEFS display at the AMS workstation.)

2.2.7.3. However the runway incursion in which Aircraft 1 was involved showed that if standard procedures were not followed as a result of distraction or other factors, the built-in procedure-based defence may not work as expected. (2.2.5.2) (2.2.6.1)

**Figure 3: Electronic flight strips displayed at AMS workstation
at UTC 00:50:00 (Local Time 08:50:00)**

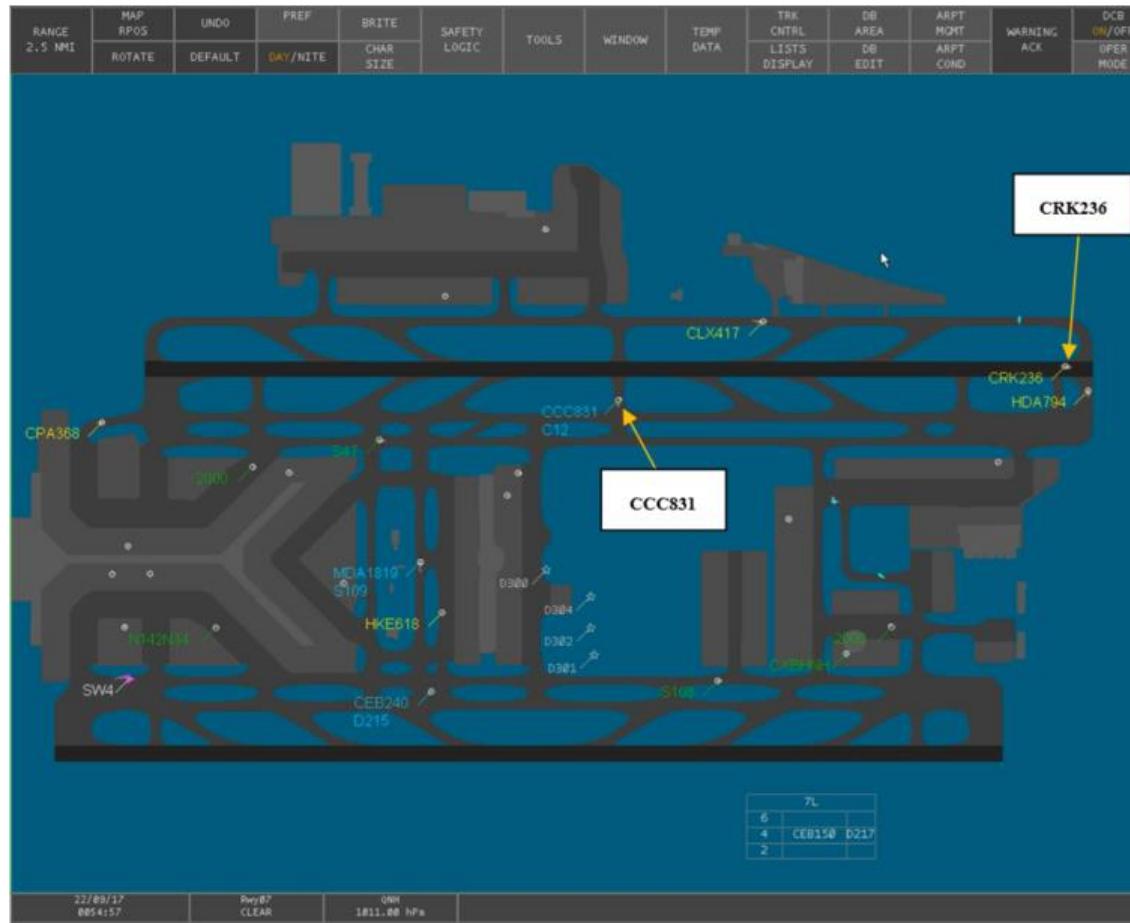
1.1.9. At 08:54:57 Aircraft 2 commenced its take-off roll on RWY07R. A few seconds later, Aircraft 1 started to enter RWY07R from J6 holding point.

Figure 4: CRK236 commenced take-off on Runway 07R at UTC 00:54:57 (Local Time 08:54:57) and the location of CCC831

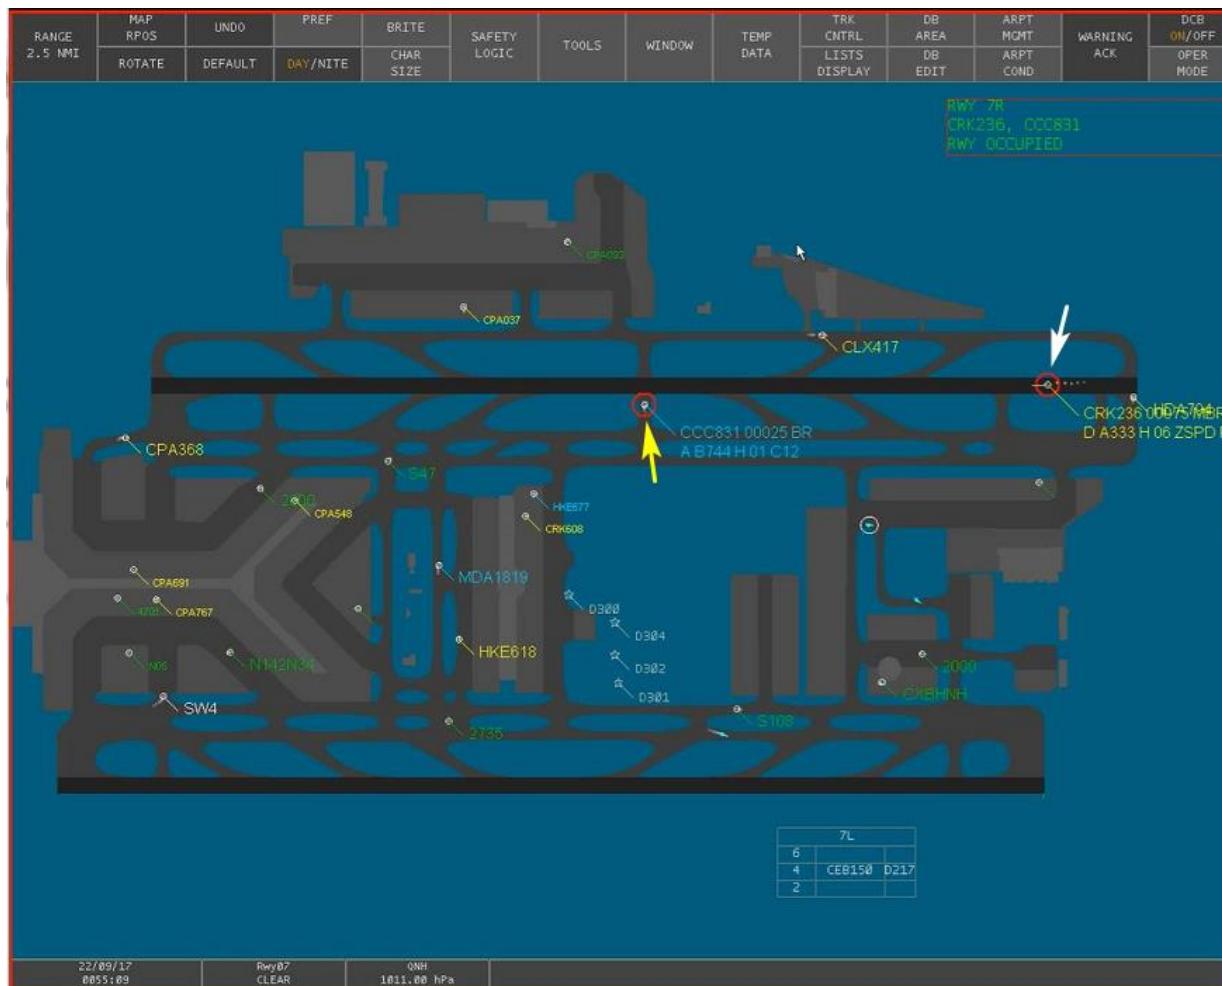
1.1.10. At 08:55:08 a visual red conflict alert was triggered and displayed on the Advanced Surface Movement Guidance and Control System (A-SMGCS) at the workstations of AMS and GMC (see Figure 5 at Appendix 9.1), but no audio alarm was heard.

Figure 5: Positions of CRK236 and CCC831 when Runway Incursion Warning was displayed at UTC 00:55:09 (Local Time 08:55:09)

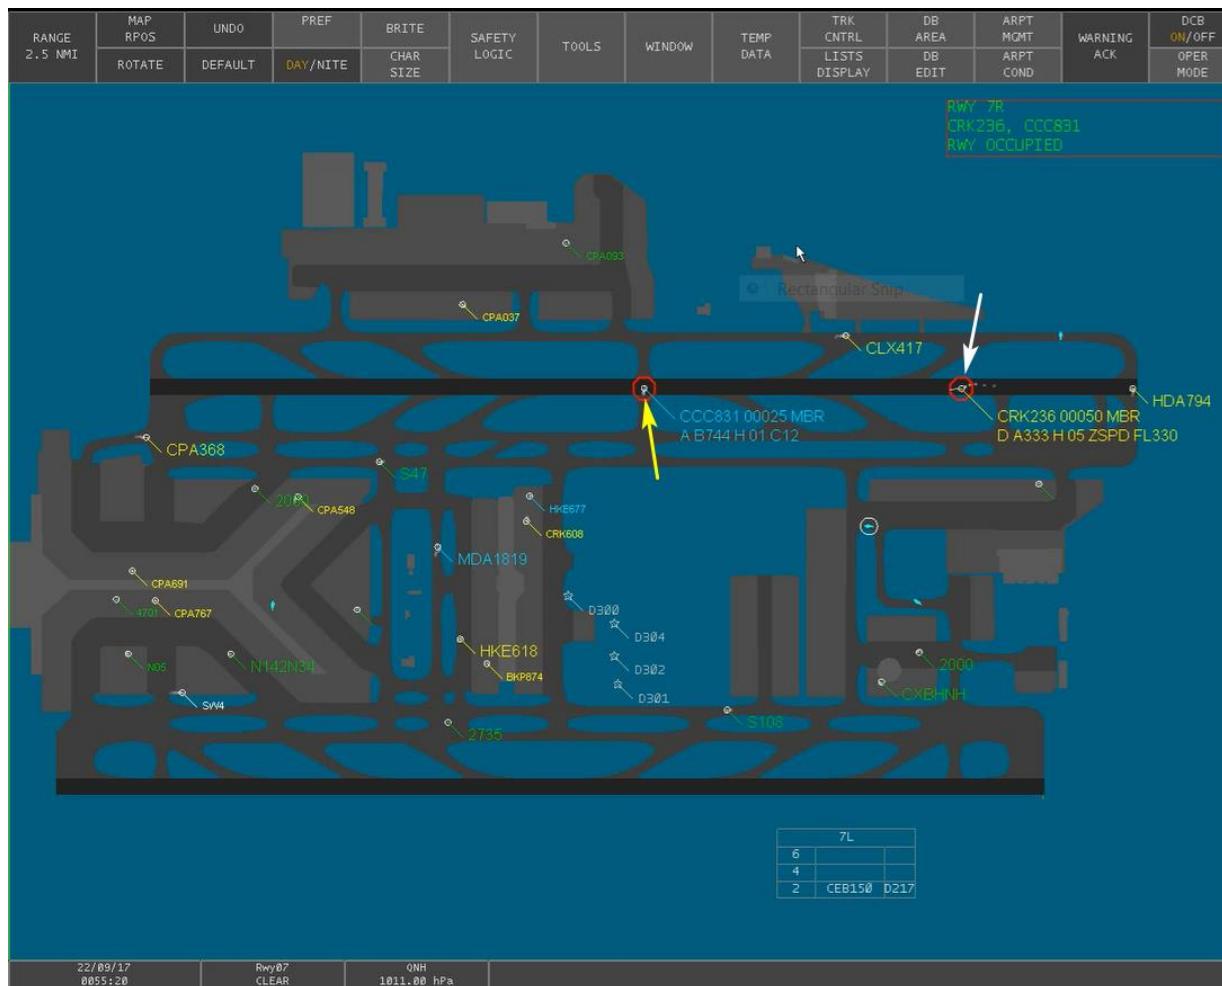
1.1.12. At 08:55:19 Aircraft 2 reported to AMS rejecting the take-off due to another aircraft on the runway. AMS instructed Aircraft 2 to stop immediately and provided traffic information to Aircraft 2. The A-SMGCS red conflict warning ceased after 08:55:21.

Figure 6: Positions of CRK236 and CCC831 when Runway Incursion Warning was displayed at UTC 00:55:20 (Local Time 08:55:20)

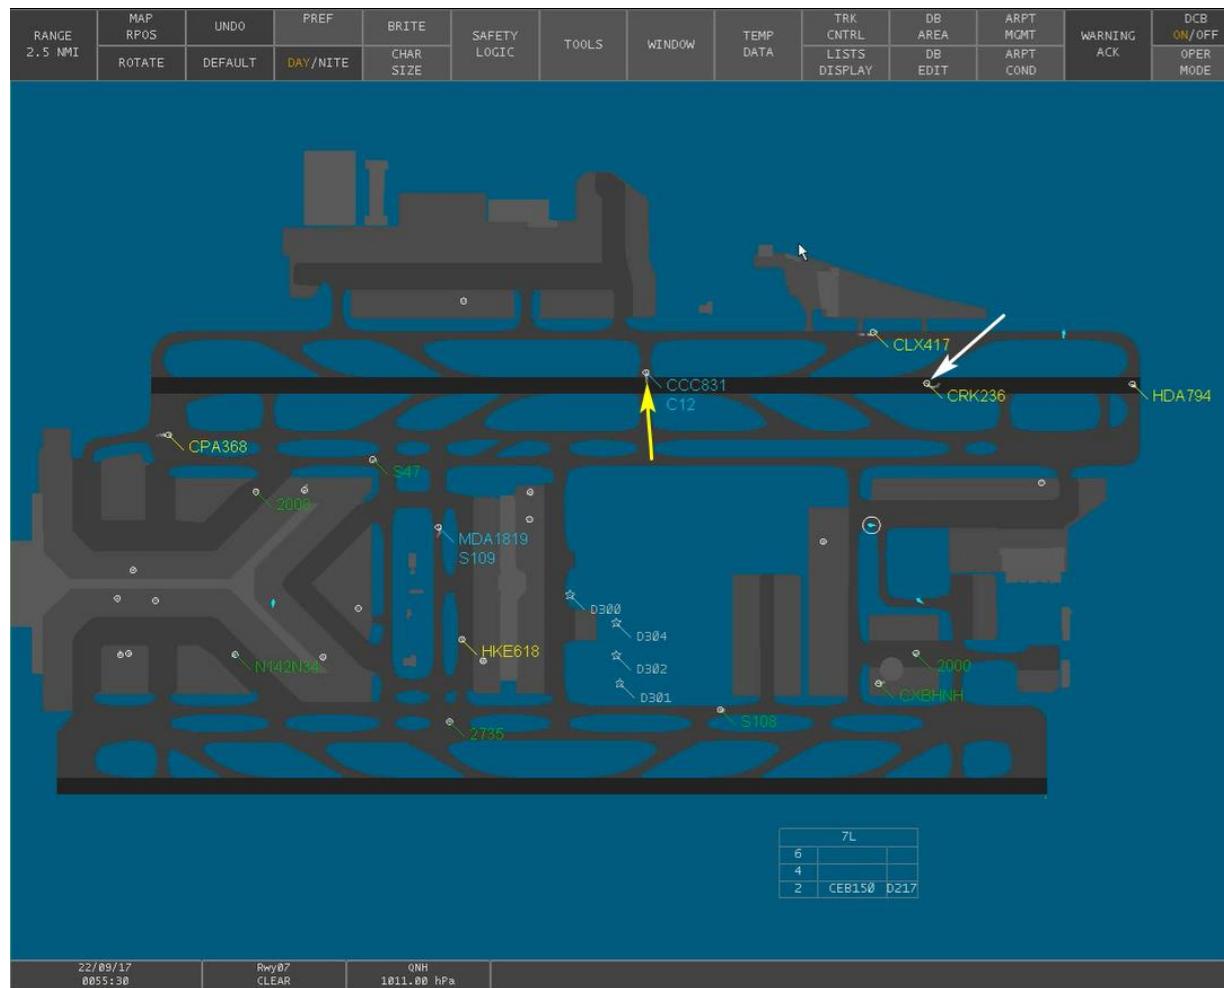
1.1.13. At 08:55:30 Aircraft 2 came to a halt on RWY07R abeam Taxiway K2. Aircraft 1 also vacated RWY07R about the same time and continued taxiing to cargo parking bay C12. The closest distance between the two aircraft was about 1,100m. (See Appendix 9.1 Figure 4-7 for records of the A-SMGCS display)

Figure 7: Display of A-SMGCS at UTC 00:55:30 (Local Time 08:55:30) when CRK236 came to a halt and CCC831 vacated Runway 07R
