Air Accident Investigation Sector

Accident -Final Report -

AAIS Case N°: AIFN/0002/2021

Severe Turbulence during Descent

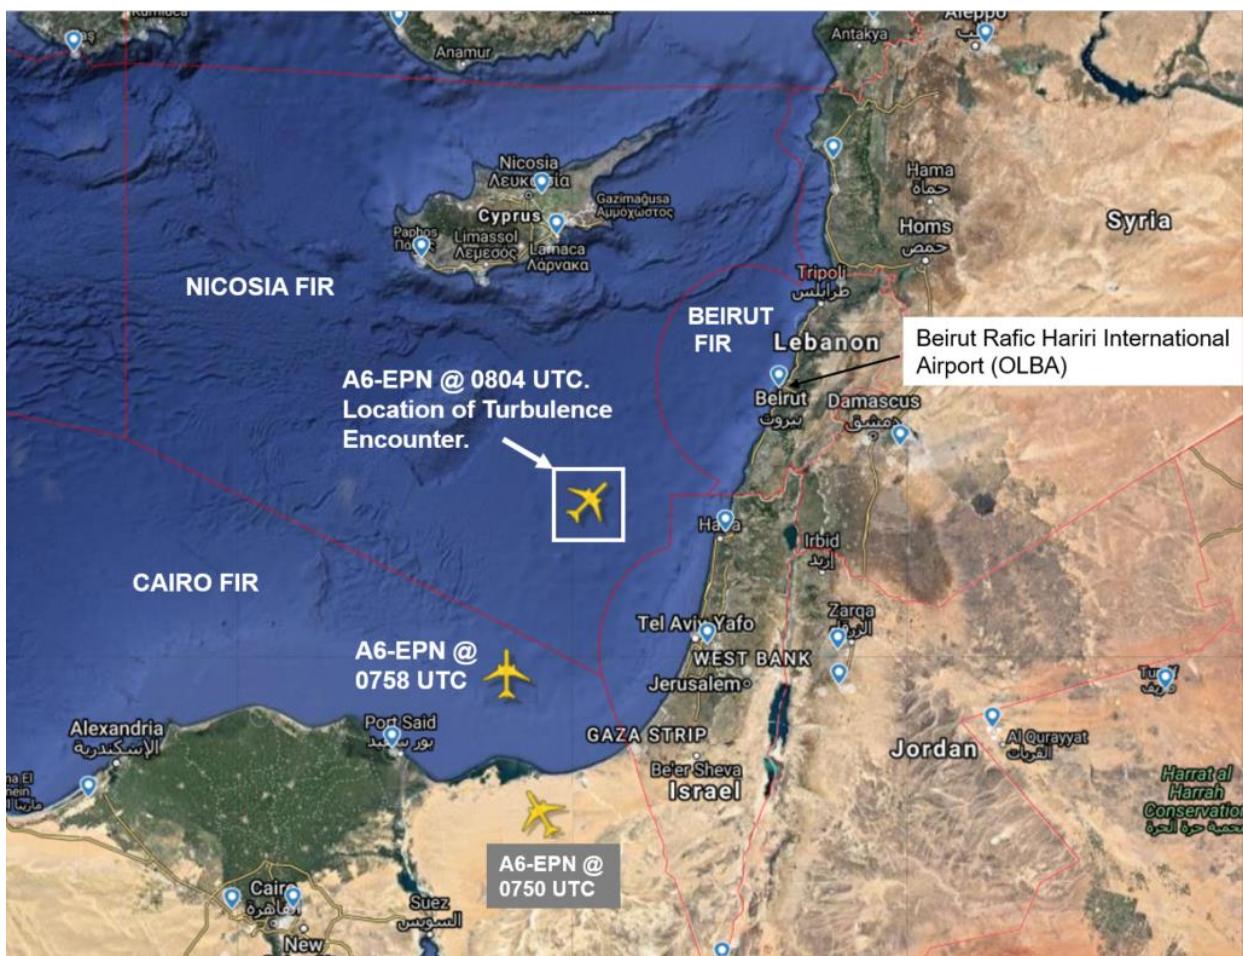
Figure 1. Aircraft approximate location at the turbulence encounter at 0804 UTC

The Nicosia ATC recordings indicated that at 0804:21, the Copilot requested "...20 NM right of track due to weather." and shortly thereafter, the Commander initiated a deviation to the right with a new selected heading of 070 degrees. In the communication with ATC, the Copilot reported that the turbulence was "Moderate to heavy." At 0807:45, the Copilot informed ATC that the turbulence decreased and stated that it was light, and additionally informed ATC that the turbulence was encountered between FL300 and FL270.

Figure 1 illustrates the selected Aircraft positions over Cairo and Nicosia FIRs, and the approximate location of the turbulence encounter which was about 100 NM southwest OLBA.

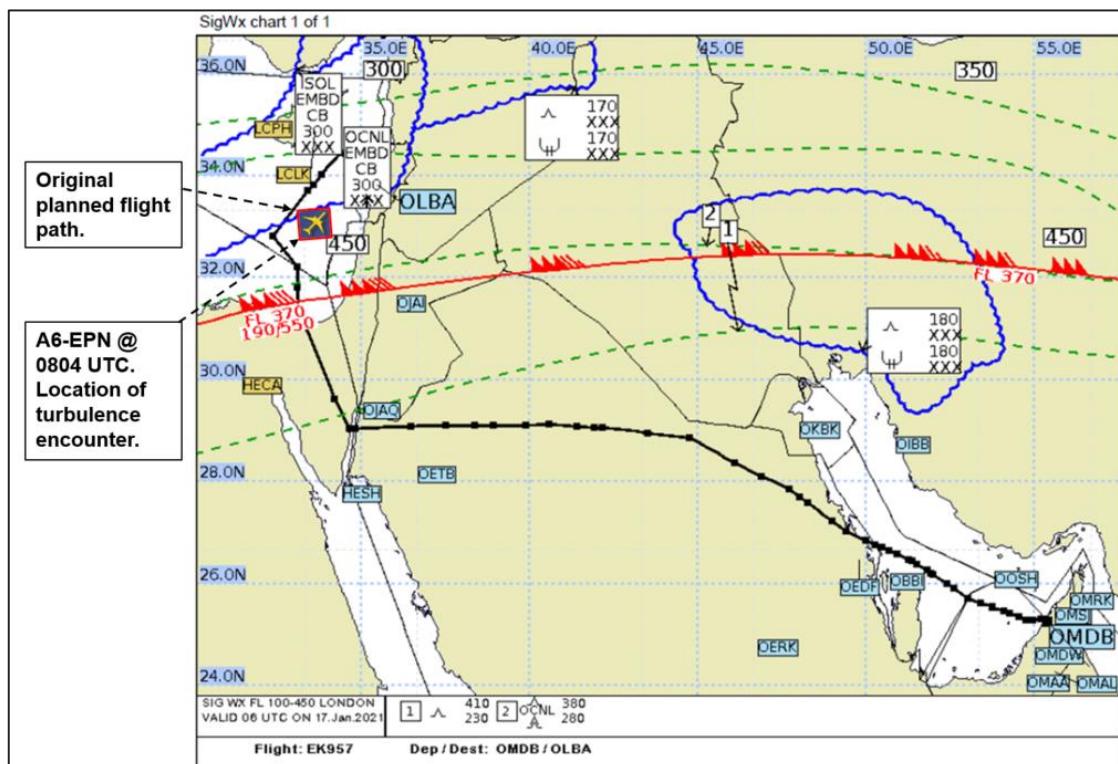
Figure 2. High-level prognostic significant weather chart over NICOSIA and BEIRUT FIR [Source: www.wrf-weather.com].

The high-level prognostic SIGWX included in the OFP forecasted occasional embedded CBs with tops of 30,000 ft affecting Nicosia and Beirut FIRs, and forecasted moderate turbulence with occasional severe turbulence between FL380 and FL280. The northern hemisphere jet stream was at FL370 with speeds of up to 170 kt close to latitude 32.0N. Figure 2 illustrates the

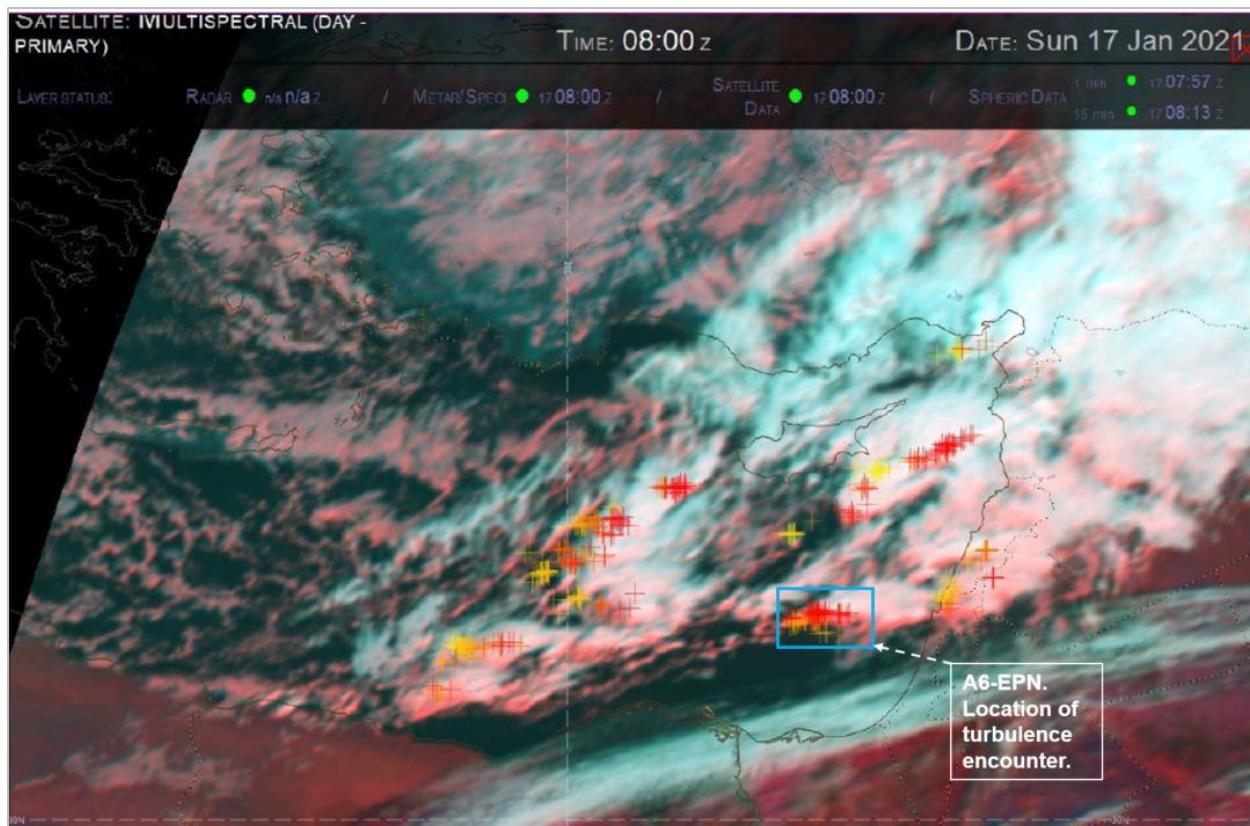
Figure 3. Satellite multispectral image over NICOSIA, Cyprus [Source: UAE NCM]

A satellite image captured at 0800 on 17 January 2021 was provided to the Investigation by the UAE National Center for Meteorology (NCM). The image depicted the weather in Nicosia FIR and surrounding area over the Mediterranean (figure 3). Lightning strikes are indicated in red and yellow colors. The blue box in figure 3 illustrates the area that the Aircraft traversed when turbulence encounter occurred. The NCM assessment of the satellite image estimated that the cloud tops appear to be near to FL300 at the time of the turbulence encounter.

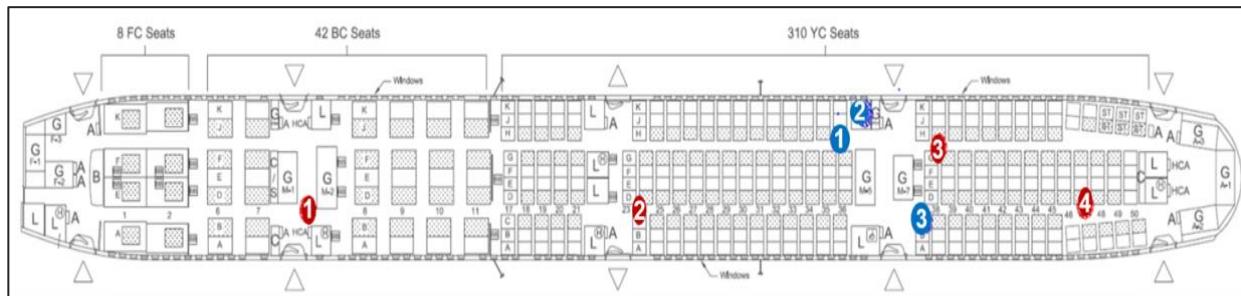
Figure 4. Aircraft cabin layout with the location of the injured occupants

- (3) The cabin crewmember (indicated by red symbol 1) stated that she was securing the galley equipment adjacent to L2A door when the severe turbulence started. The turbulence caused her to be lifted off her feet causing her to impact surrounding cabin furnishings.

- (5) The cabin crewmember (indicated by red symbol 3) stated that she was assisting another passenger to secure an infant and child at seat 38G. The cabin crewmember was holding the child and was unable to secure herself during the turbulence. Together with the child, the cabin crew was forcefully lifted off her feet impacting the ceiling by her head.

- (6) The cabin crewmember (indicated by red symbol 4) stated that he was securing the cabin and requesting passengers to take their seats. After hearing the flight crew announcement for "cabin crew to take your seats", he was unable to secure himself to a passenger seat, 47D, and during the turbulence was forcefully lifted off the seat impacting the ceiling by his head.

The FDR recorded vertical g-forces resulting from the turbulence were significant enough to cause the unsecured cabin crewmembers and passengers to be lifted off their feet and impact the cabin furnishings. It is noted that of the seven occupants injured, five were in the aft cabin including the passenger who was seriously injured.

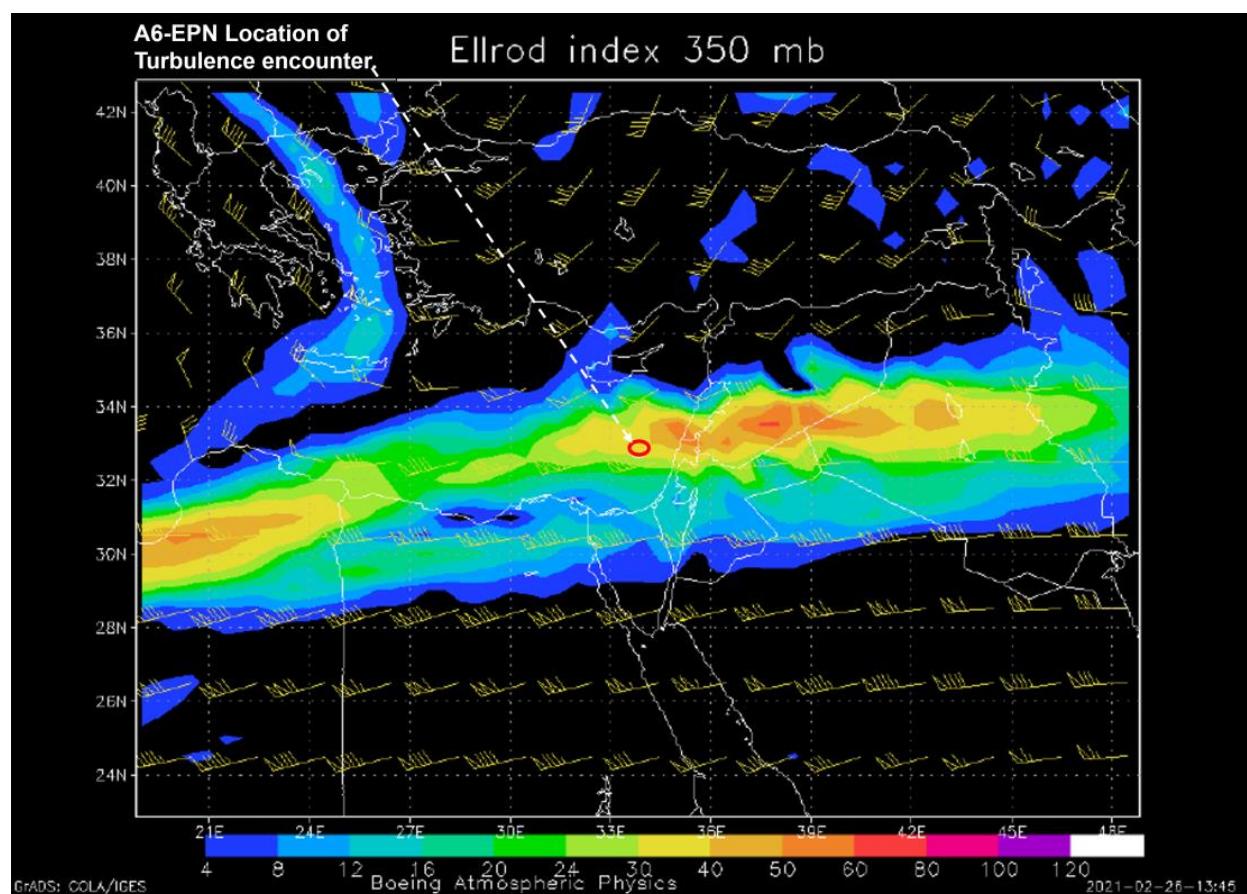
Figure 5. Ellrod Index for NICOSIA and BEIRUT FIR [Copyright of The Boeing Company]

The Ellrod Index was used for diagnosing the turbulence potential due to wind shear along the jet streams and weather fronts. For Nicosia and Beirut FIRs, the Ellrod Index is illustrated in figure 5³. The location where the Aircraft encountered the turbulence is marked by a red circle. The turbulence encounter occurred in a region with an Ellrod value of above 30 next to an area with a value above 50, which the Aircraft manufacturer stated was capable of producing strong turbulence. The computer models indicated that the jet stream peaked in strength just to the south and above the Aircraft location, reaching speeds of about 170 kt.

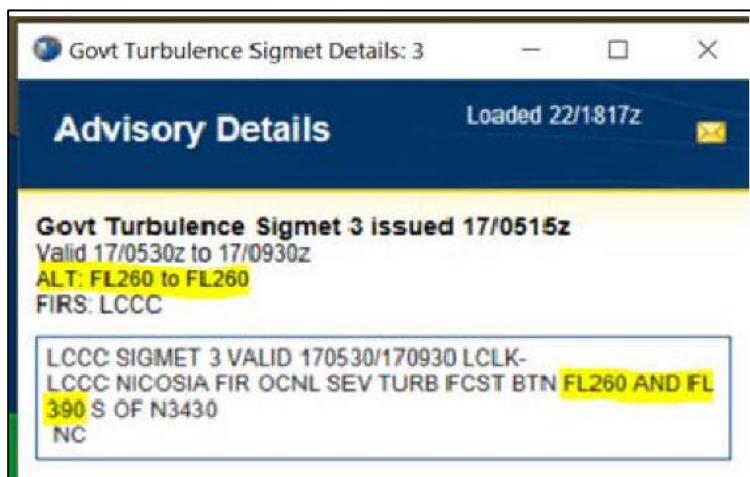
Figure 6. WSI Fusion advisory details of LCLK SIGMET 3 on 17 May 2021

As illustrated in figure 6, the Operator provided the Investigation with a copy of the flight EK957 ‘Advisory Details’ that was automatically generated by WSI Fusion based on SIGMET 3 issued by LCLK MWO office. The flight level (highlighted in yellow) noted on the advisory under the heading of ‘ALT’ states “FL260 to FL260” whereas within the contents of the SIGMET, “FL260 AND FL390” is stated.

At 0805 an alert was generated by WSI Fusion when the Aircraft was passing FL260. At 0809 an Aircraft Communications Addressing and Reporting System (ACARS) message was sent to the Aircraft based on the WSI Fusion alert generated. The ACARS message was received electronically by the flight crew after the Aircraft landed at OLBA. The Commander stated “...after landing via ACARS indicating OCNL [occasional] SVR [severe] turbulence between FL250 [FL260] and FL390. This SIGMET was held back by ACARS because it was sent during a critical phase of flight.”

The Investigation recommends that the Operator enhance the training of the dispatchers on the software application employed to read and compile SIGMET using this occurrence as evidence-based training. The Investigation also recommends that the Operator considers the risk of SIGMET format incompatibility in the safety management system and take mitigation actions to prevent miss-compilation by the Weather Services International (WSI) Fusion application.

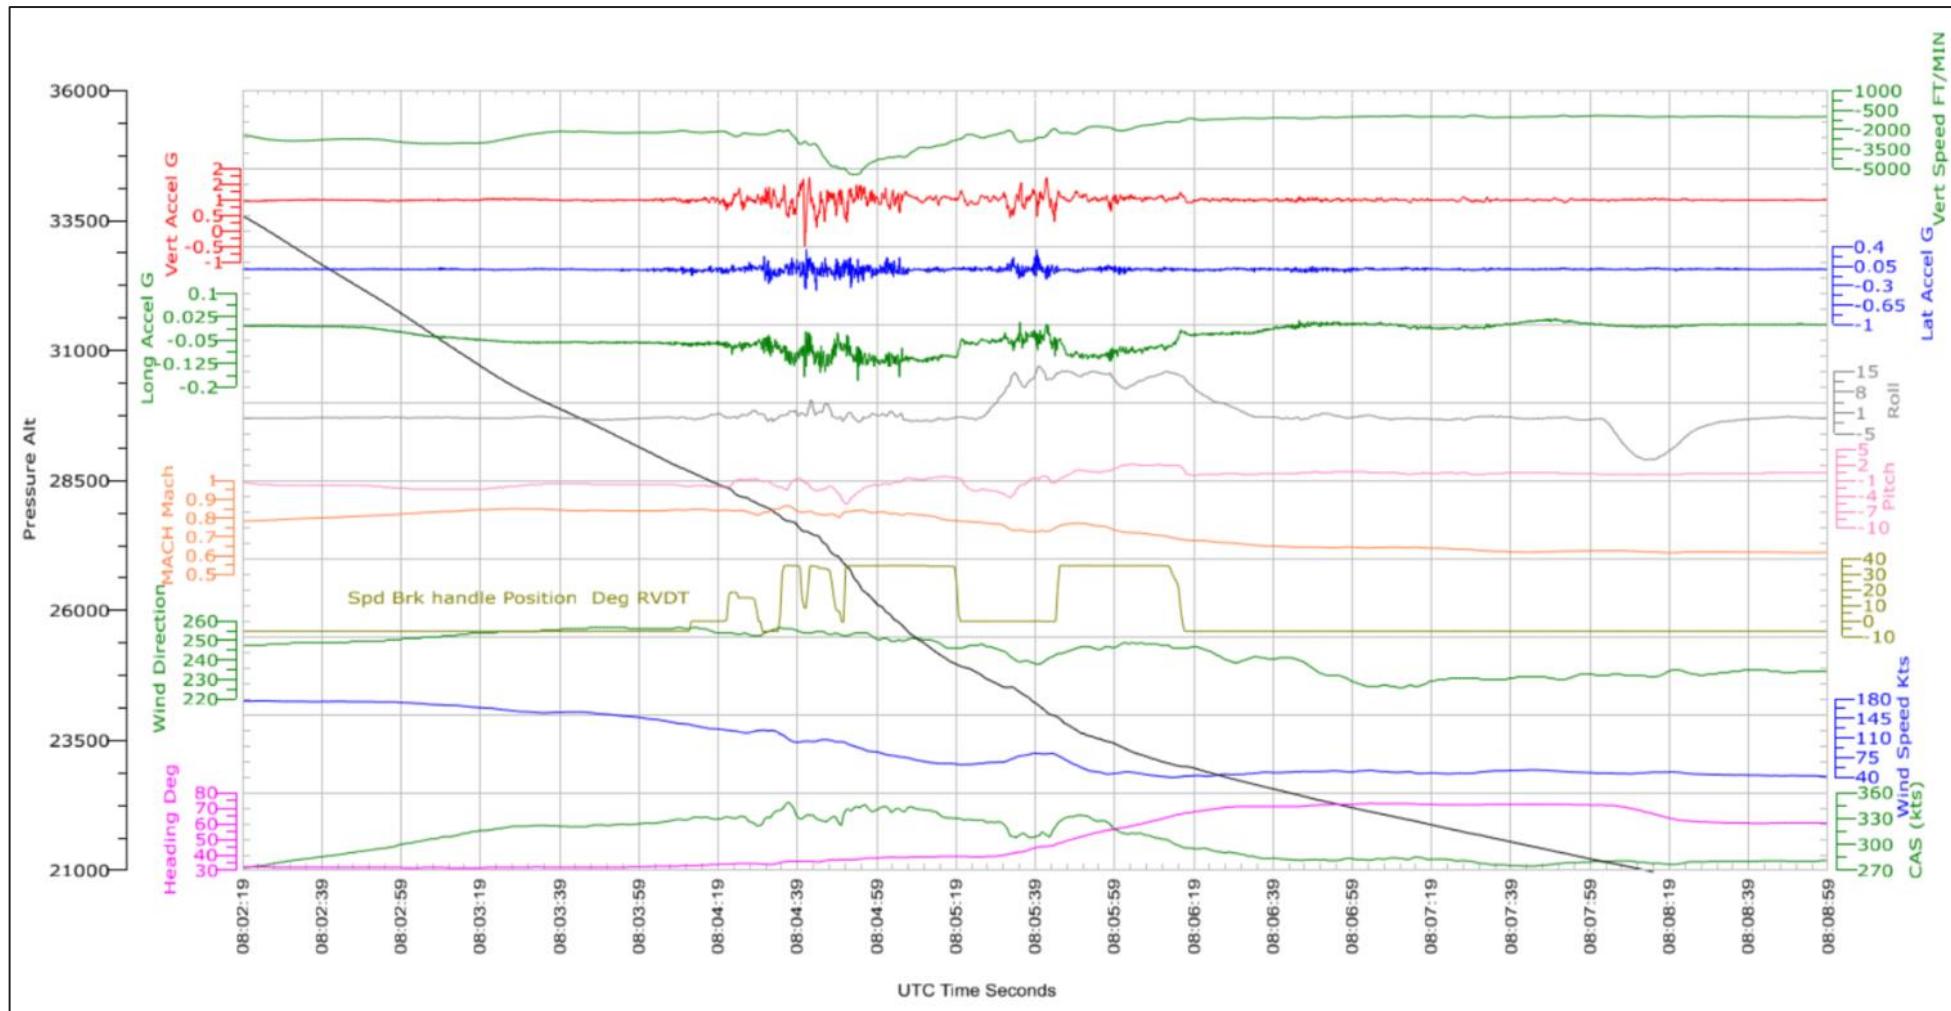
Appendix A – EK957 Turbulence Flight Recorder Data Plot

Significant turbulent conditions were recorded by the FDR during the period from 0803:56 to 0806:56, while the Aircraft was descending from pressure altitude 29,200 to 22,200 ft. During this period, the Aircraft encountered more energized turbulence between 0804:20 and 0805:08 (28,400 to 25,500 ft pressure altitude). With the Aircraft location near coordinates latitude 32.85685 degrees north and longitude 33.85498 degrees east, a peak negative vertical load factor of (-)0.49 g was recorded at 0804:41 followed approximately one second later by a peak positive vertical load factor of (+)1.72 g.
