Controlled Flight into Terrain Marginally Avoided

Serious Incident Investigation Final Report

**B747-87UF
Lo Fu Tau, Lantau Island,
Hong Kong
24 September 2017**

03-2021

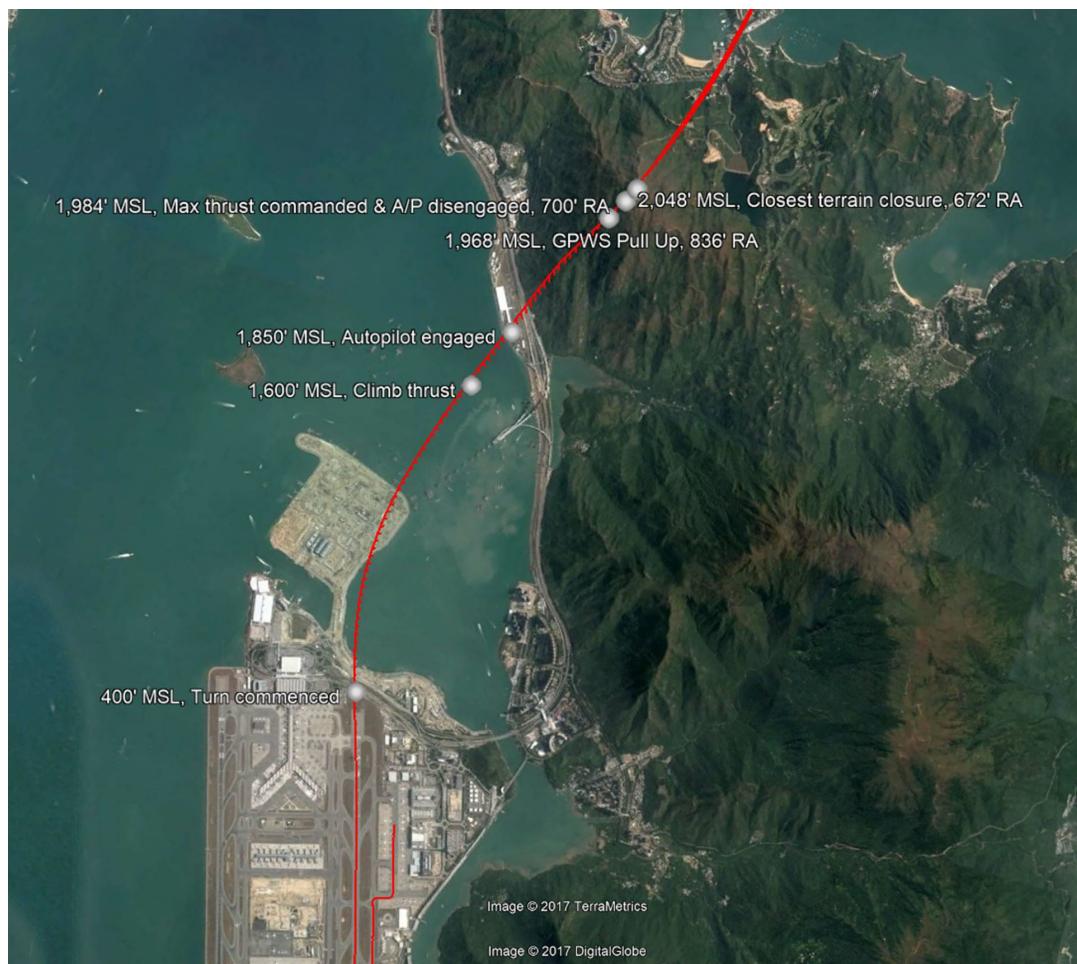
**Figure 2: Aircraft track**

- (2) At 23:44 hrs, once the aircraft took off from Runway 07R, it commanded a right turn towards the first active waypoint PORSH.
- (3) Climbing through approximately 1,800 ft AMSL, the PF called for PM to select the Left Autopilot (A/P) to command while the aircraft continued turning right towards the high ground at Lo Fu Tau. At 23:45:14 hrs, ATC informed the flight crew that the aircraft was off track and instructed the crew to turn left to resume the RASSE 1E SID. The PF started making a HDG Select heading change leaving VNAV engaged. Shortly afterwards, ATC informed the flight crew of terrain to the right of the aircraft and instructed the crew to expedite the climb to 5,000 ft AMSL (see Appendix).

- (4) At approximately 2,000 ft AMSL, the Enhanced Ground Proximity Warning System (EGPWS) on board the aircraft was triggered with a Mode 2A visual alert and the aural warning “TERRAIN, TERRAIN; PULL UP” annunciated. In response, the PF immediately disconnected the A/P and increased pitch and thrust. The aircraft passed over the high ground by approximately 670 ft AGL. Subsequently, the aircraft re-established the SID track at approximately 23:46 hrs and continued without further incident. There was neither injury to personnel nor damage to the aircraft involved and no other air traffic was affected.

- (1) Neither the Cockpit Voice Recorder (CVR) nor the Flight Data Recorder (FDR) data was available from Atlas Air. Atlas Air provided the investigation with Figure 2: Aircraft track in this report and a flight animation based on the Quick Access Recorder (QAR)⁷ data.
- (2) No Secondary Surveillance Radar (SSR)⁸ data was available from CAD. CAD provided the investigation with a manually recorded radar screen replay.

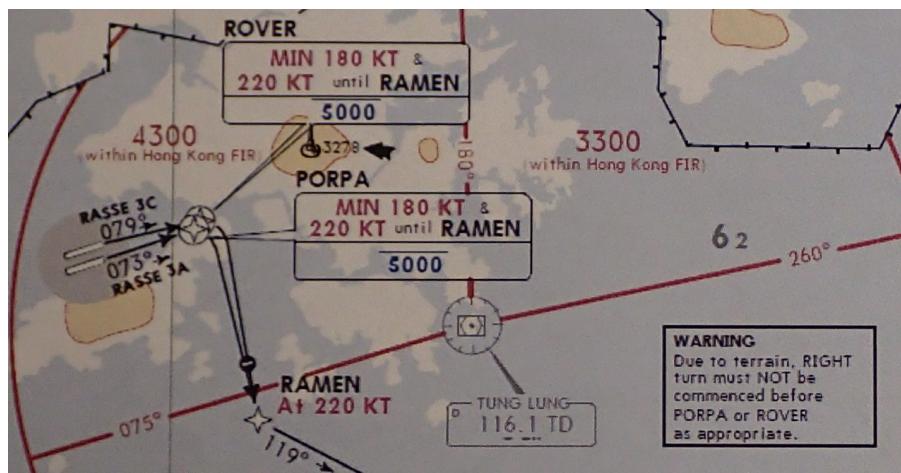
Figure 3: RASSE 3A SID

For the RASSE 3A SID, PORPA is a flyover waypoint and the departure chart includes a WARNING regarding right turn must not be commenced before waypoint PORPA.

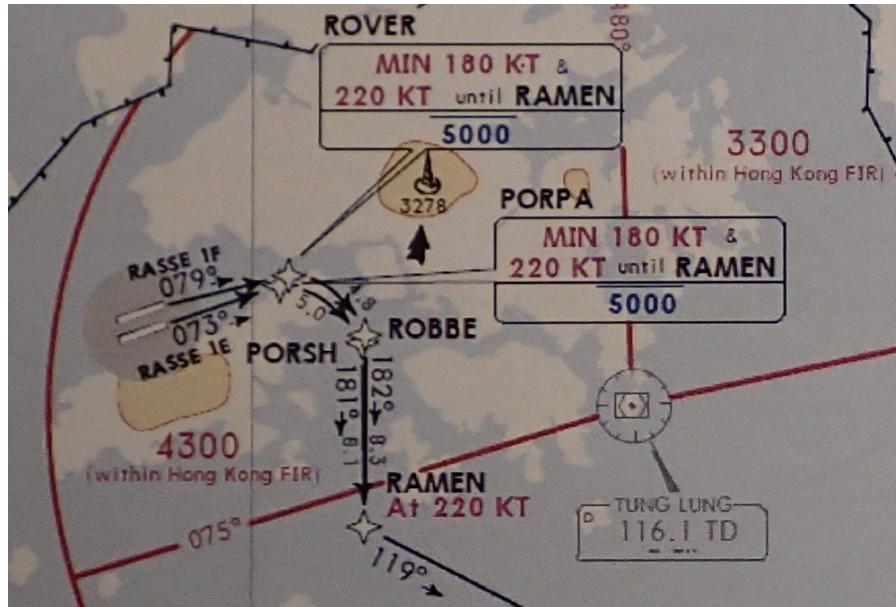
Figure 4: RASSE 1E SID

In comparison with the RASSE 3A SID, despite the WARNING regarding PORPA is not stated, the aircraft Radius-to-Fix (RF) capability will ensure aircraft flying the RASSE 1E SID tracking overhead waypoint PORPA.

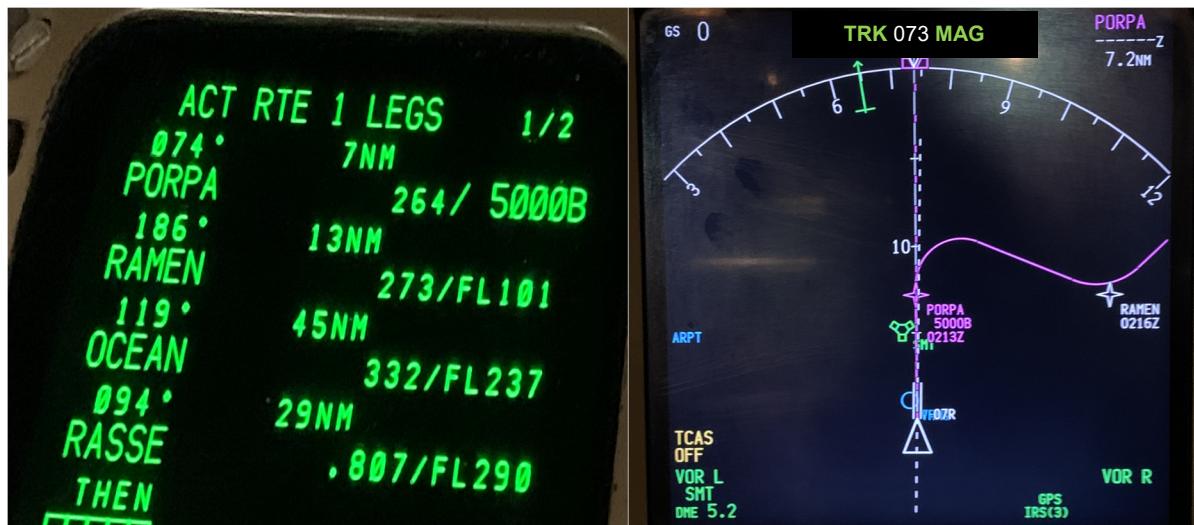
Figure 5: Simulated RASSE 3A SID that displayed on the CDU and ND

Before push-back as part of his pre-flight duties, the PIC had already loaded the company filed flight plan, the anticipated Runway 07R and RASSE 3A SID in the FMS. Also, he gave a preliminary departure briefing to the PM. The PM then did an independent route verification including the RASSE 3A SID. At that stage, the crew were mentally prepared for the RASSE 3A SID that they were anticipating. The names and symbols of the waypoints and the SID course magenta line that would have displayed on the CDU and ND with respect to the RASSE 3A SID are depicted in Figure 5.

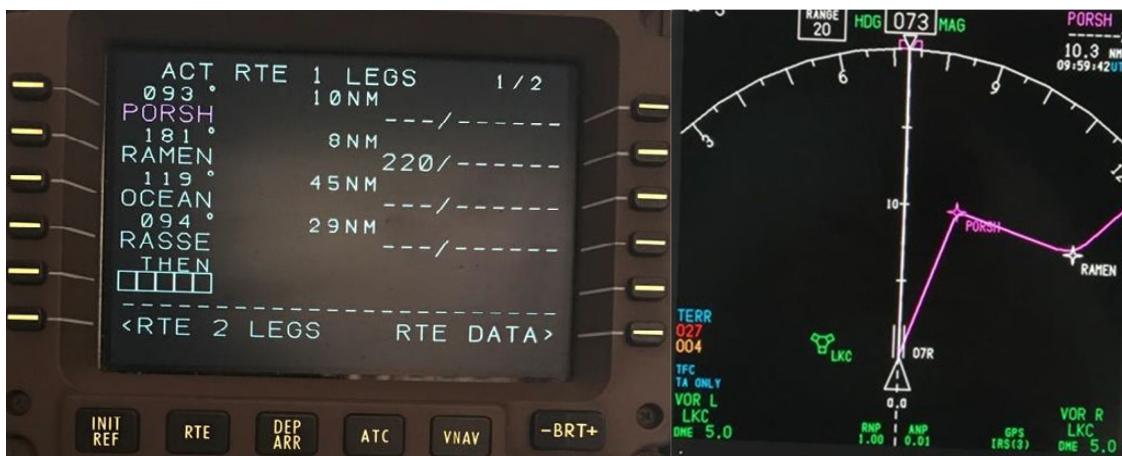
Figure 6: Simulated modified RASSE 1E SID that displayed on the CDU and ND

The crew was not familiar with the RF RASSE 1E SID and it was the first time that the crew received this clearance. Having been given the RASSE 1E SID that was unanticipated, unfamiliar and compounded with time pressure, the crew accepted the clearance. After discussion amongst the crew and possibly due to the perceived time constraint, it was eventually decided that waypoint PORPA was not part of the SID. The SID was thus manually modified, making waypoint PORSH as the first active waypoint after takeoff. By doing so, the SID course magenta line would have veered to the right (see Figure 6).

Modification of the RF SID RASSE 1E while programming the SID into the FMC by overwritten waypoint PORPA, making PORSH the first active waypoint (paragraphs 1.8.3 and 2.6).

It is recommended that SID procedures should not be manually modified (paragraph 3.2).

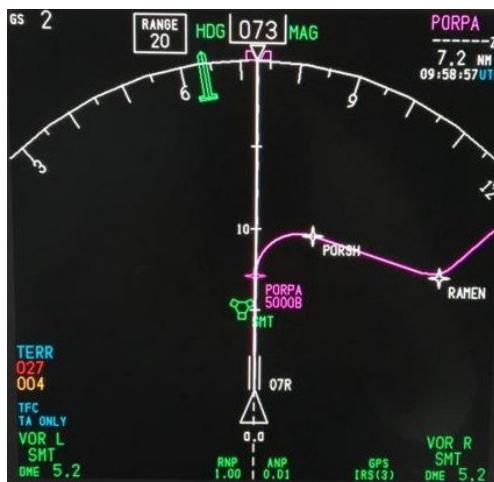
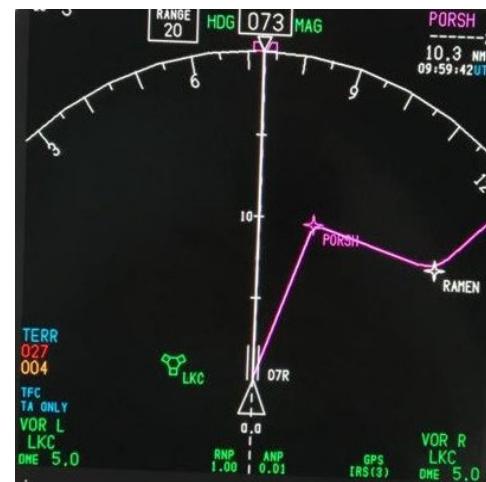
the airport diagram, between the time the SID was amended and just prior to takeoff. Not having selected the MAP display mode that shows the SID course during this period would preclude the crew from cross-checking, thus noticing and analysing the veering of the SID course magenta line to the right.

- (3) Had the RASSE 1E SID not been amended and a cross-check been done with either ND selected on the Map display mode, the crew would have seen the illustration of RASSE 1E SID (see Figure 7). As the crew amended the SID with both NDs on the AMM display mode, they would not have seen the illustration of the un-amended RASSE 1E SID in the first place. When the NDs were eventually selected to the MAP display mode at the very last moment just prior to takeoff, the right veering of the SID course would appear to be less conspicuous as the crew had not looked at the depiction of the un-amended RASSE 1E SID, with which they could compare to notice the difference. It was also not noticed that the display indicated that the first active waypoint PORSH was not on the runway heading (see Figure 8).

It is recommended that the FCOM of the operator be reviewed to ensure that discrepancies between flight plan and ATC route clearance do not exist prior to take-off (paragraphs 2.7 and 3.3.3).
