# National Transportation Safety Board Aviation Accident Final Report

| <b>Location:</b> | Jacksonville, Florida | <b>Accident Number:</b> | DCA19MA143 |
| <b>Date &amp; Time:</b> | May 3, 2019, 21:42 Local | <b>Registration:</b> | N732MA |
| <b>Aircraft:</b> | Boeing 737 | <b>Aircraft Damage:</b> | Substantial |

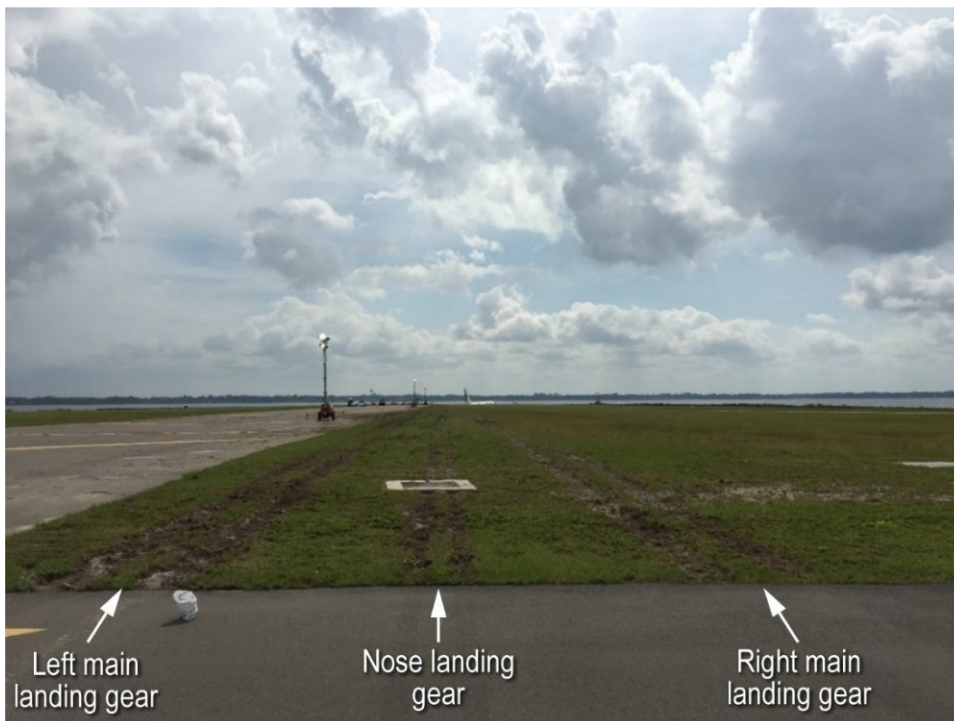
Light white landing gear track marks were visible on the pavement starting 1,592 ft from the displaced threshold (12 ft past the touchdown point of 1,580 ft computed by the onboard performance tool [OPT]) to the end of the pavement. The airplane's tracks showed variation in position relative to the right of centerline after touchdown and exited the paved surface about 55 ft to the right of centerline. The tracks continued in the grass area, deviating farther to the right of centerline and extending to the point at which the airplane struck the rock berm and entered the river, 90 ft right of centerline. Figure 1 shows the transition of track marks from the pavement to the grass and figure 2 shows the airplane at final rest in St Johns River.

**Figure 1.** Photograph of tire marks from the accident airplane's landing gear

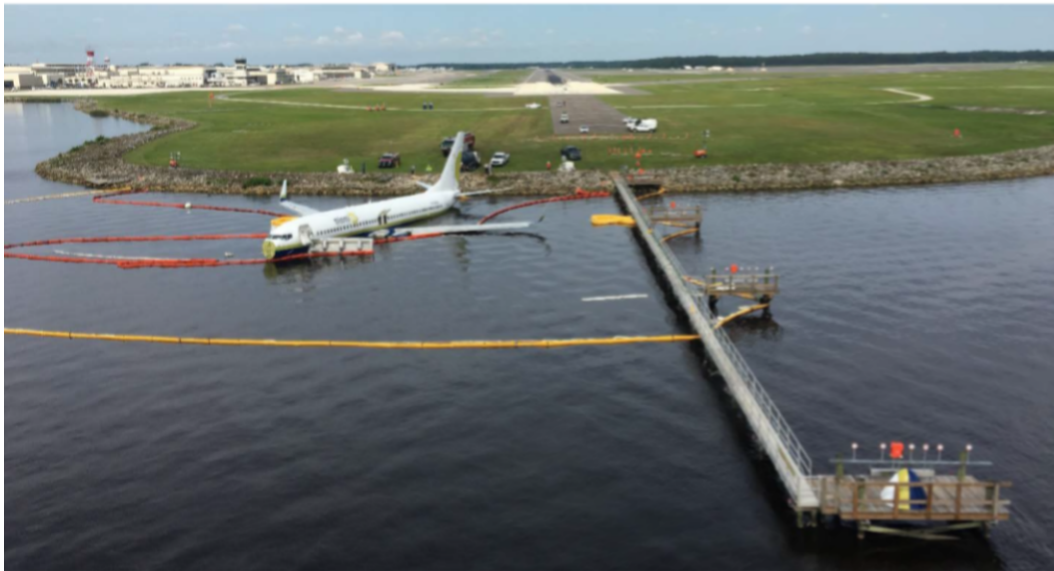
**Figure 2.** Photographs of accident airplane in St. Johns River

The airplane was mostly intact but sustained substantial damage. Portions of the engine cowlings, the radome, and both main landing gear separated during the accident sequence and were in the water adjacent to the airplane or on the rock embankment. Three life rafts were recovered in the water around the airplane. The L1 and R1 (forward) doors and the four overwing emergency exits were open. The L2 and R2 (aft) doors were closed. The L1 door
