# Air Accident Investigation Sector

## Serious Incident - Final Report -

AAIS Case N°: AIFN/0007/2020

## Descent below Vertical Profile during Approach

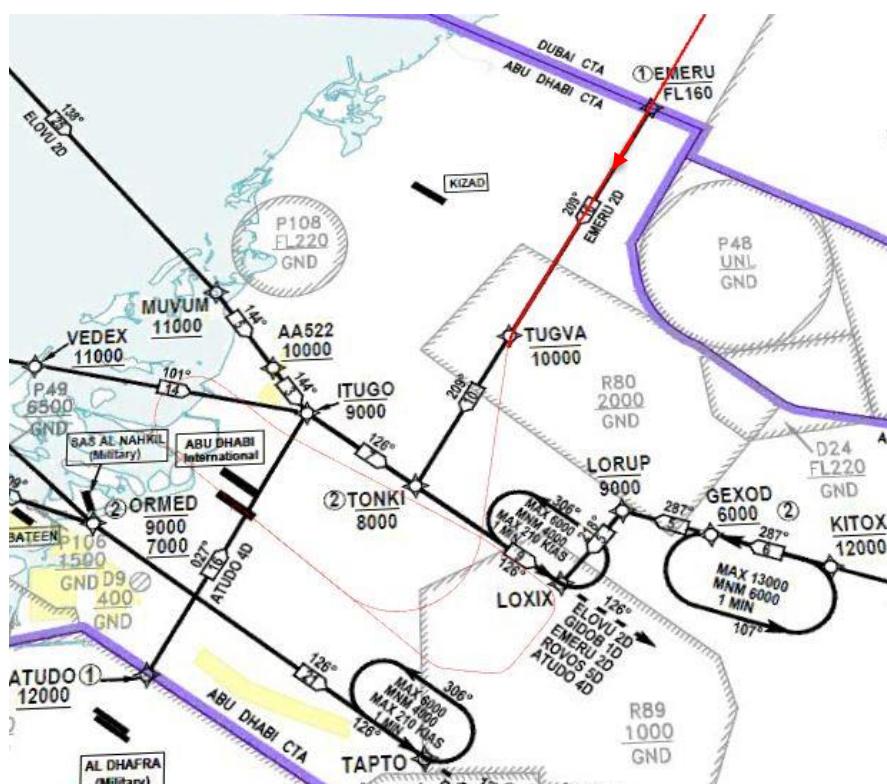
At 0937, the Aircraft commenced its descent, subsequently followed standard arrival EMERU 2D (figure 1), and continued to proceed for an RNP AR approach (RNAV (RNP) Y) to runway 31L at OMAA (figure 2).

Figure 1. EY9878 flight path on arrival (red thick-line) following OMAA STAR RNAV 1 runway 31L/R chart

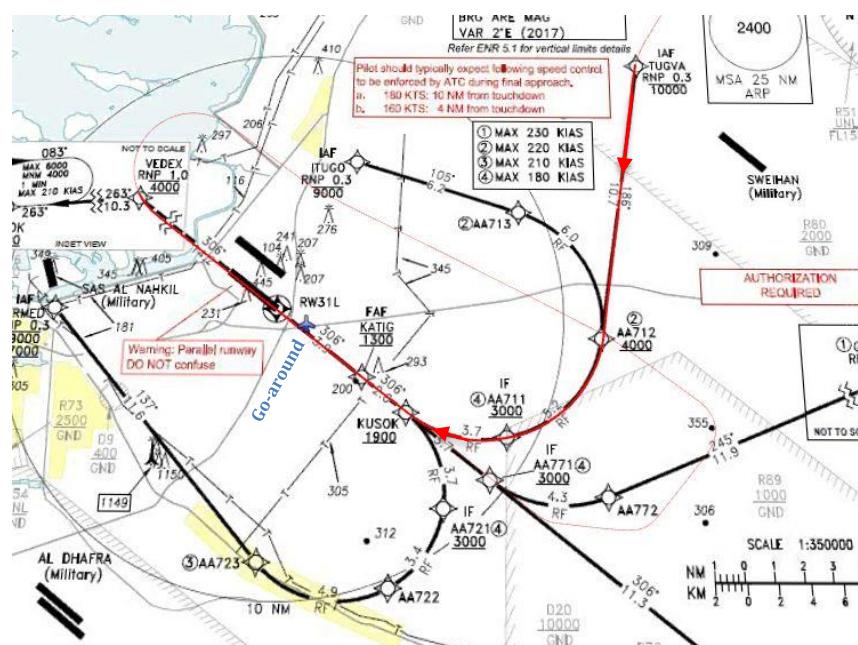
At 1001:06, when the Aircraft was on final approach at a distance of approximately 1.3 nautical miles from the threshold of runway 31L and approximately 210 feet radio altitude (RA), the flight crew initiated a go-around. The go-around initiation was decided by the Commander after sighting four reds of the precision approach path indicator (PAPI) and subsequently carried out by the Copilot as PF.

**Figure 2.** EY9878 flight path of first approach and go-around (red thick-line) following instrument approach chart of OMAA RNAV(RNP) Y Runway 31L

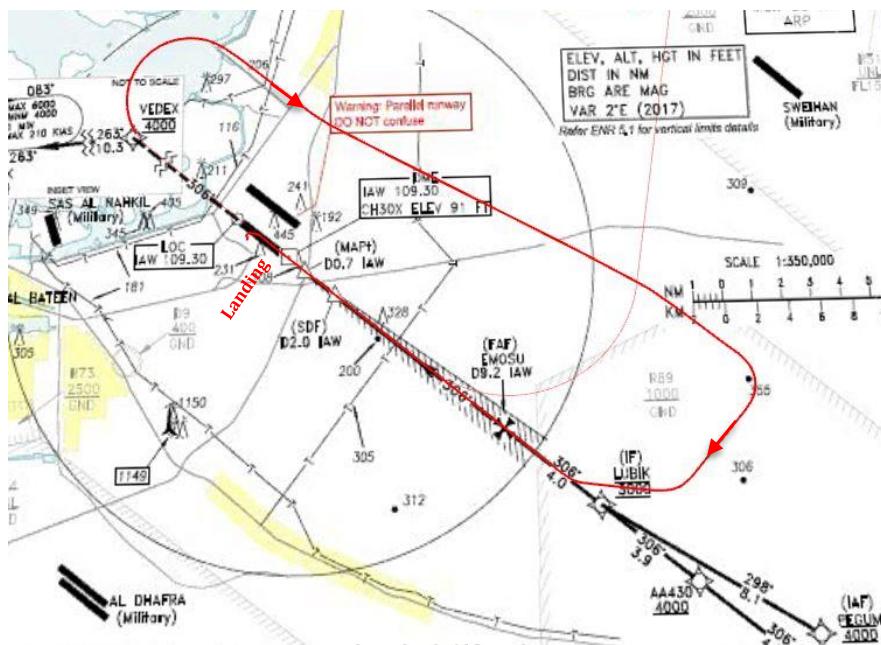
After the go-around, the flight crew informed air traffic control (ATC) that they were ready for a second approach to the same runway (31L). While the ATC provided vectors for the second approach on instrument landing system (ILS) approach to the runway, the Aircraft leveled off at 4,000 feet indicated altitude.

**Figure 3.** EY9878 flight path of second approach and landing (red thick-line) following instrument approach chart of OMAA ILS Runway 31L

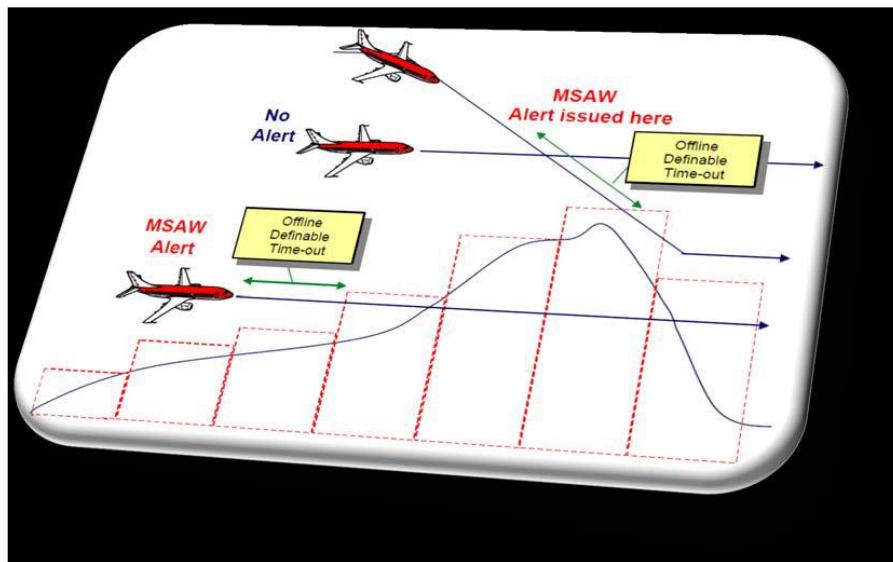
to the controller and an acoustic alarm will be heard. The MSAW will be generated 30 seconds before the aircraft is predicted to be below minimum safe altitude (figure 4).

Figure 4. Minimum safe altitude warning (MSAW) - [Source: GAL ANS]

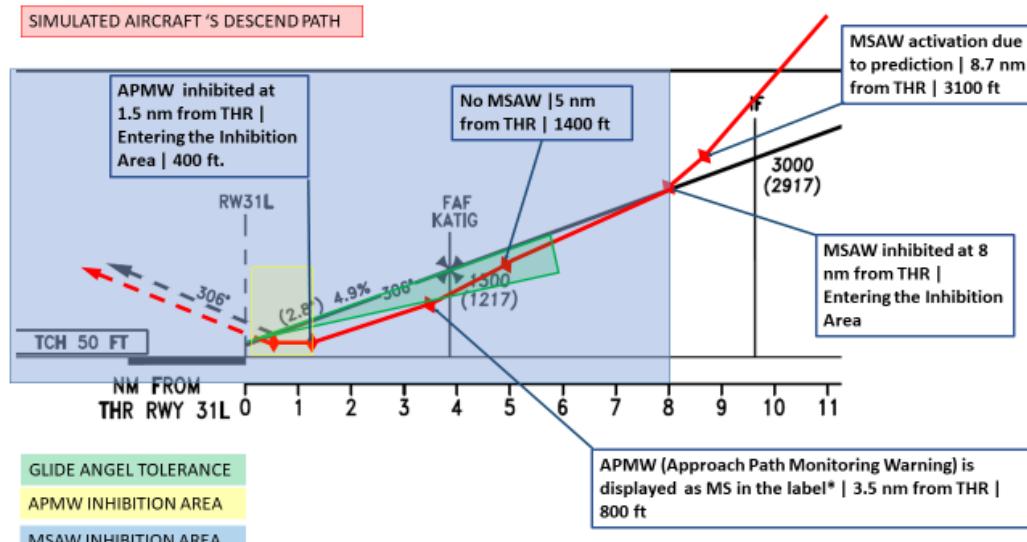
Based on the simulation conducted by GAL ANS and time synchronization with the flight data, the first MSAW activation in the Incident flight occurred at 0958:27 when the Aircraft was at approximately 8.7 nautical miles from the runway 31L threshold, crossing 3,100 feet as shown on the ATC display. The duration of the MSAW activation was ten seconds. The Aircraft was at around eight nautical miles from the threshold upon entering the "MSAW Inhibition Area" when the warning was de-activated (figures 5 and 6). The warning activation corresponded to a prediction by the system, which calculated that the Aircraft was descending with a high rate of descent close to the configured minimum safe altitude.

**Figure 5.** Vertical section of the Aircraft descent trajectory and the warning alerts  
[Source: GAL ANS]

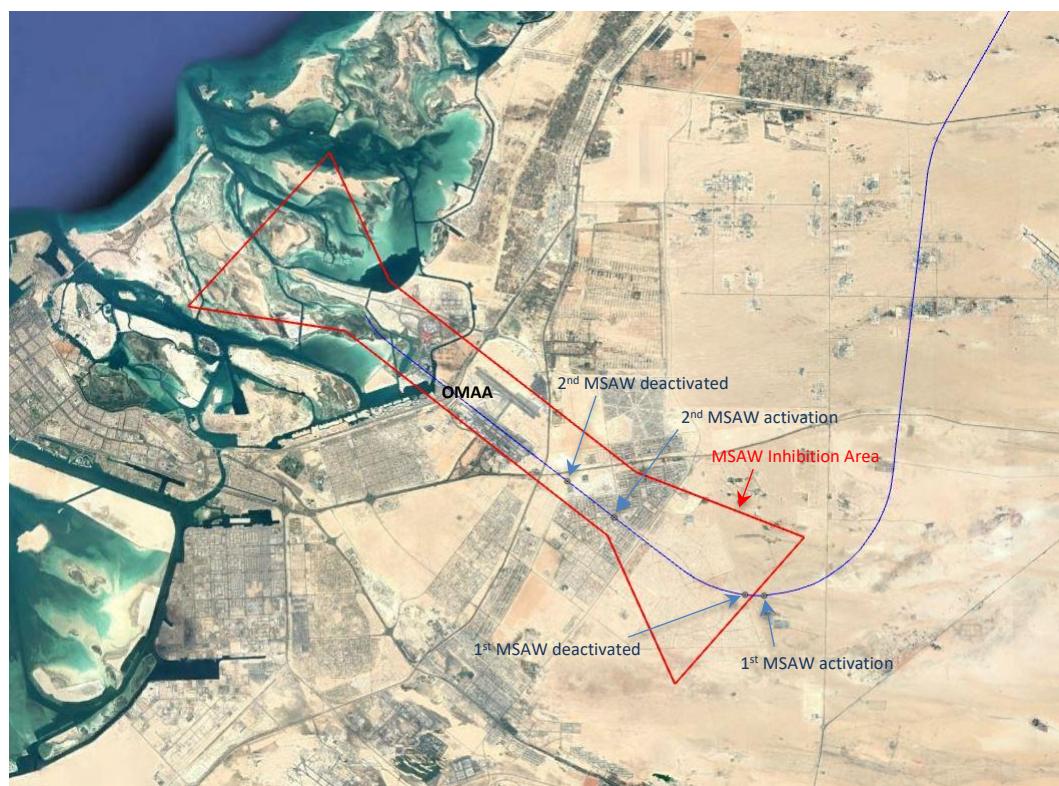
**Figure 6.** Aircraft positions when MSAW were activated and deactivated

The second MSAW was activated at 1000:16 when the Aircraft was at approximately 3.5 nautical miles from the threshold and passing 800 feet as displayed on the ATC radar. The duration of this warning was 45 seconds. The Aircraft was at around 1.5 nautical miles from the threshold and passing 400 feet on the ATC radar display when the warning was deactivated. This second MSAW was actually an approach path monitor warning (APMW) with an MS in a yellow label on the radar display.

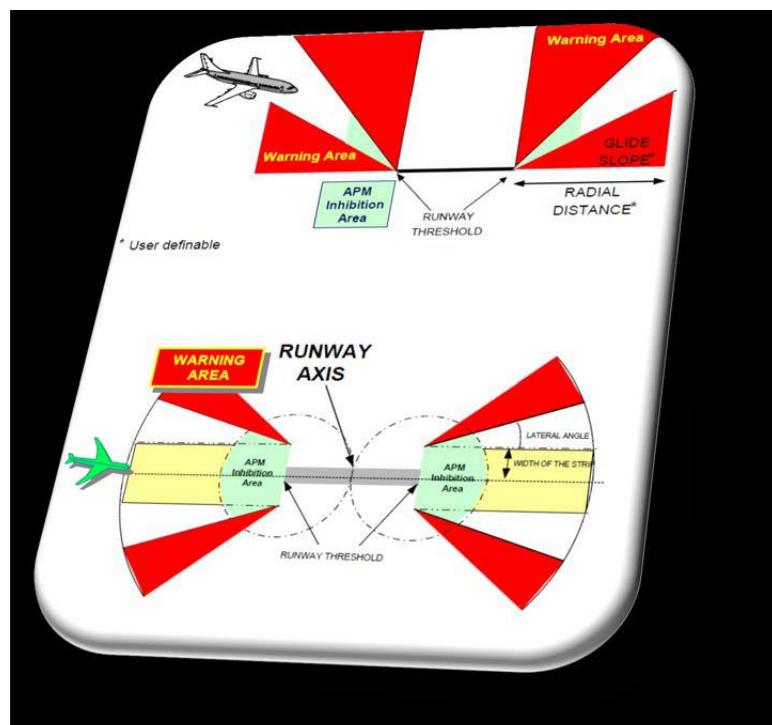
Figure 7 shows the vertical and horizontal views of the APMW. The APMW was inhibited at 1.5 nautical miles from the threshold.

**Figure 7.** Approach path monitor warning (APMW) – vertical and horizontal views [Source: GAL ANS]

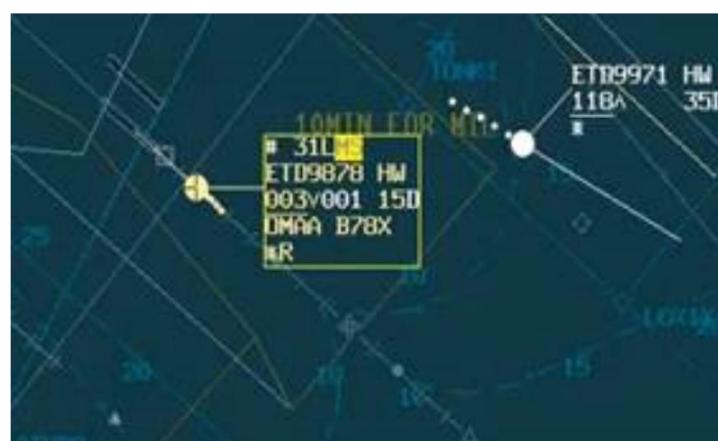
Figure 8 shows the radar screenshot indicating that the Aircraft was at two nautical miles from the threshold of runway 31L, at an altitude of 300 feet, which correlated to approximately 200 feet below the required vertical profile. As per the logic and alerting description of the warning system, the MS (minimum safe, in a yellow label) was displayed, and an acoustic alarm was activated.

**Figure 8.** Radar screenshot - Aircraft at two nautical miles on final approach, indicated altitude 300 feet (corrected), and activation of minimum safe altitude warning [Source: GAL ANS]

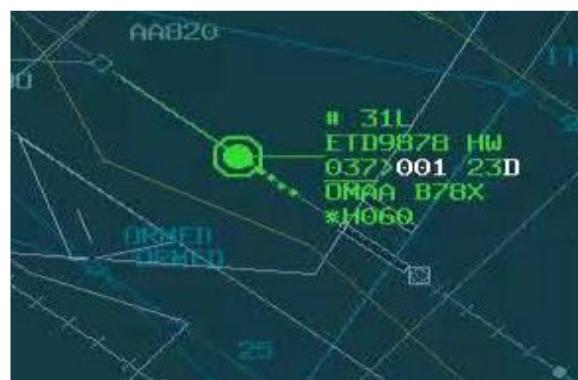
**Figure 9.** Radar screenshot - Aircraft leveled off after missed approach, indicated altitude 3,700 feet (corrected) [Source: GAL]

In response to this Incident, OMAA Operations Management of GAL ANS – OMAA Operations (OPS) issued a Supplementary Instruction (SI) 029-21 applicable to OMAA Tower Control, and SI 027-21 applicable to OMAA Approach Control. Both SIs contained instructions on how to deal with instances in which an “MS” is activated while an aircraft is executing an approach into OMAA and established on final (see section 4.2.2 of this Report).
