Technical report IN-033/2019

Accident on 16 July 2019 involving a Boeing 737-800 aircraft operated by Air Europa, registration EC-LYR, and a Boeing 737-8AS aircraft operated by Ryanair, registration EI-FRP, to the south of Écija (Seville)

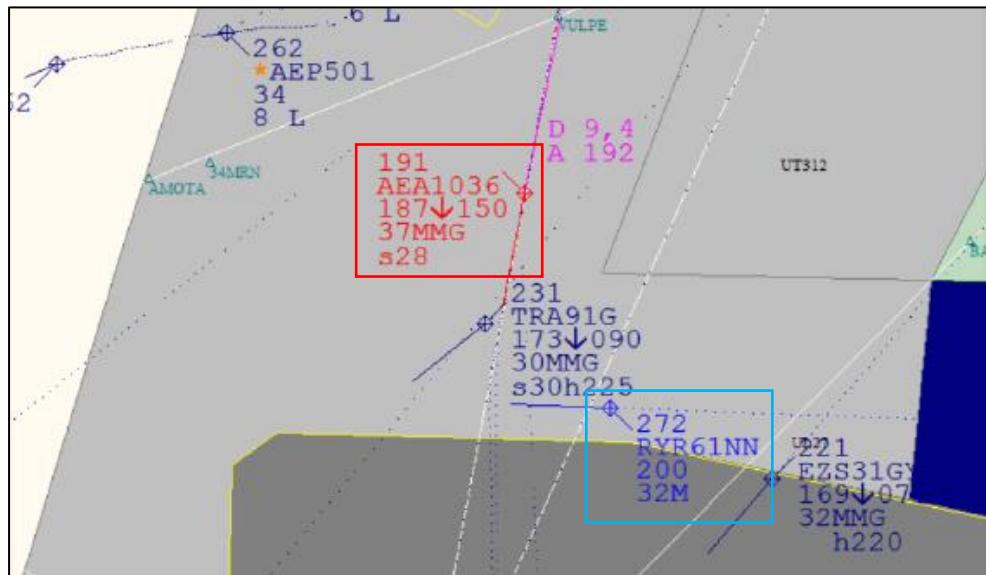
At 13:08:32, the LECSMA4 sector controller transferred aircraft AEA1036 to the LEMGAPM sector, while it was still approximately 15 NM from the sector boundary. See Illustration 4.

Illustration 4: Moment aircraft AEA1036 was transferred (boxed in red) to LEMGAPM (13:08:32).

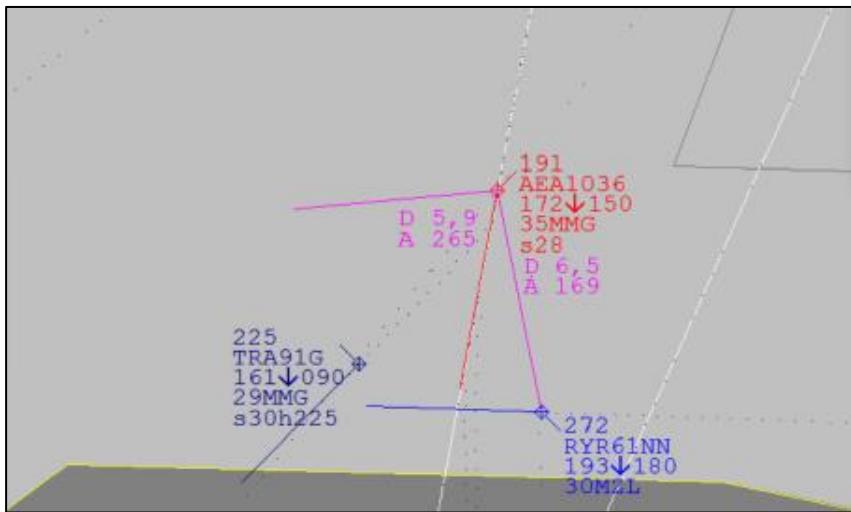
At 13:09:25, the LEMGAPM sector contacted the AEA1036 aircraft and instructed it to turn to a heading of 265° and descend to FL 150. The aircraft had previously been on a 191° heading, which meant it had to adjust its course by 74°. The aircraft's speed at that time was 350 kt, and that of the aircraft ahead of it in the sequence (whose callsign was TRA91G) was 290 kt. This aircraft had also been instructed to turn west a few seconds earlier. See Illustration 5.

Illustration 5: Position of the aircraft at 13:09:25.

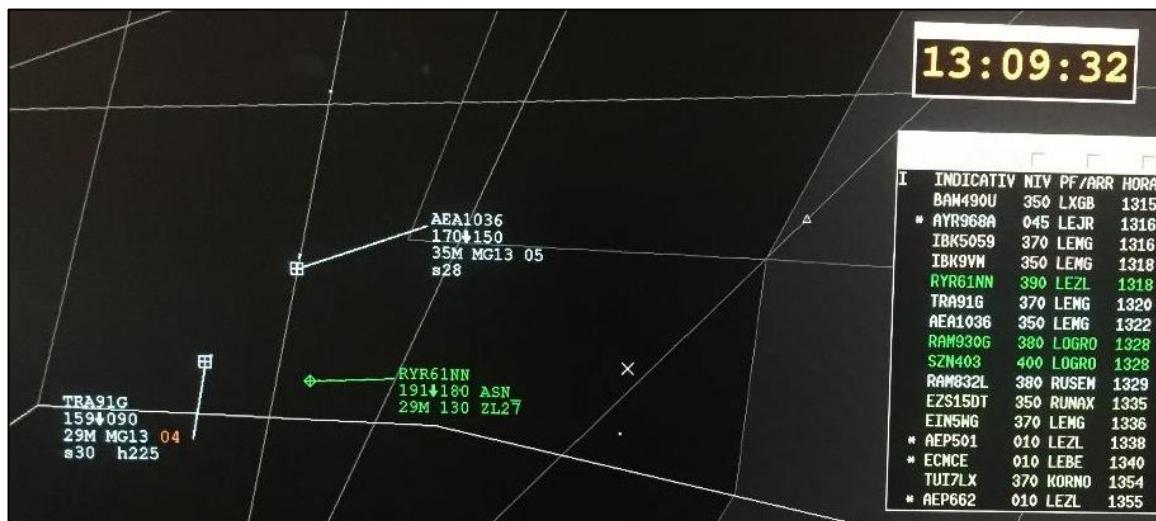
Due to the way the SACTA system works, when the LEMGAPM sector controller accepted the AEA1036 aircraft and assumed its control, it changed from green to white on the LECSMA4 sector display screen (indicating a traffic not under their control), as you can see from the real-time recording of his screen at 13:09:32 (Illustration 6). This signifies that the aircraft is now under the control of another sector.

Illustration 6: Image of the LECSMA4 sector's screen at 13:09:32

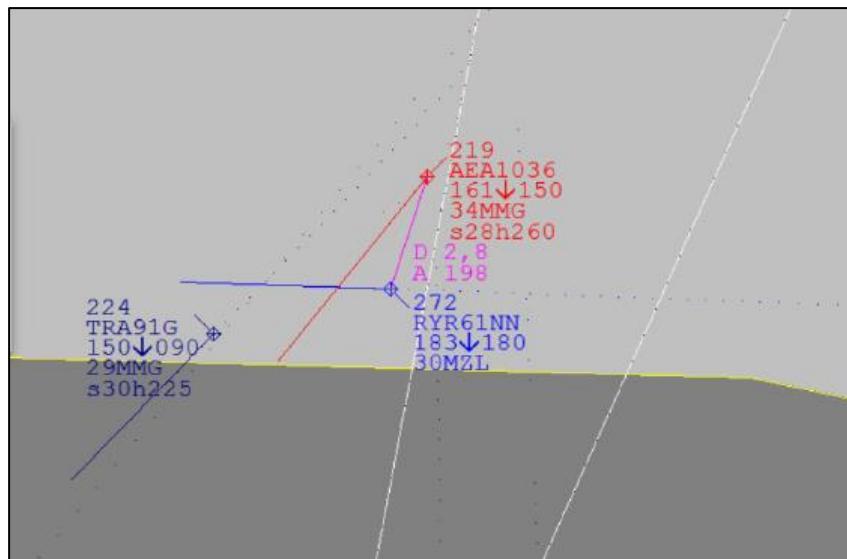
At 13:10:06, the LECSMA4 sector controller transfers the RYR61NN aircraft to the LECSAPT sector while it's still approximately 20 NM away from crossing the sector boundary. At that moment, the distance between the aircraft was 2.8 NM and 2,200 ft. Aircraft AEA1036 had already started its turn to the west. See Illustration 7.

Illustration 7: Moment aircraft RYR61NN was transferred to LECSAPT (13:10:06).

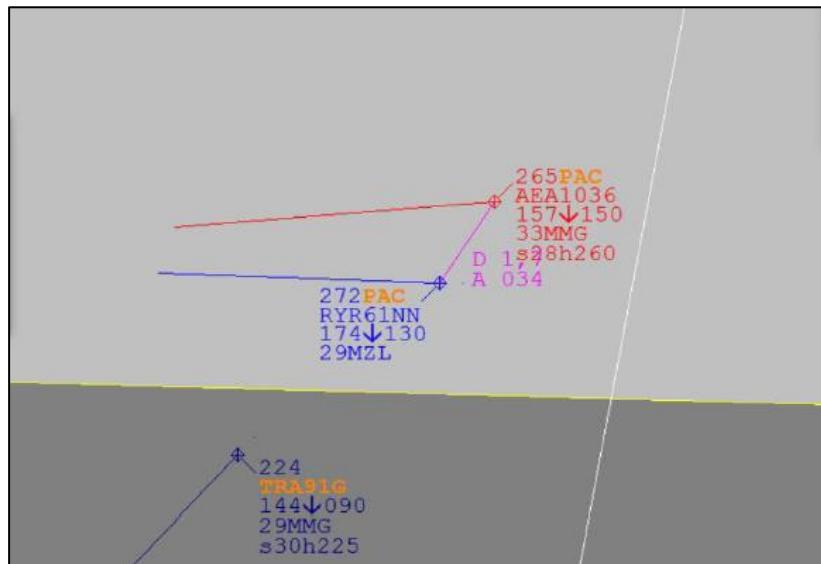
According to Palestra, at 13:10:33, the STCA-PAC function was activated. At that moment, the aircraft were separated by 1.7 NM and 1,700 ft. The AEA1036 aircraft had started to reduce its ROD while the RYR61NN aircraft was continuing to increase it. See Illustration 8

Illustration 8: Position of the aircraft when the STCA-PAC function was activated (13:10:33)

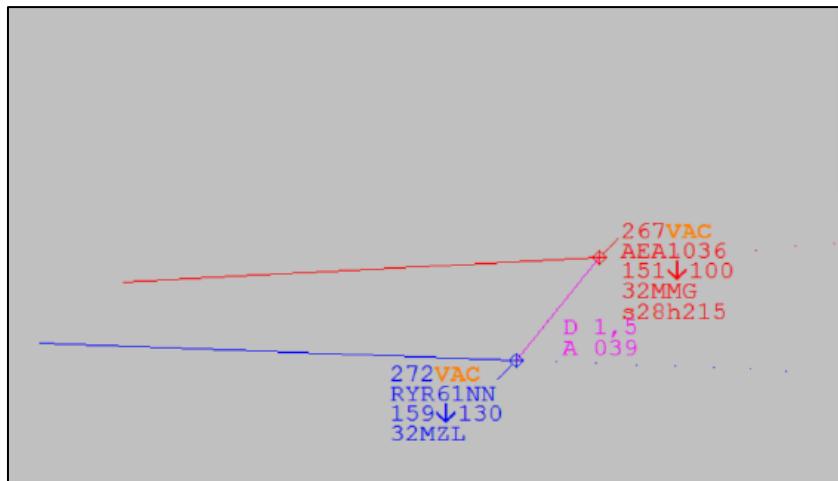
At 13:11:02, the STCA-VAC alert was activated due to the prescribed separation being violated. At this point, the distance between the aircraft was 1.5 NM and 800 ft. See Illustration 9.

Illustration 9: Position of the aircraft at 13:11:02.

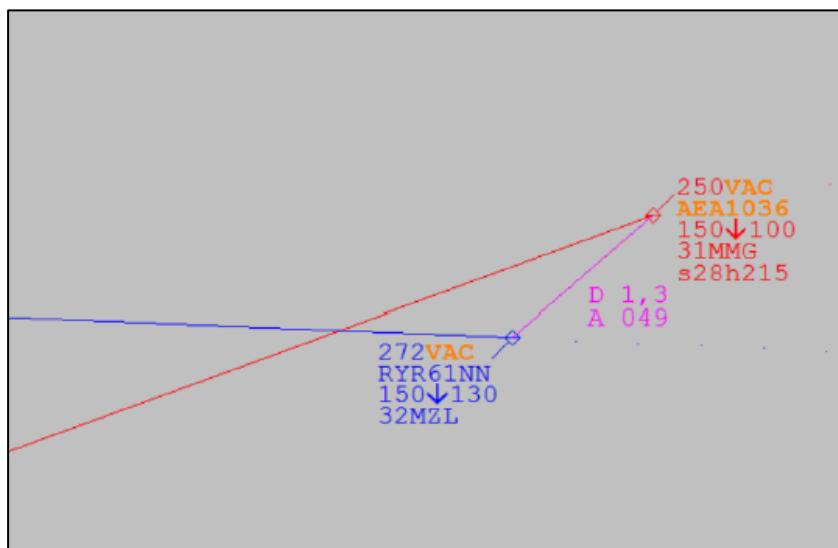
Finally, the aircraft reached the minimum recorded distance between them at 13:11:17, being separated by 1.3 NM and 0 ft. At that moment, aircraft AEA1036 had already started a turn towards 215°, as instructed by the LEMGAPM sector controller. See Illustration 10.

Illustration 10: Position of the aircraft at 13:11:17. Minimum distance (1.3 NM and 0 ft)

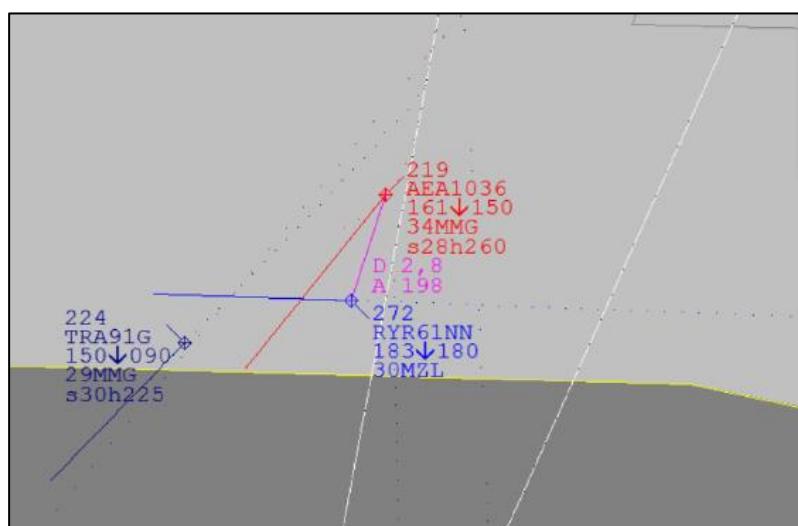
However, this could be interpreted as specifying that the accepting unit should not instruct a turn of more than 45° on accepting an aircraft. To check whether this interpretation would have prevented the conflict, we performed a simple calculation to plot the trajectories the two aircraft would have followed if the AEA1036 aircraft only made a 45° turn and maintained that heading and speed. To do this, we used the Palestra image at 13:10:06, the time at which the aircraft had just started to turn (30 seconds after acknowledging). For aircraft AEA1036, we used a heading of 236° (which is the original 191° plus 45°). The RYR61NN aircraft maintains its heading (272°).

Illustration 13: Position at the beginning of the calculation (13:10:06).

With these calculations, a minimum horizontal distance between them of 1.17 NM is reached 44 seconds later. Therefore, even with a turn of only 45°, the minimum distance would still have been violated.

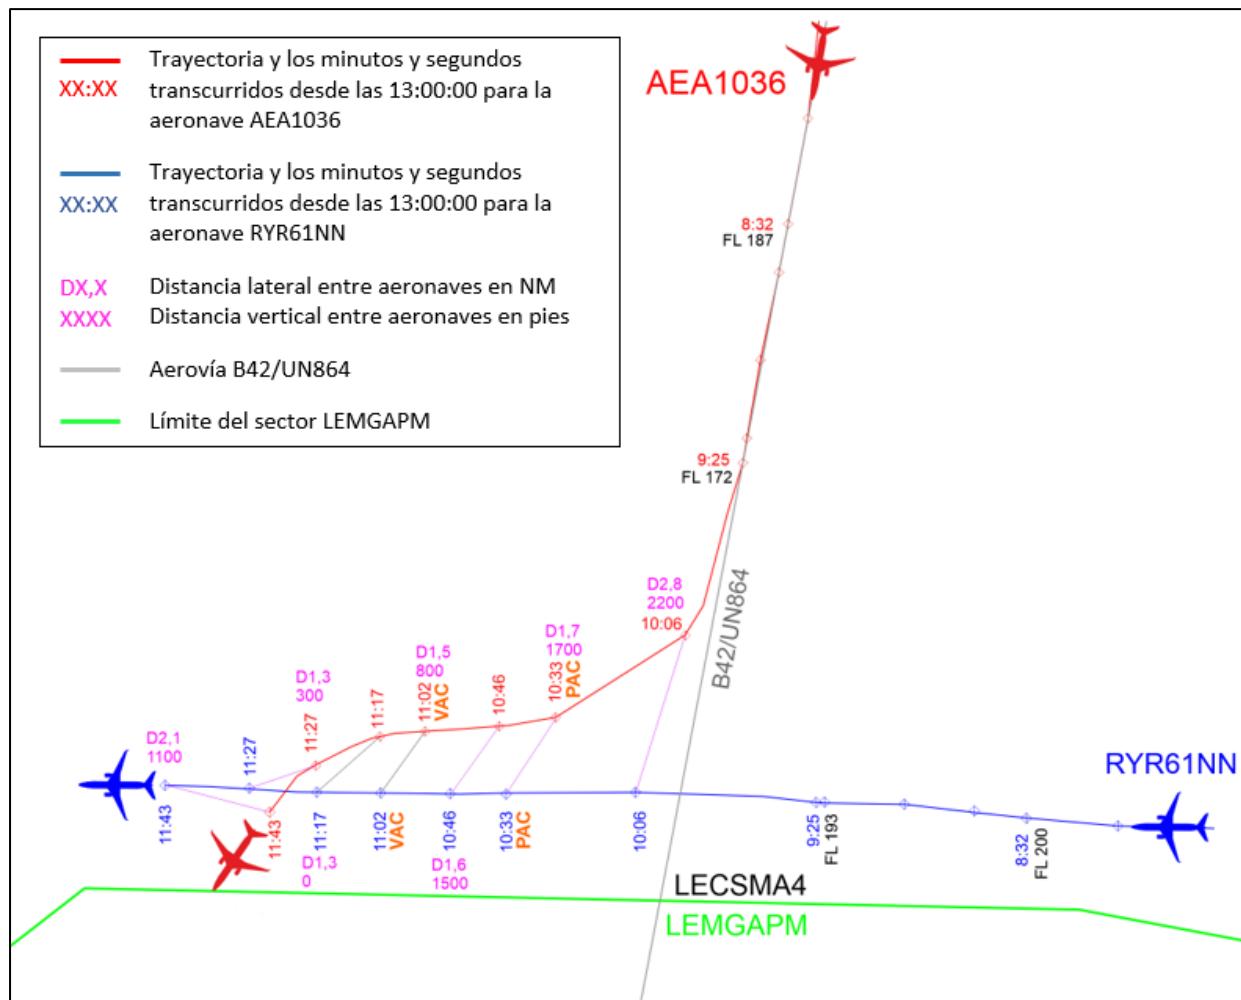
Illustration 16: Trajectory of both aircraft and their positions at different times.

controller instructed it to turn to its right to follow a 265° heading (a turn of 74°) and descend to FL 150 as cleared, which caused the trajectories of the two aircraft to converge.

At 13:11:02, the first violation of the prescribed minimum separation occurred with the aircraft being 1.5 NM and 800 ft apart, activating the STCA-VAC function between them. The ROD of the RYR61NN aircraft was almost 3 times higher than that of the AEA1036 aircraft (3,263 v 1,113 ft/min).

In conclusion, we have determined the loss of separation was caused by the LECSMA4 sector controller's early transfer of the RYR61NN aircraft to the collateral sector before it was free for descent due to the prior turn of the AEA1036 aircraft.

REC 37/21: It is recommended that Enaire makes the necessary changes to ensure that LECS and LEMG APP controllers do not instruct aircraft to turn before they are in their area of responsibility unless there has been prior coordination between the units.
