Aircraft Accident Investigation Bureau of Myanmar

**FINAL REPORT ON TAIL STRIKE INVOLVING AN AIRBUS A330-343
AIRCRAFT (REG: 9V-SSI) AT YANGON INTERNATIONAL AIRPORT,
ON 25 NOVEMBER 2019**

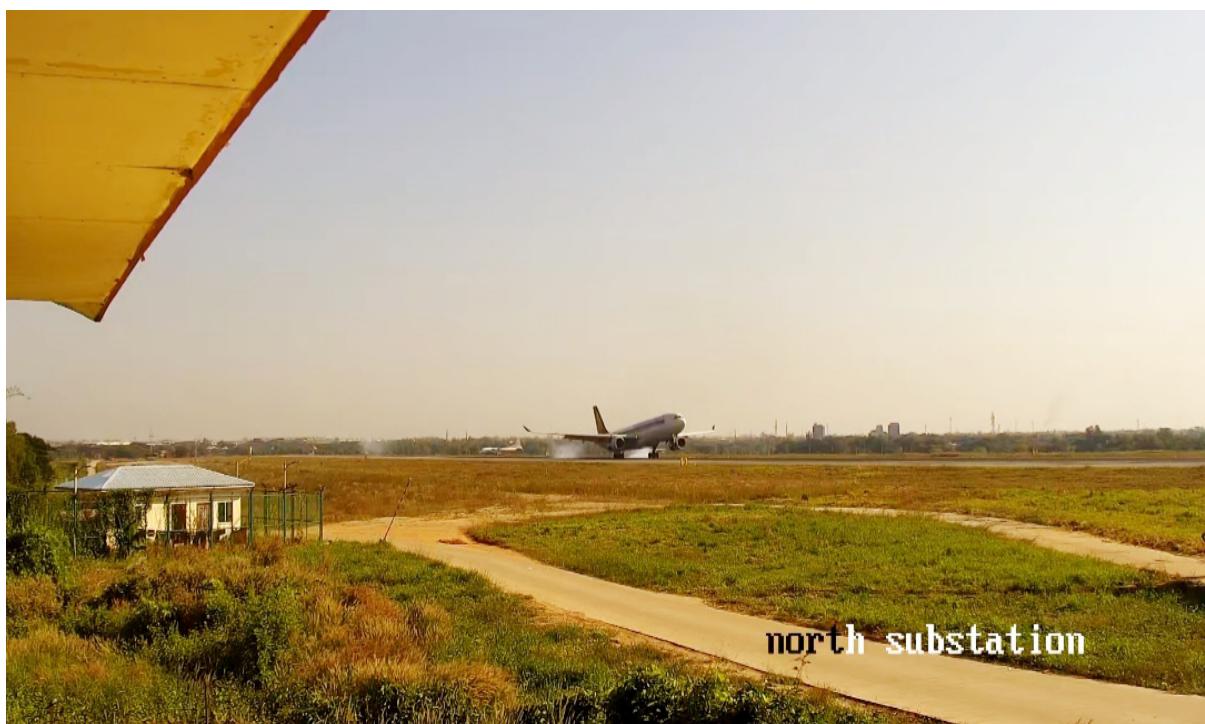
Figure (2) Main landing gears touched down on the runway

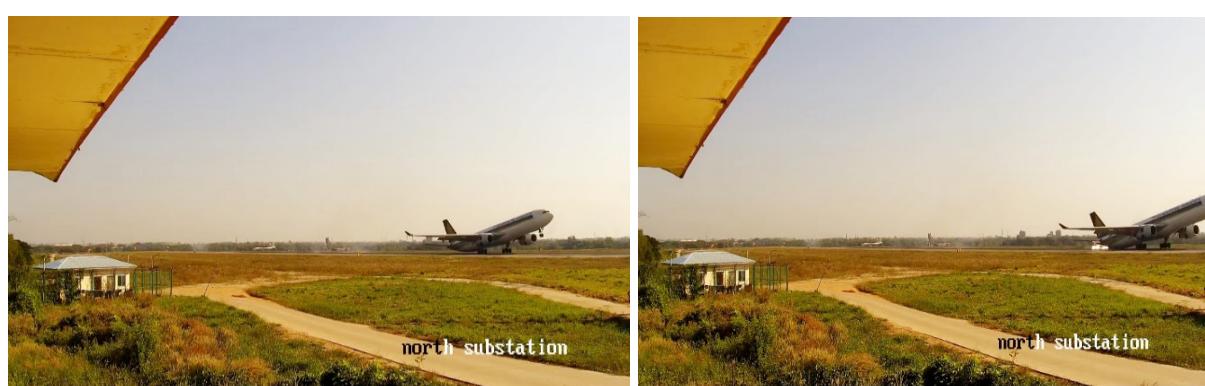
A surveillance camera located at a lookout hut in the vicinity of the runway recorded the event landing. Figures (2) and (3) shows the sequence of the tail strike.

Figure (3) Photos showing the tail strike on the runway

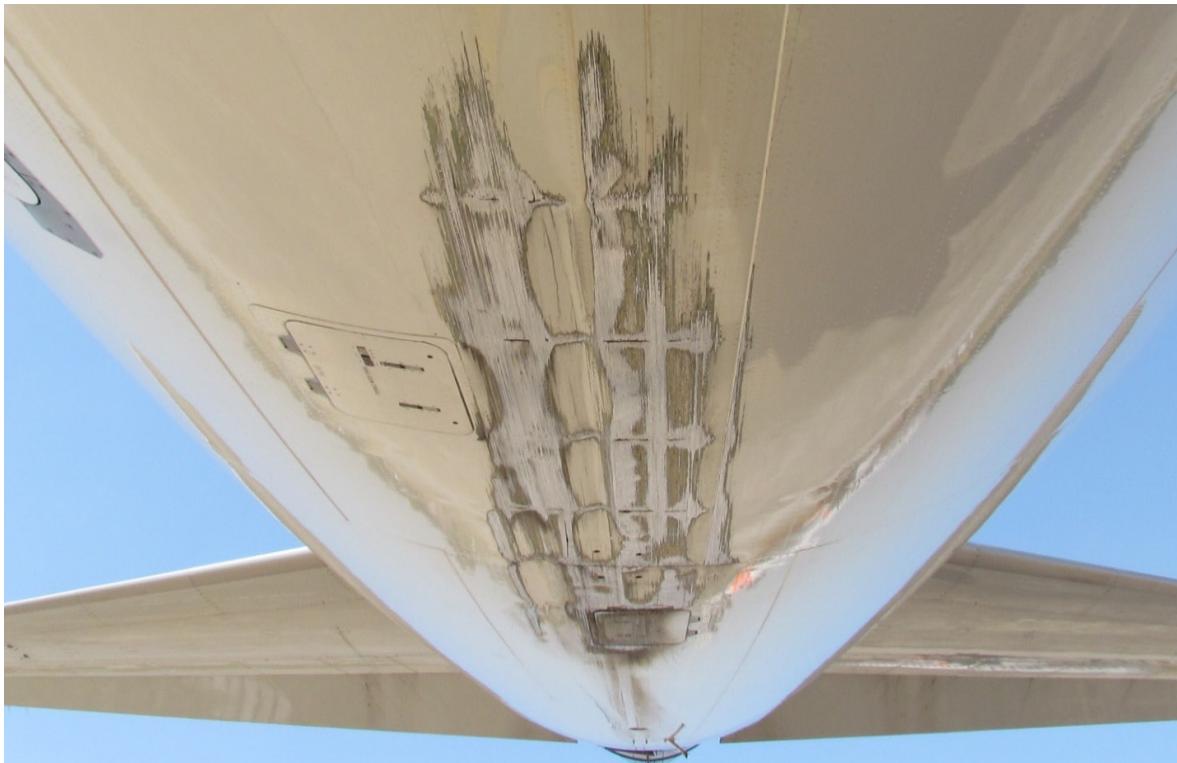
- (a) Fuselage Lower Skin between frames 68 and 73 in the tail section were dented, scratched and torn
- (b) Fuselage frames between frames 60 and 73 in the tail section were bent and scratched

Figure (4) Scrape marks on aircraft tail section

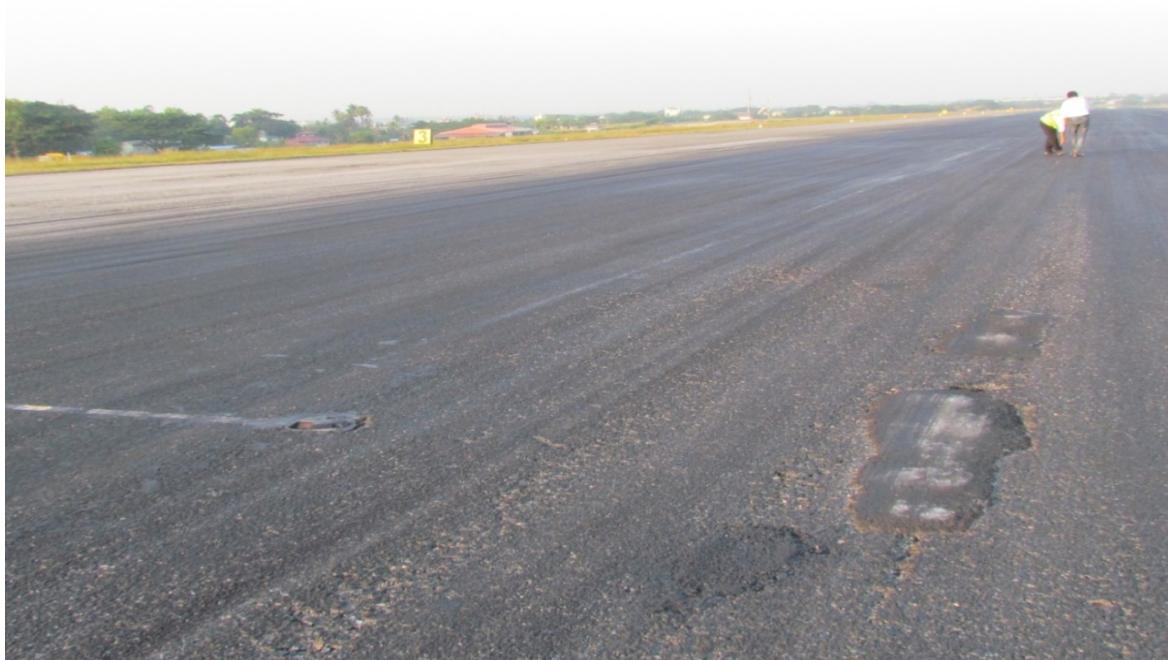
Scrape marks were found on the surface of the runway.

Figure (5) Scrape marks on the runway

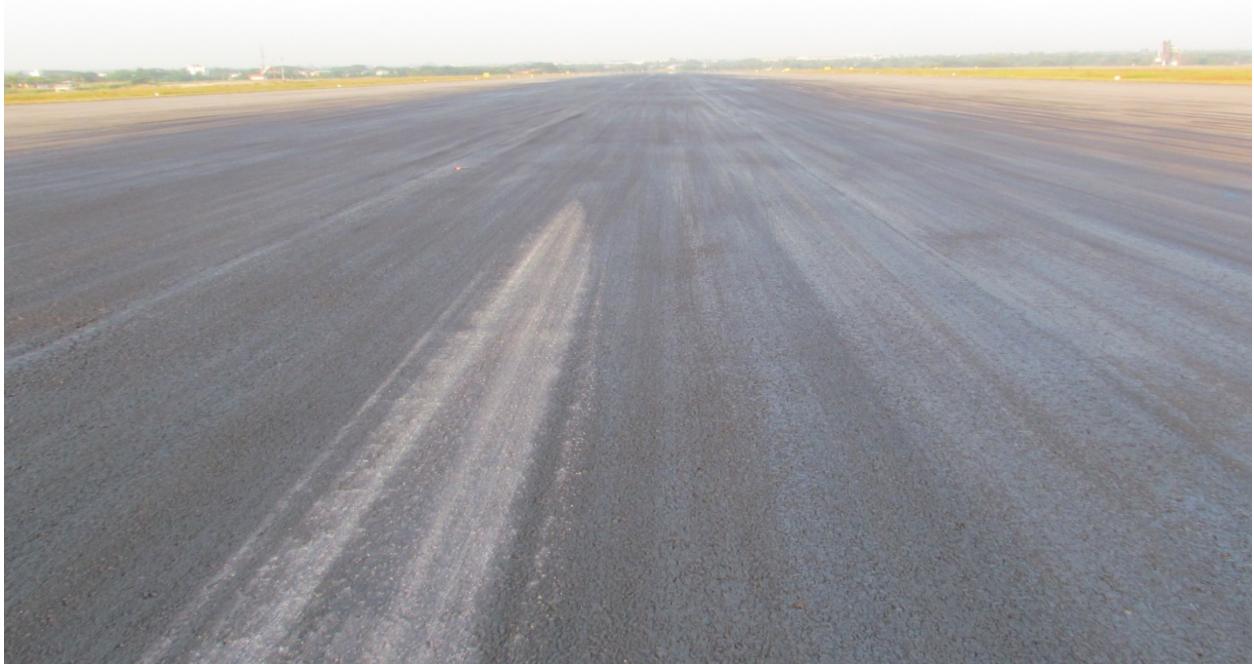
Figure (6) Tail strike marks on the runway

The coordinates of serious incident site were Latitude N 16°54' 42", Longitude E 96°08' 26". The tail strike marking on the runway was 56.1m long and 0.7m wide. The tail strike could be seen clearly at the 1.5m of runway centerline and about 3,000ft from the Runway 21 threshold near the Distance Marker Board 8/3.
