# Technical report

## IN-006/2020

Incident involving a Boeing 767-375ER aircraft operated by Air Canada, registration C-GHOZ, at Madrid-Adolfo Suárez Airport (Madrid) on 03 February 2020

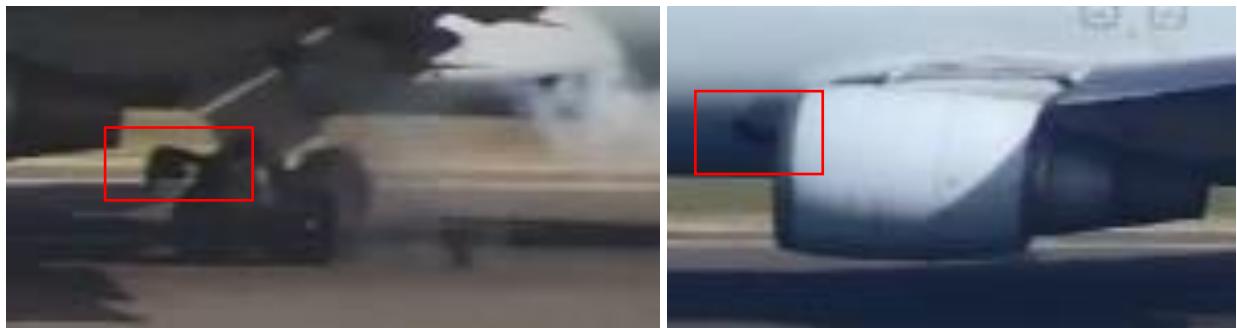
Figure 2. Tyre number 5 piece and ingestion by the engine (14:58:03, t=+0 s)

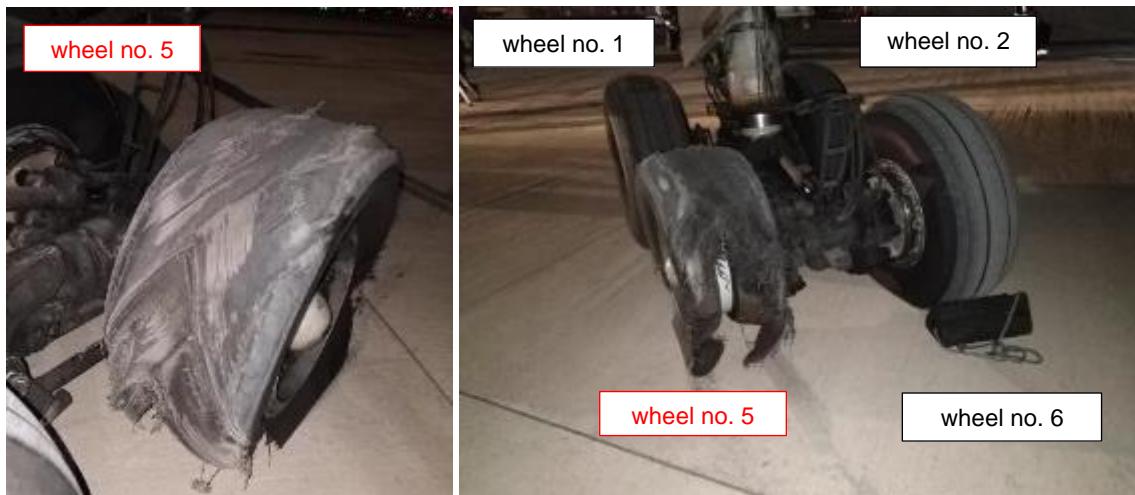
Figure 5. Left main landing gear (seen from behind) after the landing

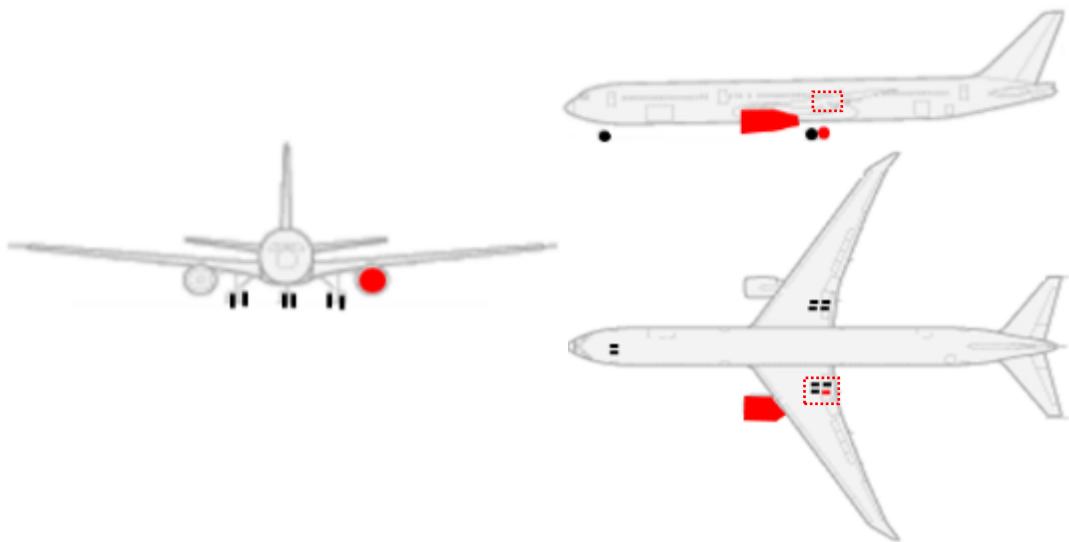
The aircraft sustained significant damage to the left main gear (wheel number 5, panel and tilt sensor) and left engine (engine interior and exterior fairings). The fairing of flap number 3 and various panels located above the left main gear sustained minor impacts.

Figure 6. Damage to the aircraft

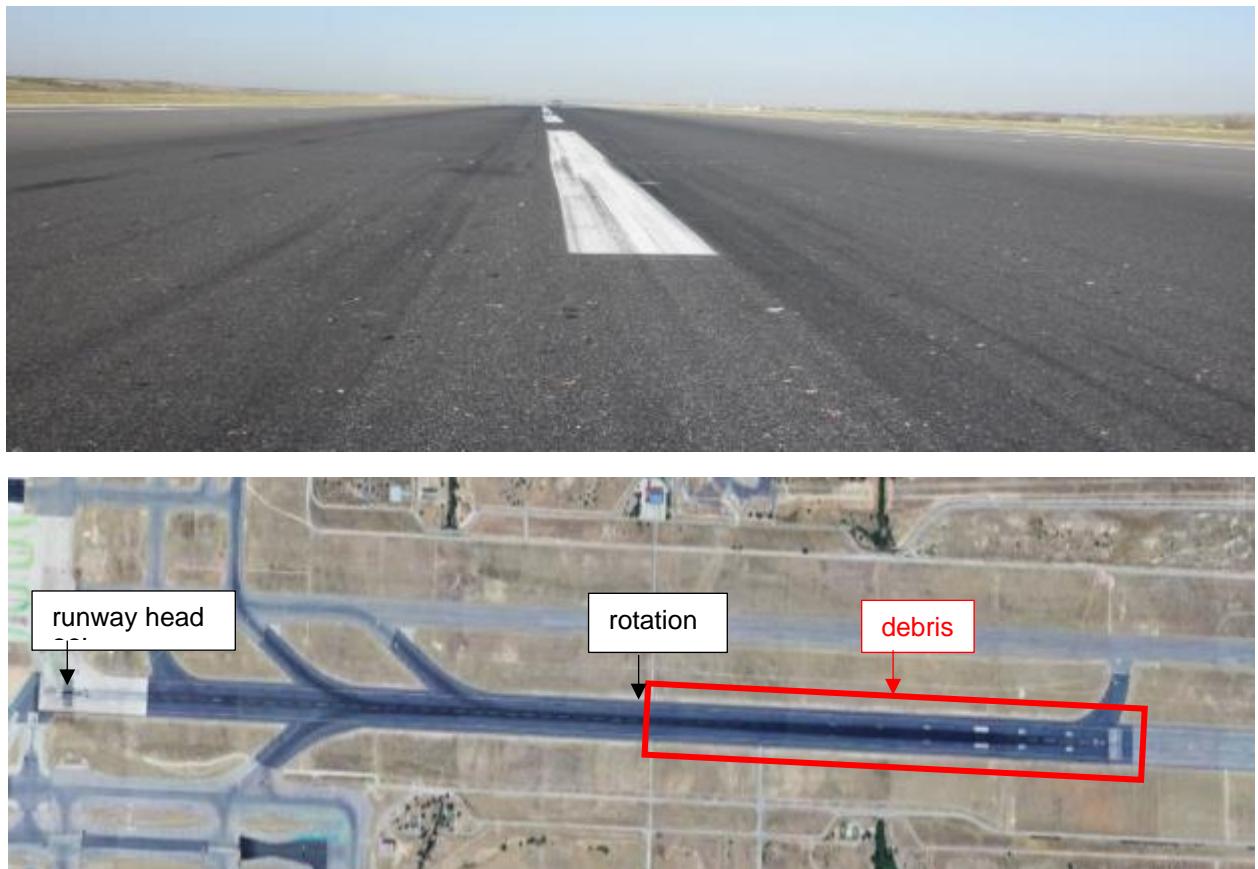
The debris was scattered over approximately 1,400 m of the runway, along the area shown in figure 10, and consisted of:

- a multitude of wheel fragments of different sizes: the smallest measuring a few centimetres in thickness and length and the largest being over a metre in length.
- material (honeycomb) that was later identified as belonging to the engine cowling (nose cowl inlet).

Figure 10. Dispersion of debris on runway 36L

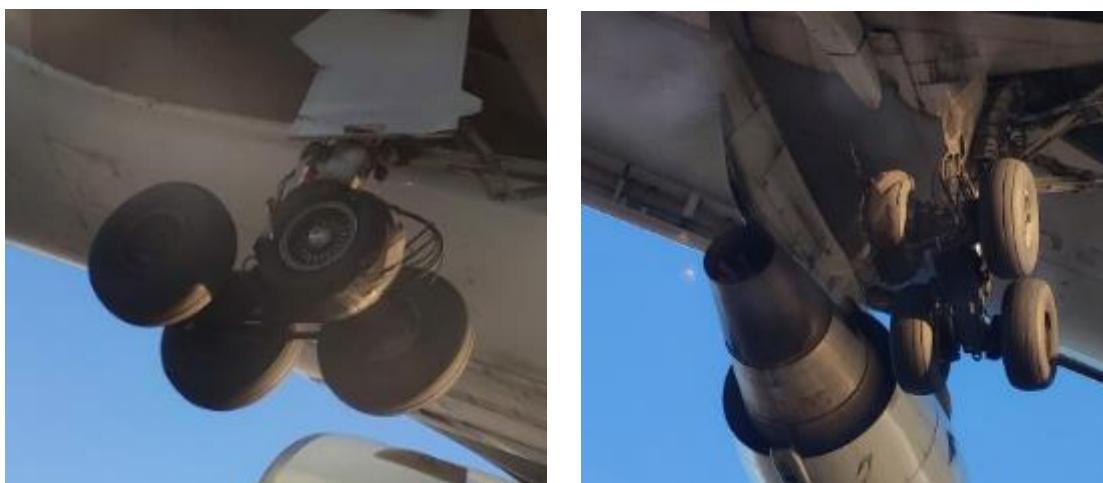
The inspection, conducted between 17:49 and 18:03, required the ACA's gear and flaps to be extended. The military aircraft positioned itself under both sides of the ACA aircraft and inspected the main and nose landing gear. He confirmed the damage to one of the left-landing-gear wheels and that the remaining 3 left wheels and the right and forward landing gear appeared to be fine. The EF-18A pilot took several photos, two of which are shown in figure 12. After completing the inspection, the landing gear was retracted and locked correctly.

Figure 12. Photographs taken by EF-18A

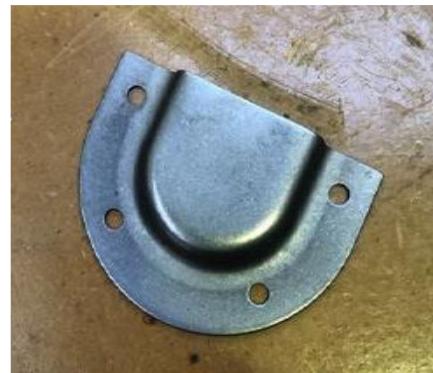
Of all the pieces collected, only one was identified as not belonging to the aircraft. This piece, shown in the image, was metallic and measured 45\*35\*6 mm. Its condition was unaltered and shiny, ruling out its involvement in the event.

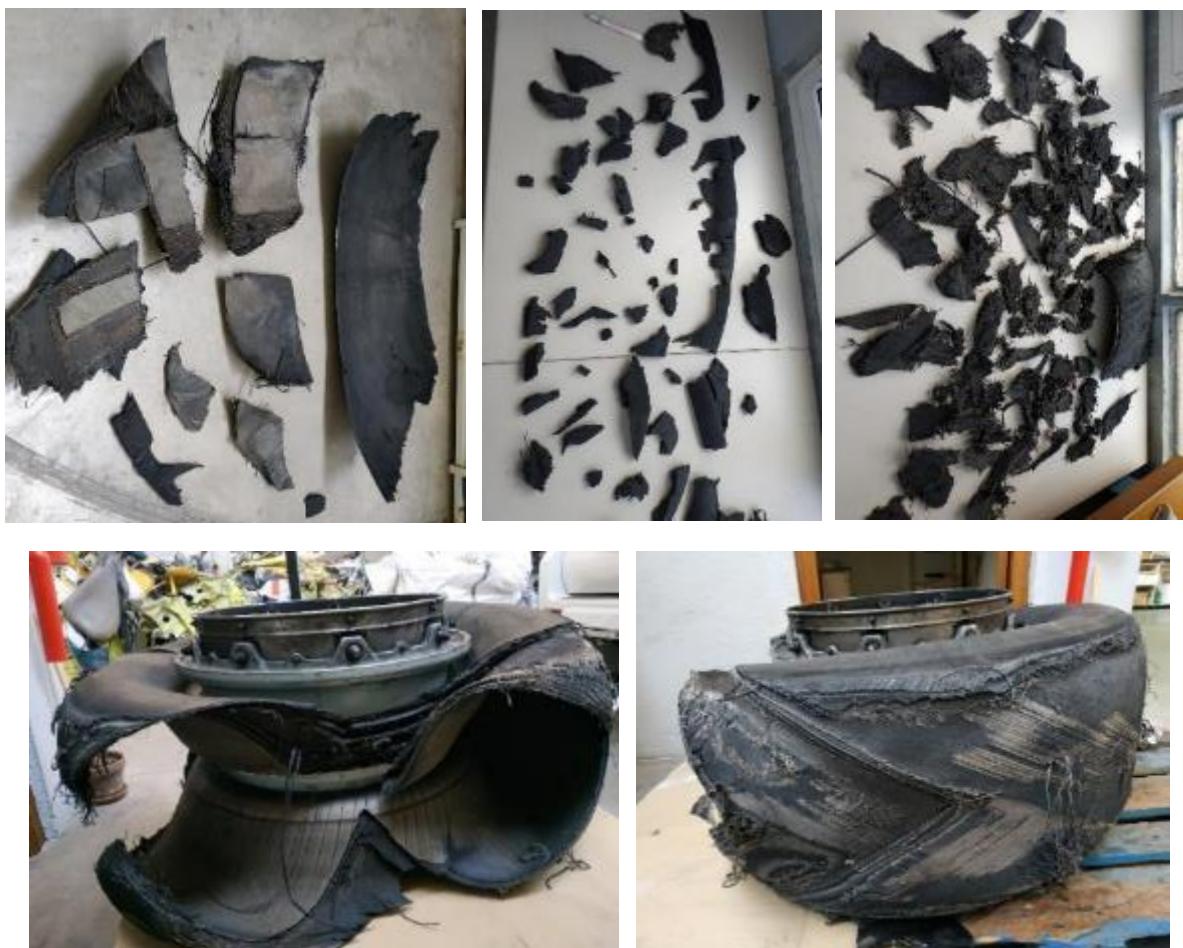
The sizes of the recovered fragments varied: the largest was 132x40 cm, and the smallest was 1x1 cm. The thickness of the pieces also varied: some were made up of just the tread or casing, and others contained the entire tyre section. Some of the fragments had cuts that would have been caused by the engine blades. All the recovered items were preserved for further investigation (section 1.16). The remaining wheels on the left main gear (numbers 1, 2 and 6) were fully intact.

Figure 13. Remains of wheel no. 5

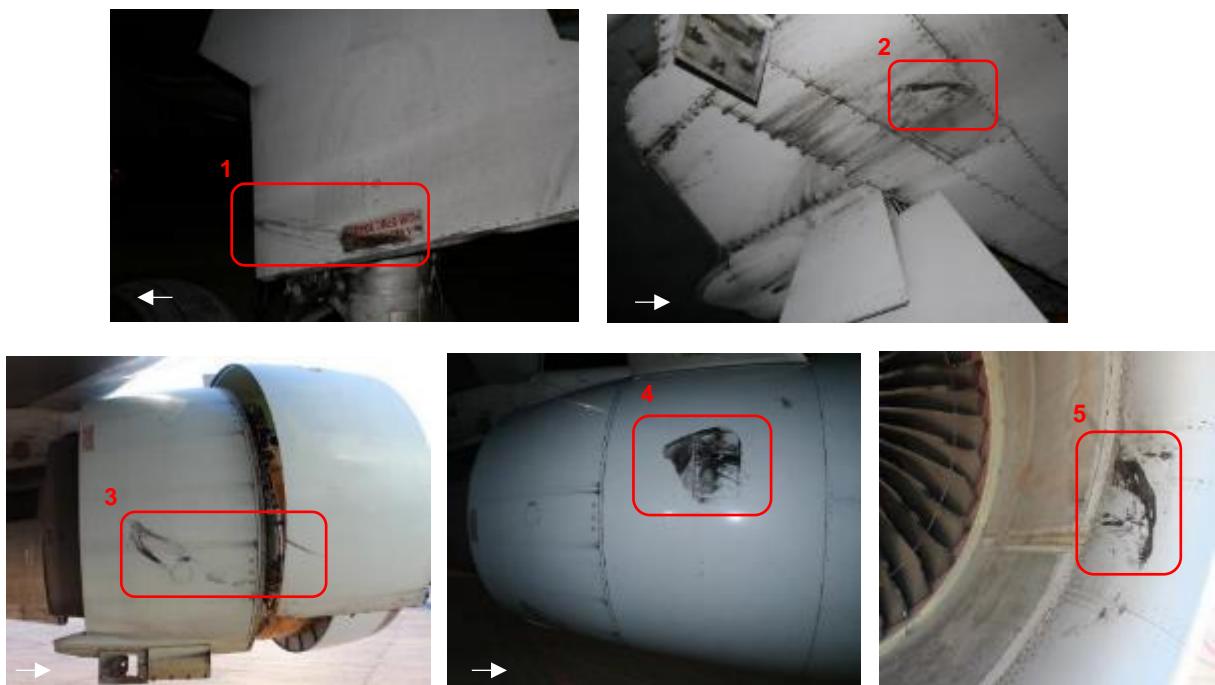
1. left main gear panel
2. underside of the left wing
3. right panel of the thrust reverse
4. right fan cowl
5. nose cowl inlet

Figure 14. Rubber marks (travelling in the direction of the white arrow: towards the front of the aircraft)

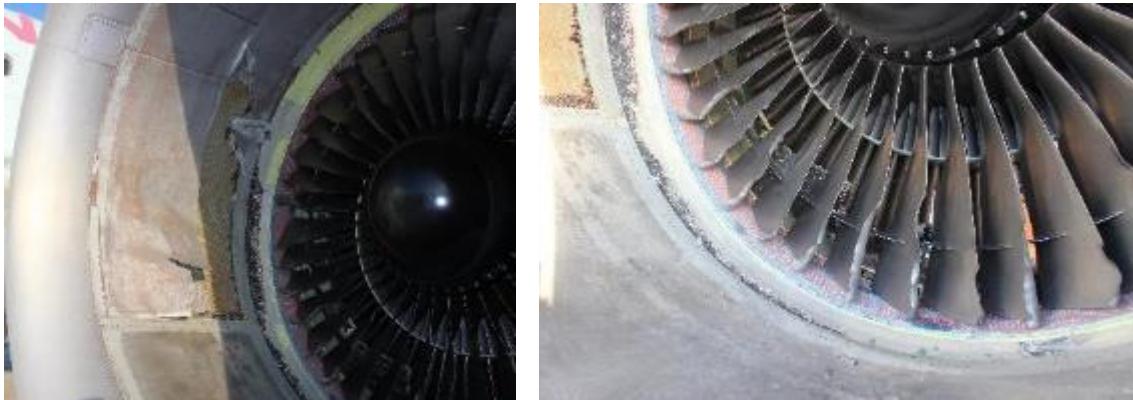
remains of ingested material were found in the booster, and there was minor damage (minor tip curl) to some blades.

Figure 15. Damage to the fan

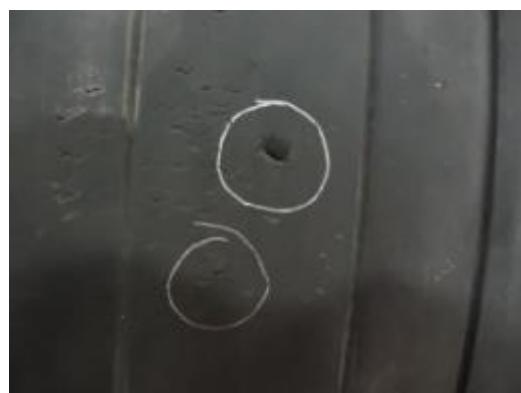
It was reviewed the history of the left main gear wheels, identifying that wheel number 6 had been replaced on 30/01/2020, three days before the event. It was removed due to the presence of two cuts. To determine whether these cuts could have also affected wheel number 5, it was retrieved the information on wheel number 6. However, due to the size of the cuts (approximately 1 cm), it was ruled out the possibility that they could have affected wheel no.5.

Figure 16. Cuts on wheel number 6 (paired with no. 5), produced on 30/01/2020

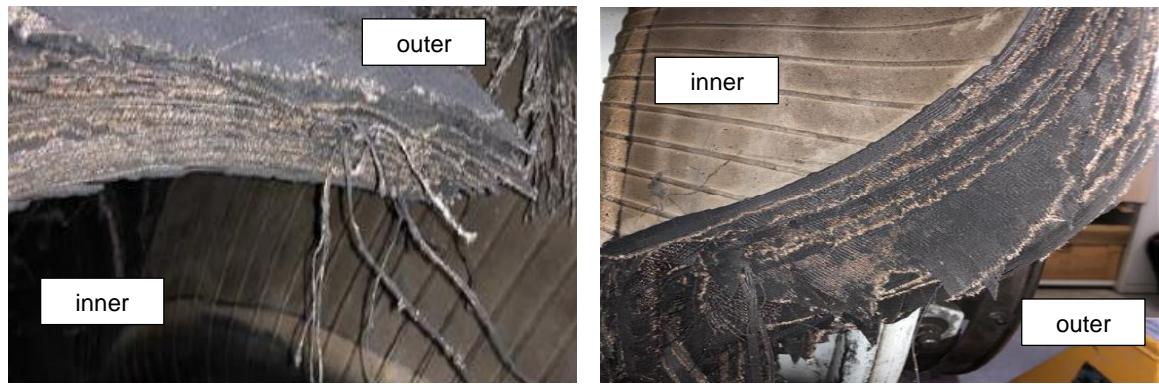
- The fragments belonging to sector 7 displayed direct ruptures in all the plies. In these breakages, all the ruptures were perpendicular to the tyre surface.
- The fragments belonging to sectors 4, 5, 6, 8, 9, 10, 11 and 12 displayed tapered ruptures. In these breakages, the plies had ruptured in a staggered and gradual way, showing a progression from ply to ply.

Figure 18. Direct ruptures (left) and tapered (right) in the casing of tyre no. 5

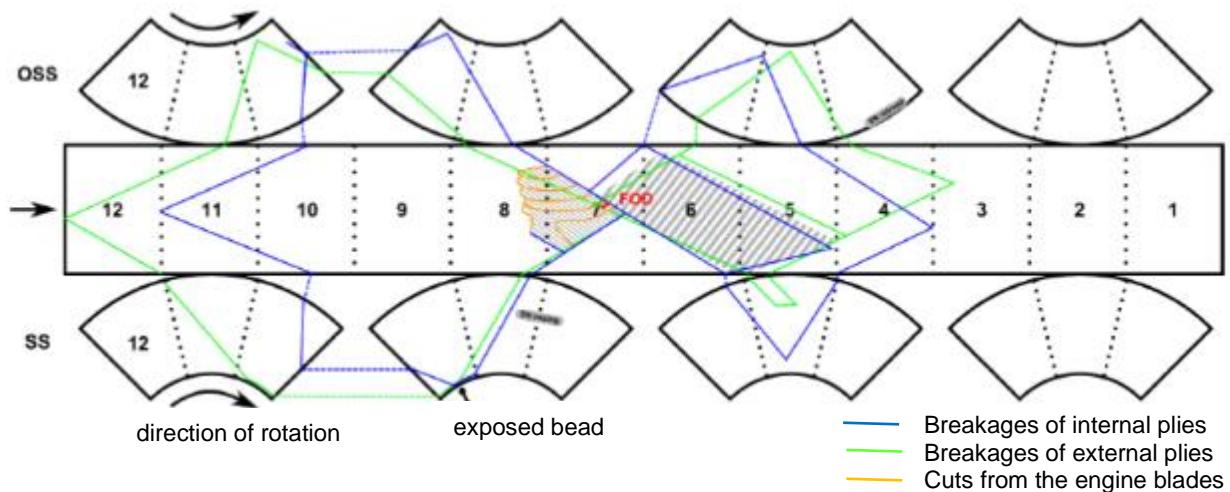
The following graphic representation of the fragments' rupture layers (internal in blue and external in green, in figure 20) and their position on the tyre, shows that in the direct rupture zones, the fracture lines between the pieces were closer together, whereas in the staggered fracture zones, the fracture lines were separated.

Figure 19. Reconstruction of tyre number 5

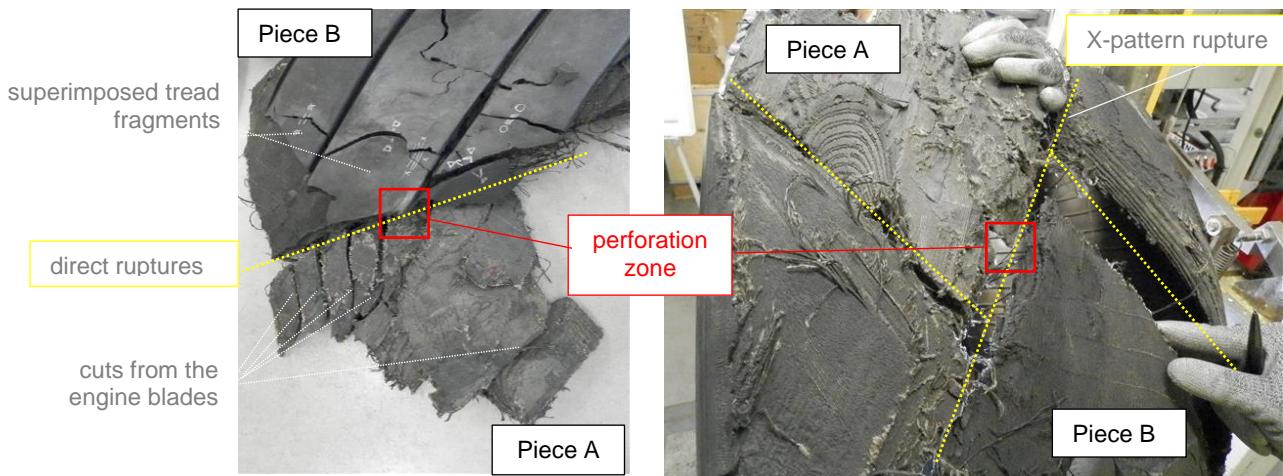
- Piece B: belonged to sectors 7, 6 and a small portion of 5. This piece had no cuts and hadn't been ingested by the engine. Associated with piece B were 4 tread fragments, which have been superimposed over piece B in the left-hand image in figure 21.

Figure 20. Pieces A and B from sector 7 viewed from the exterior

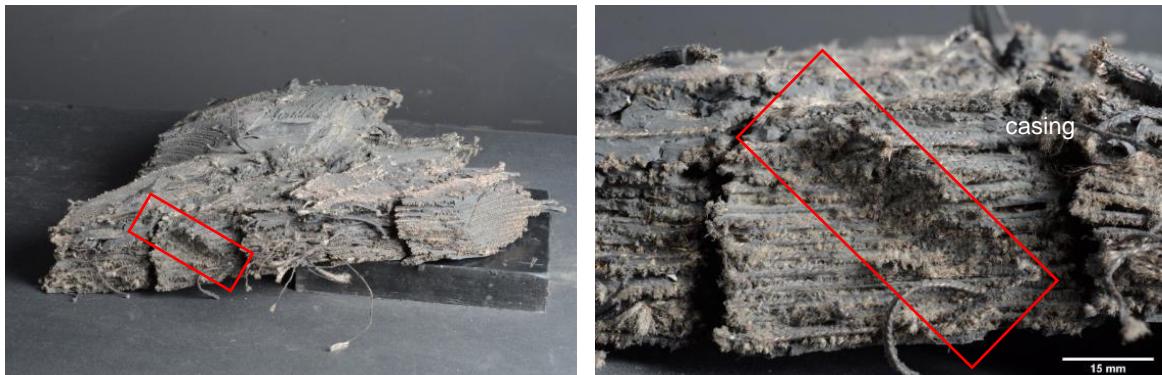
A detailed observation of the pieces revealed perforation marks in the tread and almost all the plies of the tyre casing around the join between pieces A and B. These perforation marks were found in pieces A and B and in one of the tread fragments that had separated from part B.

Figure 21. Perforation in piece A (casing)

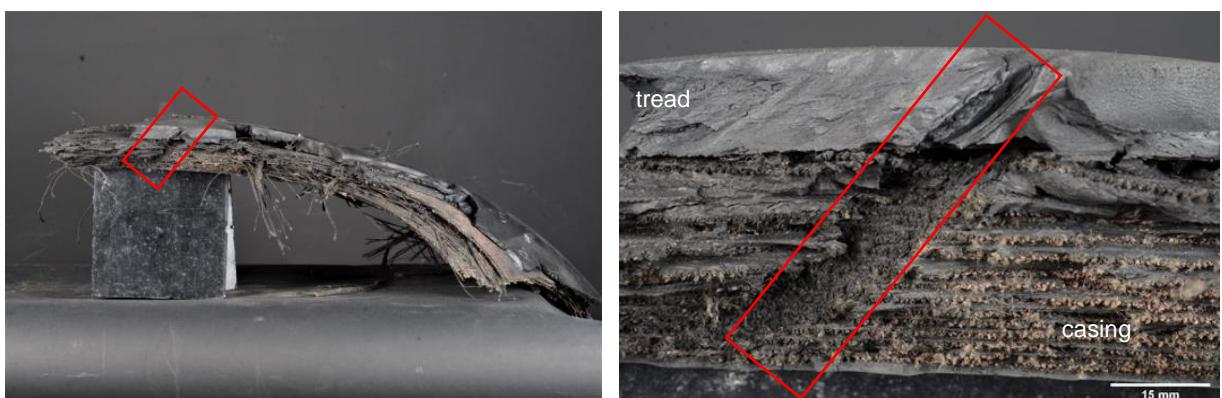
Figure 22. Perforation in piece B (casing and tread)

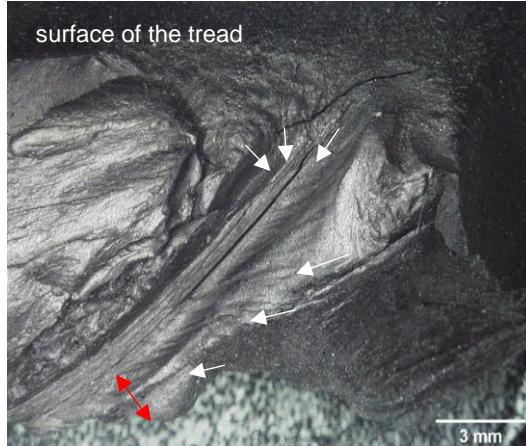
The measurements taken for piece B (figure 24) showed that the perforation was approximately 1.5 mm wide and extended for about 70 mm (7 cm) through the tread and casing on an almost wholly oblique path relative to the tyre surface.

Figure 23. Deformation of the material in the tread of piece B
