DUTCH  
SAFETY BOARD

# Loss of flap part, Boeing 747-400

*The Hague, February 2022*

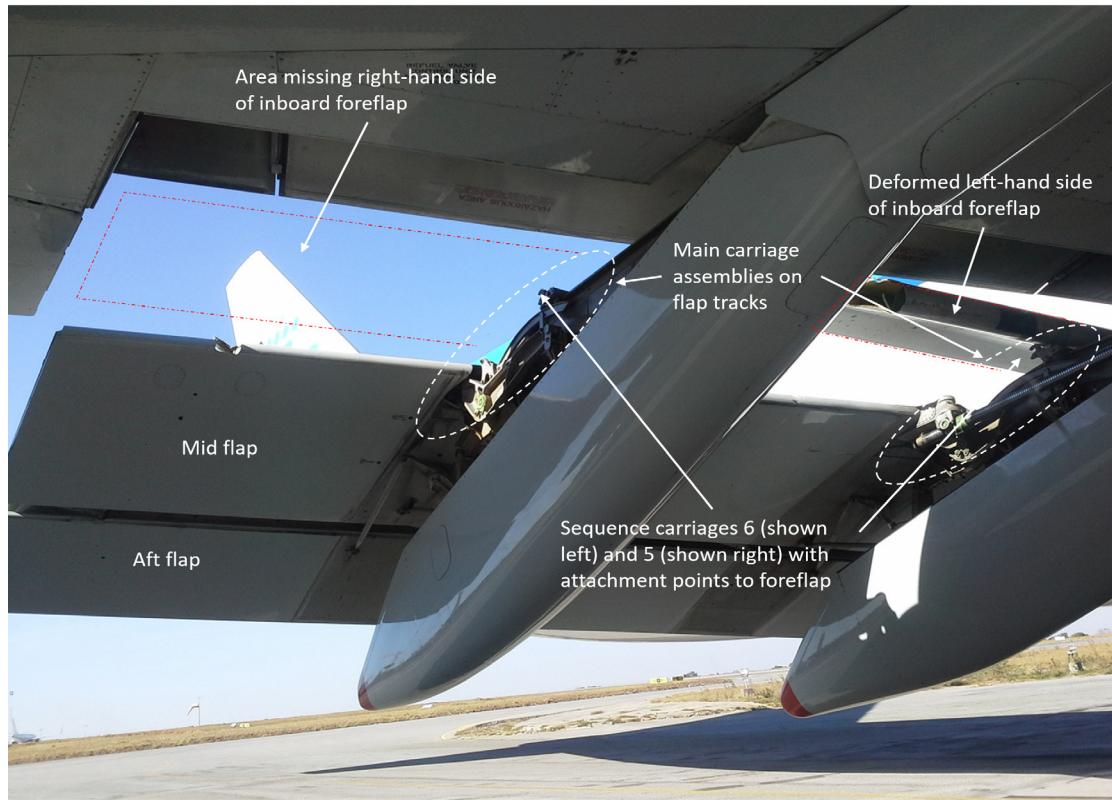
The foreflap separation caused moderate damages to the right wing inboard flap system and the right aft fuselage of the aircraft. The right inboard flap assembly was damaged at the foreflap and mid flap sections. The foreflap was partially missing; it was approximately broken in halve. The right hand side of the foreflap had separated and was later recovered. The left hand side of the foreflap was deformed, but still attached to sequence carriage assembly 5, which was also deformed due to the unusual forces exerted (see Figure 1). The mid flap section sustained multiple damages and was beyond economical repair. The separated right hand side of the foreflap caused damages to the right hand aft wing and body fairing, and the right aft fuselage, among other parts. The aft flap was not damaged.

Figure 1: PH-CKA's right wing trailing edge inboard flap system and damage. (Source: owner of the aircraft)

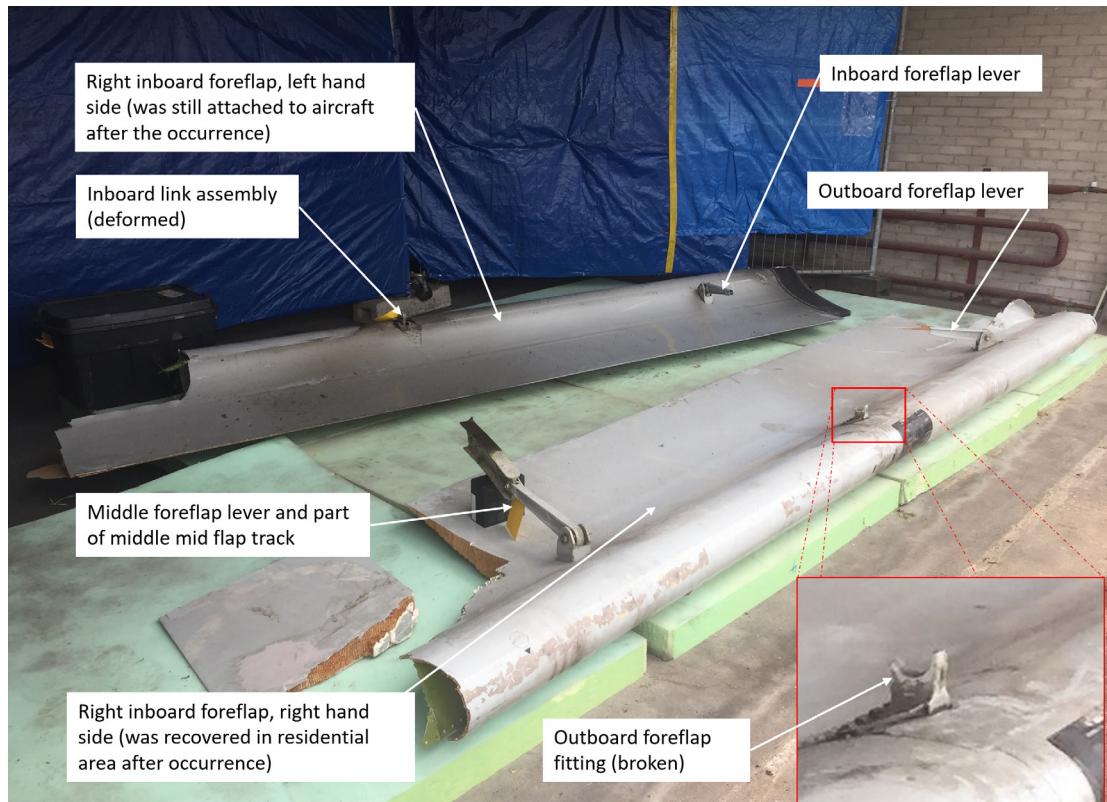
Examination of the recovered right wing inboard foreflap parts revealed that the outboard foreflap fitting had failed (see Figure 2). Visual inspection of the outboard fitting revealed that the lug of the fitting was broken with signs of fatigue and overload failure. It could not be determined when exactly the outboard fitting lug had failed.

Figure 2: Broken parts PH-CKA's right wing inboard foreflap. (Source: Dutch Safety Board)

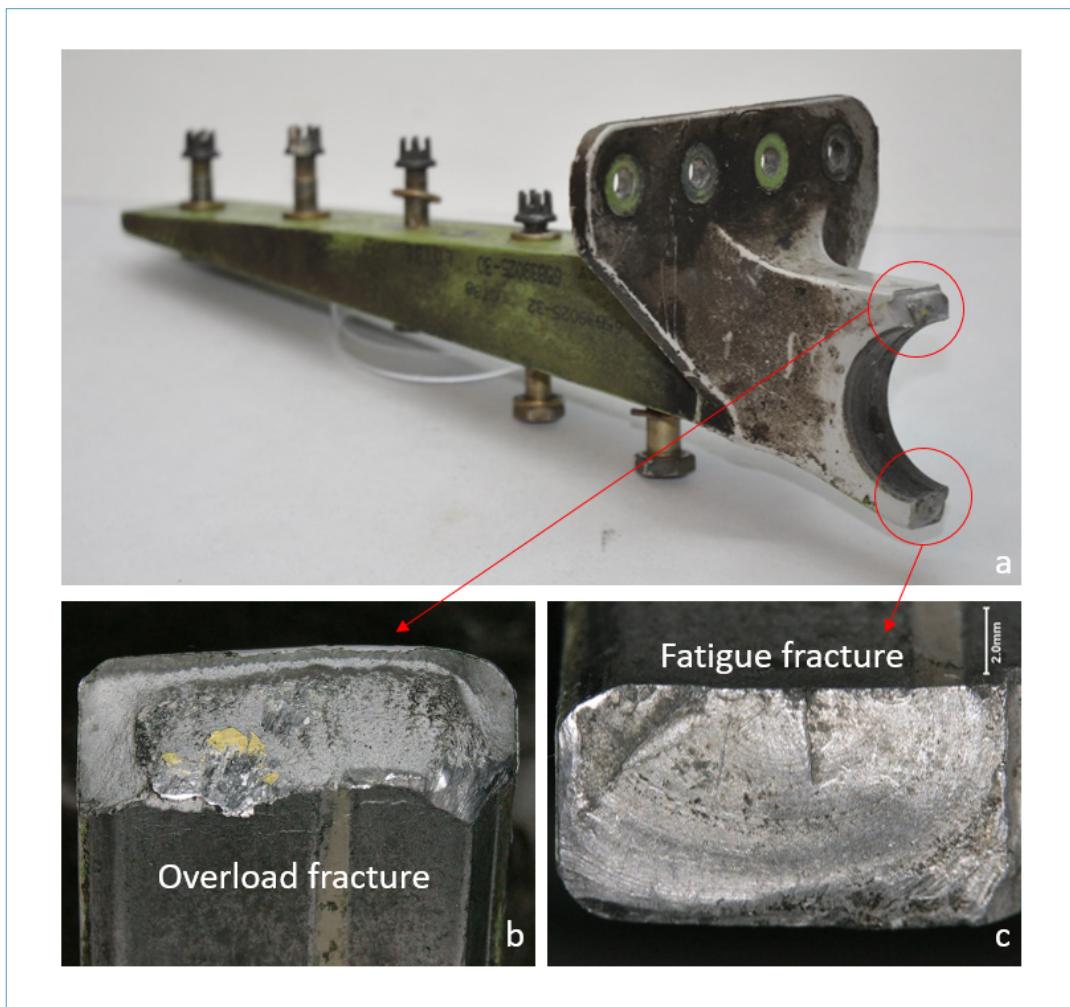
The contracted maintenance organisation performed a metallurgic failure analysis of the outboard foreflap fitting.<sup>2, 3</sup> The examination revealed that the broken foreflap lug had two different fracture fronts (see Figure 4 a). The front side of the lug (see Figure 4 c) was the result of a fatigue fracture. And the rear side, i.e., opposite side of the lug showed an overload failure (see Figure 4 b). This overload failure was the consequence of the fatigue fracture which had caused the lug to open and break.

Figure 4: Broken outboard foreflap fitting lug (a), overload fracture (b) and fatigue fracture (c) surfaces. (Source: owner of the aircraft)

The maintenance organisation's metallurgic failure analysis of PH-CKA's broken right wing inboard foreflap outboard fitting determined that a progressed form of pitting corrosion and fatigue fracture was the root cause of the foreflap fitting failure. The failure of the outboard fitting caused the foreflap to come lose, move upwards and backwards into the airstream, then break in half and separate from the aircraft. The separated part caused subsequent damage to the aircraft.

On 15 November 2019, which is after the incident with PH-CKA, Boeing issued alert SB 747-57A2367 to further improve the reliability of the trailing edge flap system. This alert SB requires operators to periodically replace specific parts of the trailing edge flap system. For the inboard foreflap outboard fitting specifically, a replacement interval of every six years or 5,880 flight cycles is required. This replacement time interval is well before the eleven to sixteen years failure time period of the foreflap outboard fitting, as also mentioned in Paragraph 3.1.2. Therefore, the periodic replacement of the inboard foreflap outboard fitting as required by alert SB 747-57A2367 is deemed an effective preventive measure, according to the Dutch Safety Board.

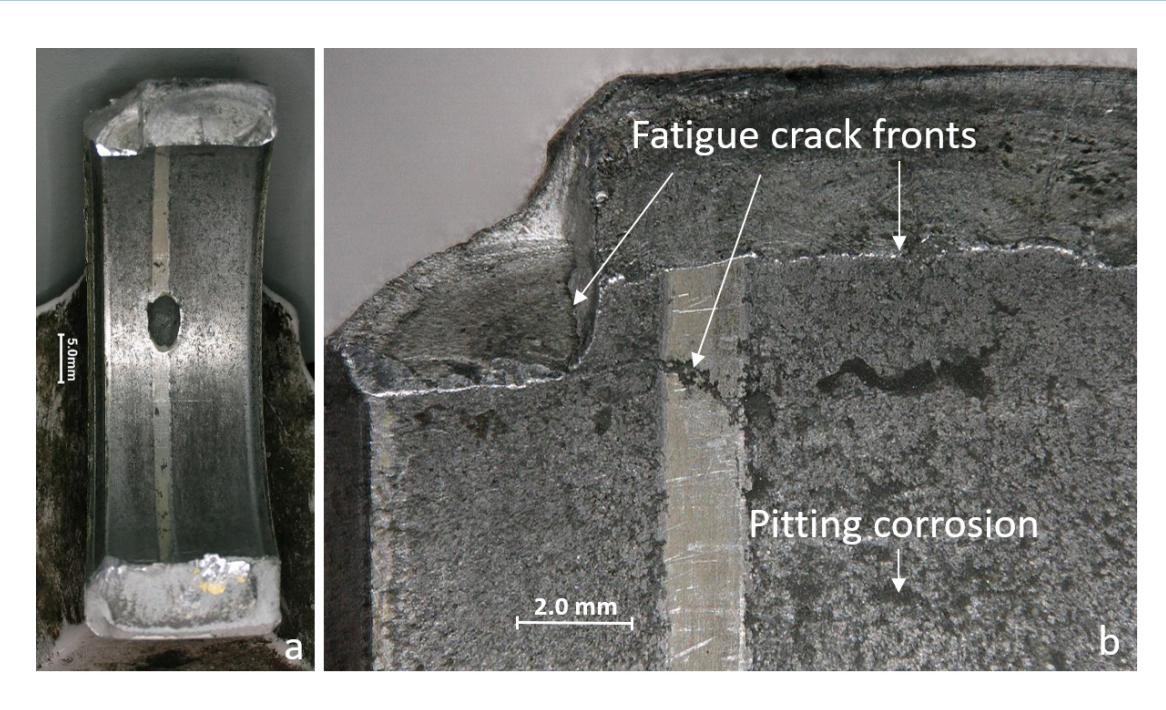
The failure analysis further demonstrated that the inner surface of the foreflap fitting lug had a highly pitted surface area (see Figure 5 a), indicating numerous corrosion points. These corrosion points led to the fatigue fracture that had caused the failure of the fitting lug and of several other fatigue crack fronts (see Figure 5 b). These fatigue cracks reduced the functional area and thus the tensile strength of the fitting lug. When the forces on the fitting lug exceeded the remaining tensile strength, the lug failed at the weakest point, i.e. the most developed fatigue crack front.

Figure 5: Outboard foreflap fitting inner surface with visible pitting corrosion and close up off pitting corrosion (a) and fatigue crack fronts (b). (Source: owner of the aircraft)

The maintenance organisation's report also stated that the forming of the pitting corrosion on the inside surface of the outboard fitting lug was likely caused by moisture that had entered, and accumulated, in the area between the fitting lug's inner surface and the outer surface of the bearing. The forming of this type of corrosion is a long term process. It is likely that the pitting corrosion on the inside of the right hand side inboard foreflap outboard fitting lug was already present long before it failed. The maintenance documentation showed that the service life at the moment of failure of the foreflap fitting was 16 years. Noted that at the moment of failure, there was no life limit requirement for the fitting established.

The analysis further stated that the pitting corrosion was caused by moisture that had been present between PH-CKA's inboard foreflap outboard fitting lug inner surface and fitting lug bearing. For moisture to enter and pitting corrosion to form on the inner surface of the fitting lug, play between the fitting lug and the bearing must have been present. Once pitting corrosion has started, the inner surface of the fitting lug gradually loses material which in turn increases the play, causing more moisture to enter. Because the forming of pitting corrosion is a long term process, it is likely that the pitting corrosion on the inside of the fitting lug was already present before the replacement of the fitting lug bearing of PH-CKA in July 2018.

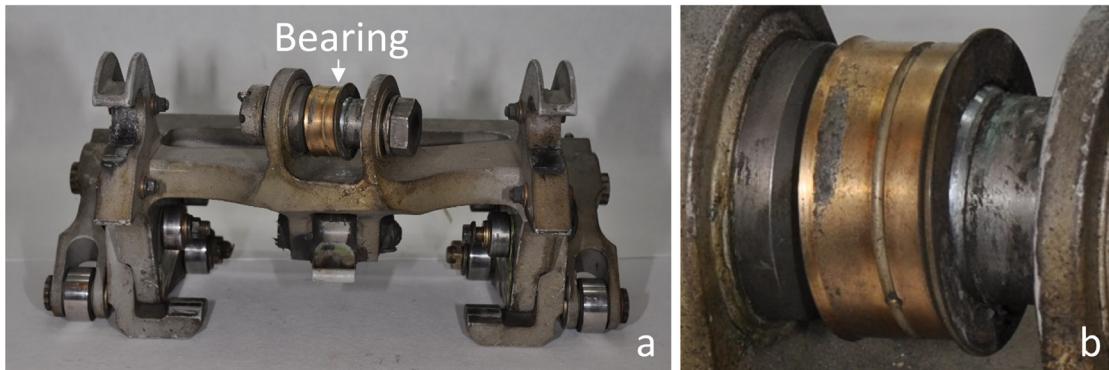
The outboard foreflap fitting bearing was still attached to sequence carriage assembly number 6, see Figure 6a. Figure 6b illustrates a close up of the bearing.

Figure 6: Sequence carriage assembly 6 with outboard foreflap fitting bearing (a) and close up of the bearing (b). (Source: owner of the aircraft)
