Investigation Report

Type of Occurrence: Serious Incident

Location: Frankfurt/Main Airport

Type: A350-941

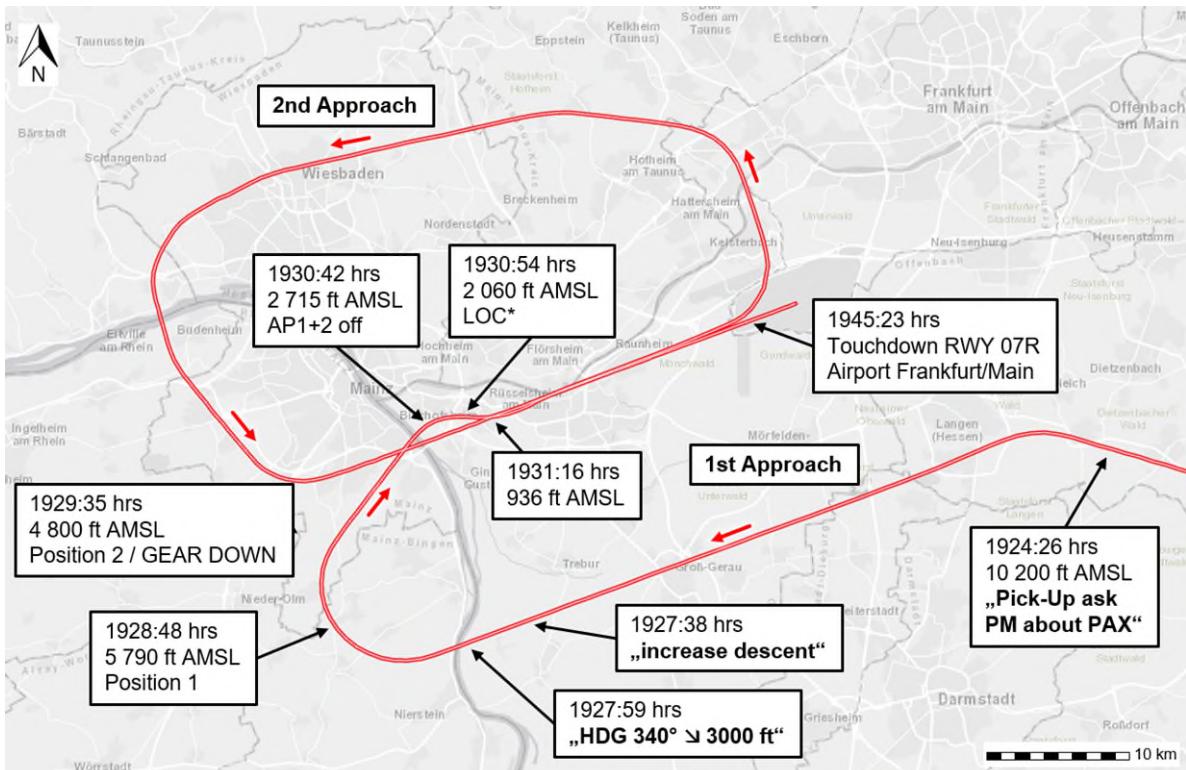
Fig. 1: Depiction of the first approach, the go-around and the second approach to runway 07R

The relevant times, the altitudes and the flight path are depicted in Figure 1. This data, the Flight Mode Annunciator and other aircraft configurations are based on the FDR data. At 1928:48 hrs, at 5,790 ft AMSL, the flaps were put into position 1. At the time, the autopilot of the co-pilot (AP2), both Flight Directors and the OPDES / HDG Mode were active. Shortly afterwards the speed brakes were fully extended and the flaps put into position 2. At 4,800 ft AMSL, the landing gear was extended. At 1929:55 hrs (at 4,200 ft AMSL), the autothrottle mode was active as THR IDLE. At the time, the rate of descent was approximately minus 2,000 ft/min.

At 1930:20 hrs, at 3,680 ft AMSL / 3,480 ft AGL, deviation from the localizer was about 0.25 Dots right of the extended runway centre line. At 1930:22 hrs, the aircraft was at 3,610 ft AMSL / 3,390 ft AGL, about 9 NM from the runway threshold and had flown through the runway extended centerline as the APPR button was pushed, which activated the approach mode arm. In addition, autopilot No. 1 was activated. The aircraft was 0.75 Dots above the glide slope and the rate of descent was minus 2,420 ft/min.

At 1930:23 hrs, the aircraft passed 3,570 ft AMSL / 3,350 ft AGL in OPDES mode. At the time, the aircraft was 0.6 Dots above the glide slope and the PF selected a vertical speed of minus 3,200 ft/min on the FCU. The PF changed the selected flight altitude on the FCU from 3,000 ft to 6,000 ft. Shortly afterwards, the glide slope was passed through with a rate of descent of minus 3,000 ft/min. The speed brakes were retracted at 3,160 ft AMSL / 2,965 ft AGL and the pitch down increased from minus 3° to minus 8° and the calibrated airspeed increased. The autopilot was disengaged and the speed brakes extended at 2,715 ft AMSL / 2,500 ft AGL were passed. At the time, rate of descent was minus 3,350 ft/min.

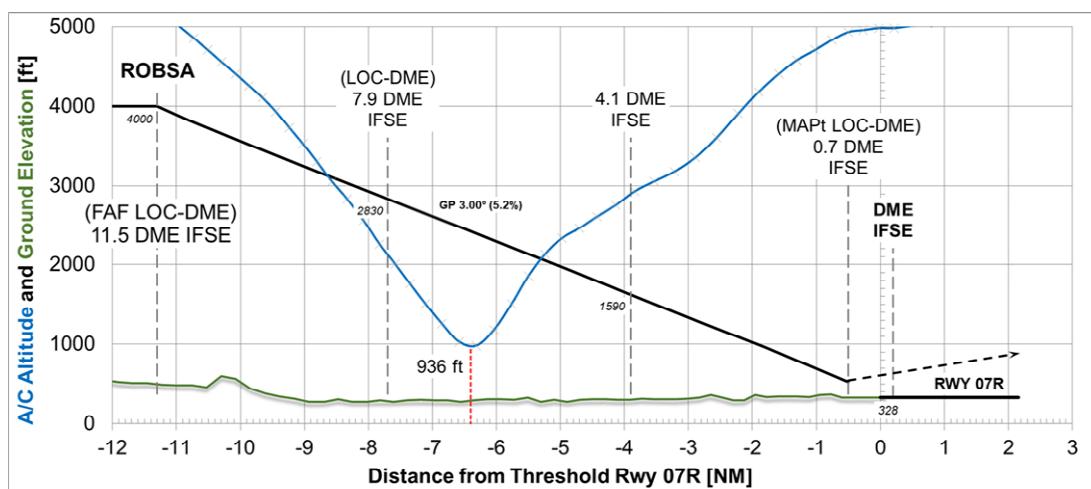
Fig. 2: Vertical profile of the first approach to runway 07R

After the go-around procedure was initiated the aircraft descended another 184 ft. The lowest altitude was 668 ft AGL (936 ft AMSL) at a distance of 6.43 NM to the runway threshold 07R. At the time, the aircraft was 4.1 Dots below the glide slope (Fig. 2).

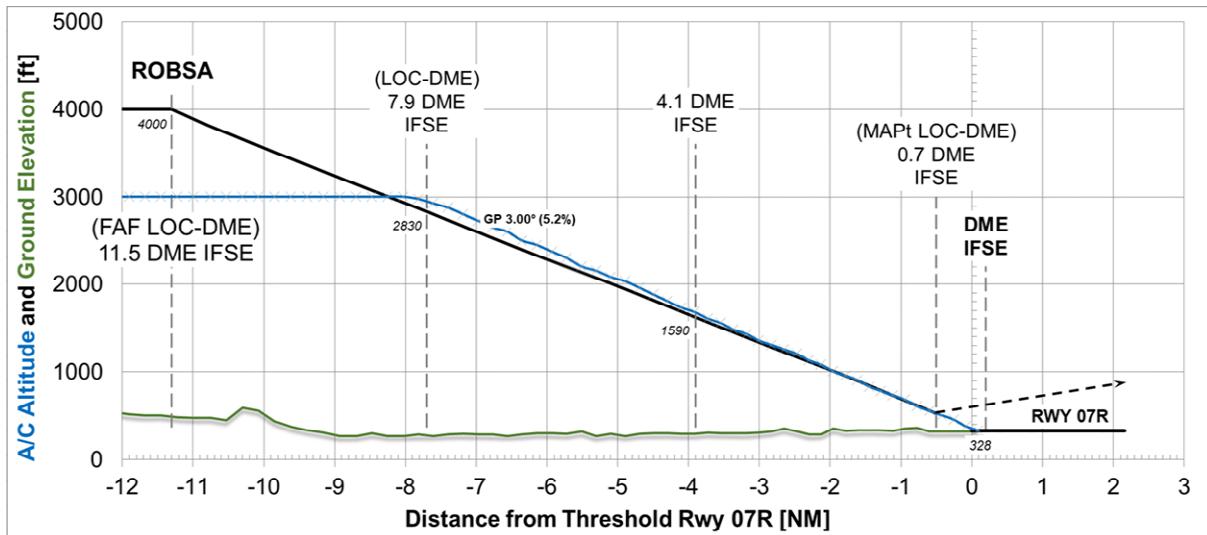
Fig. 3: Vertical profile of the second approach to runway 07R

The second approach was conducted with the use of the ILS of runway 07R. The 3° glide path of runway 07R was captured from about 2,500 ft AGL.

During the second approach (Fig. 3), the aircraft was at 2,238 ft AGL at that point. The subsequent landing at 1945 hrs on runway 07R occurred without any further problems.

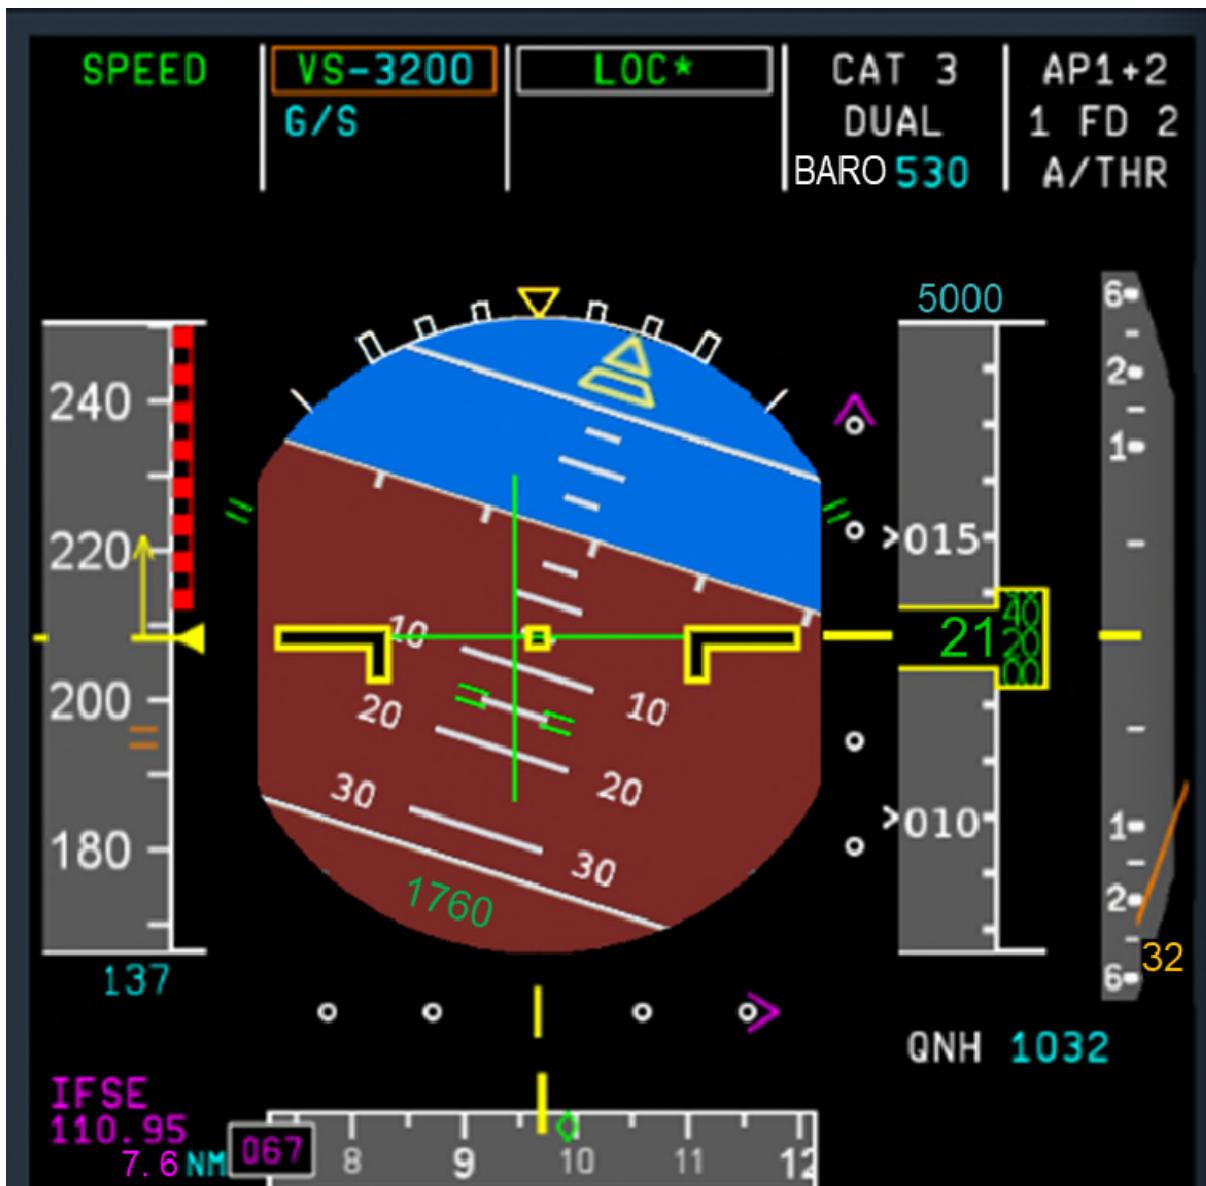
Fig. 6: Simulated PFD indication as LOC was captured during final approach

At 1930:54 hrs, at 2,060 ft AMSL / 1,820 ft AGL, the Flight Mode Annunciator (FMA) showed LOC Captured² (LOC*).

When the aircraft was on the localizer of runway 07R with the mode Localizer Captured, the rate of descent reached a maximum value of minus 4,009 ft/min.

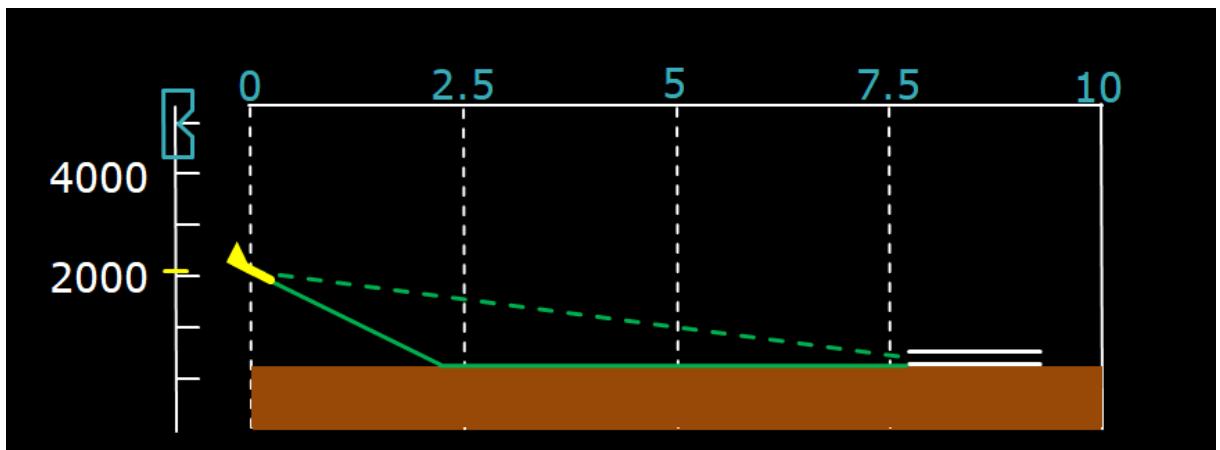
Fig. 8: Simulated VD indication at about 2,100 ft AMSL during final approach

Figure 8 shows the simulated VD indication as the aircraft was at about 2,100 ft AMSL during the final approach. An ND range of 10 NM was chosen for the depiction.

The green line shows the actual vertical flight profile and the broken green line the one from the FMS calculated based on waypoint information. The pilots can use the VD to change the V/S selection at the FCU so that the green and the broken lines coincide and the actual vertical flight profile corresponds with the one calculated by the FMS.

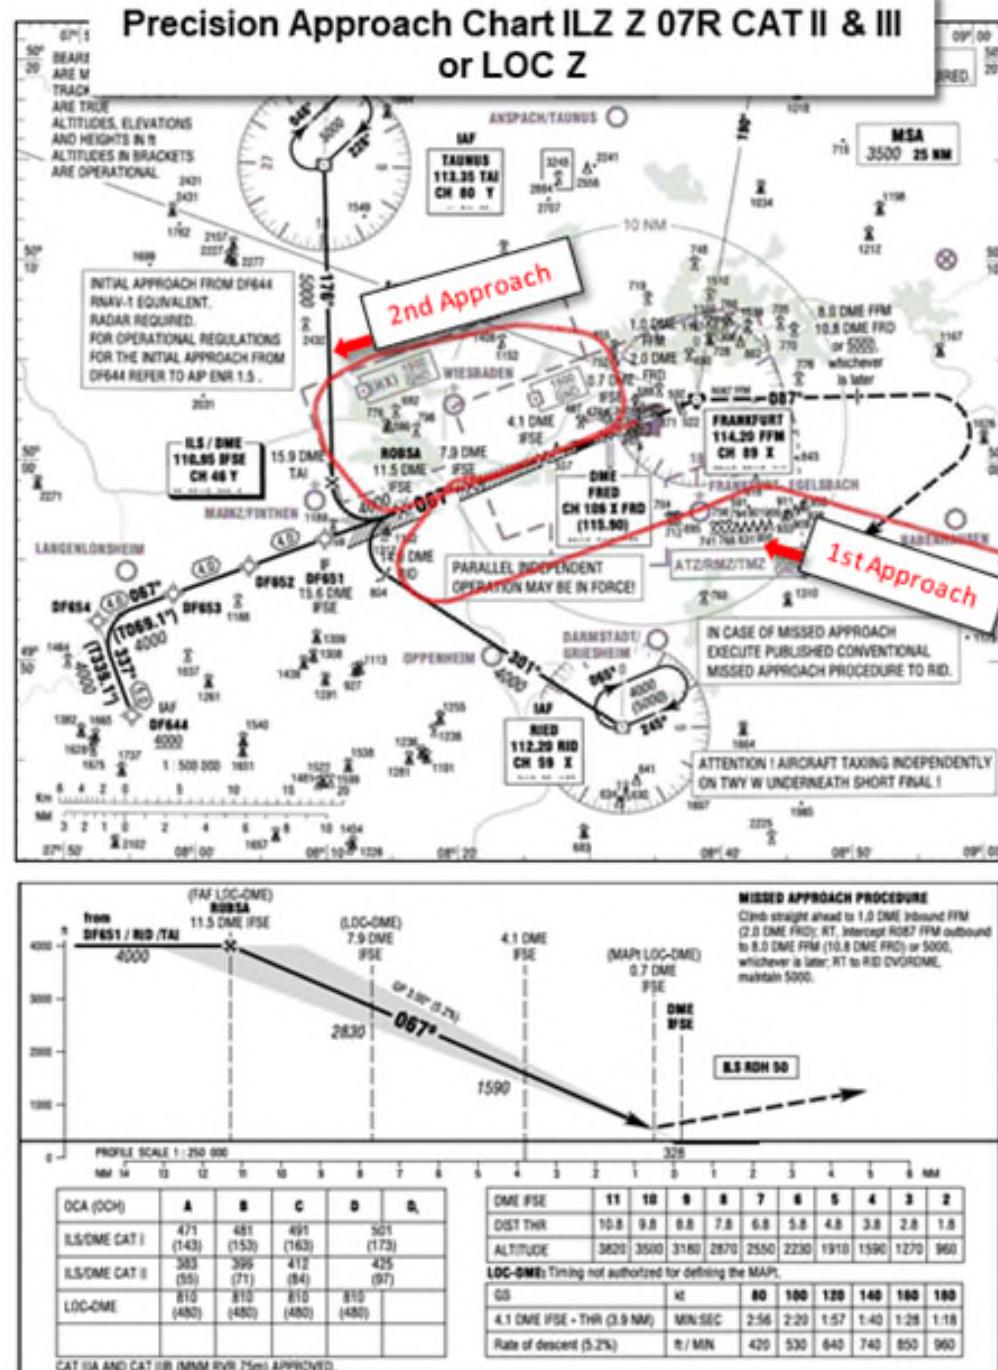
Fig. 15: Flight paths (red) in the precision approach chart ILS Z 07 R

Figure 15 shows the two approaches drawn into the precision approach chart ILS Z 07 R.

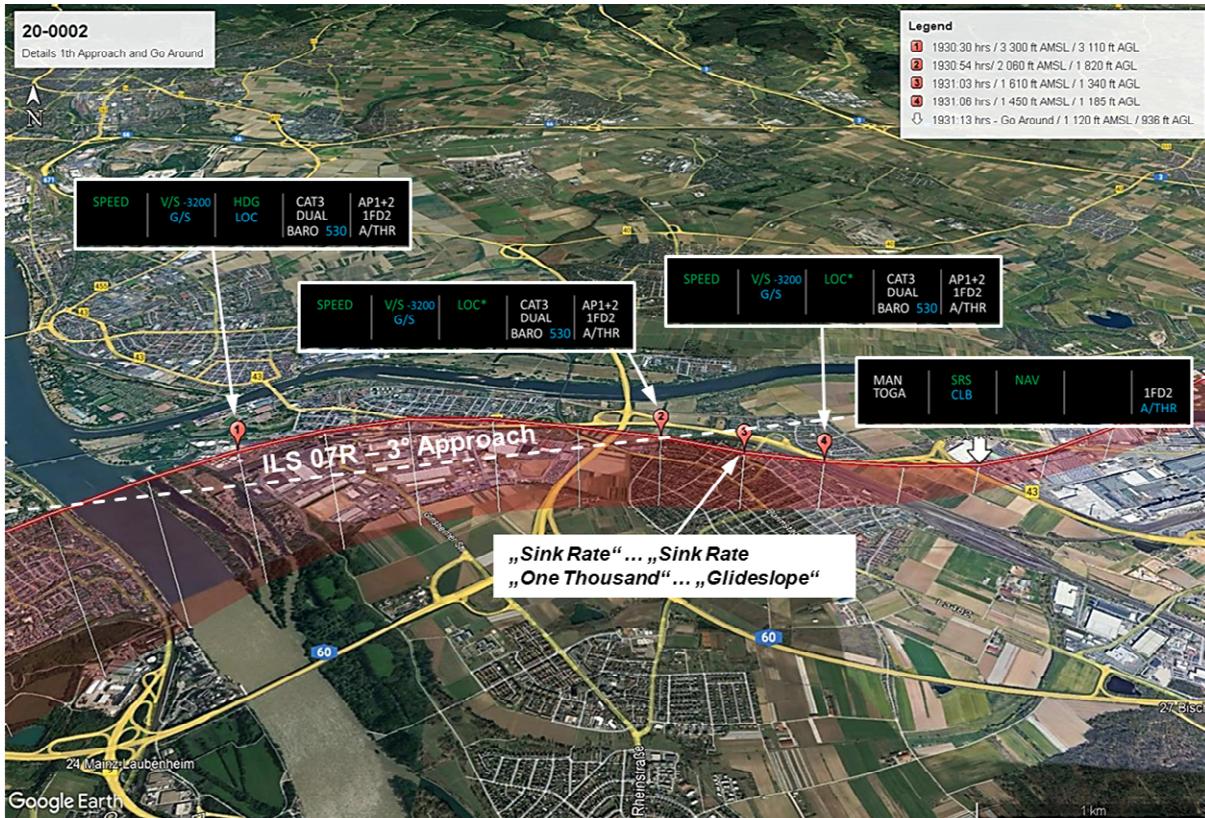
Fig. 16: First approach including FMA indications

The approach, beginning at about 5,000 ft AMSL, was drawn into the Google Earth™ map and depicted in respect to the 3° ILS approach. The FMA indications compiled by the BFU are depicted at the appropriate positions (Fig. 16).

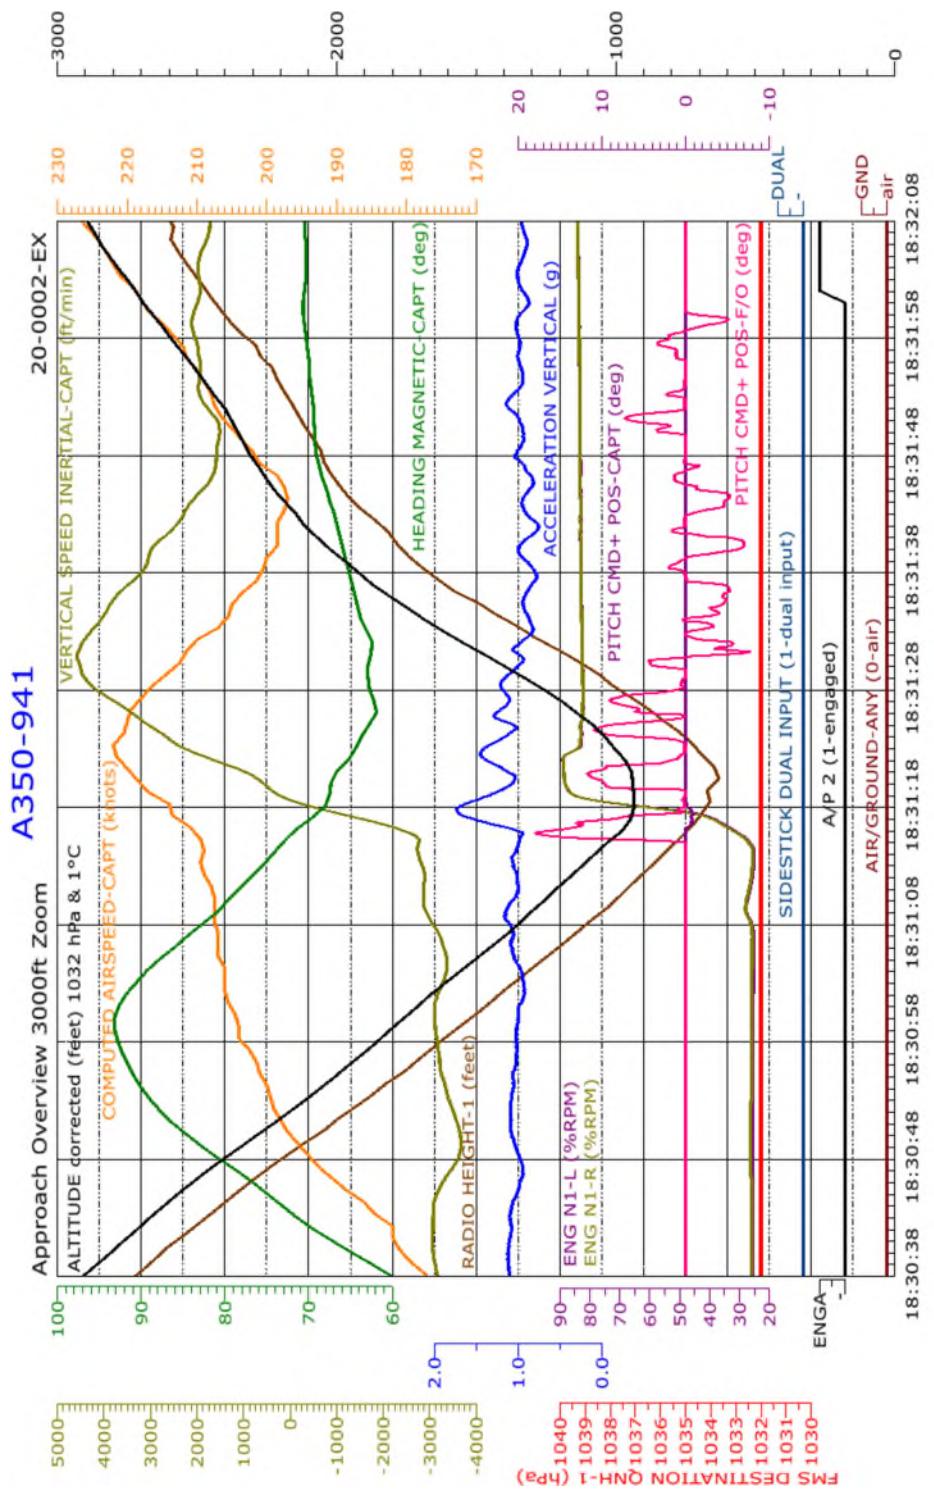
Fig. 32: Occurrence close to the ground

At 1931:03 hrs, at 1,610 ft AMSL / 1,340 ft AGL, the GPWS warning sink rate and glide slope³ could be heard twice on the CVR recording. At the time, the rate of descent was minus 3,370 ft/min and the aircraft was more than 4 Dots below the glide slope. At 1,505 ft AMSL / 1,240 ft AGL, the PF selected an altitude of 5,000 ft on the FCU, this corresponded with the go-around altitude in accordance with the precision approach chart for runway 07R. The autopilot mode changed from LOC* / V/S to LOC* / OPCLIMB⁴. The rate of descent was minus 3,300 ft/min and CAS 201 kt.

At 1931:06 hrs, the aircraft was at 1,450 ft AMSL / 1,185 ft AGL. The PF selected an altitude of 100 ft and a SVS of minus 3,200 ft/min on the FCU. The mode LOC* / OPCLIMB changed to LOC* / V/S. At 1,400 ft AMSL / 1,135 ft AGL, the rate of descent was minus 3,000 ft/min and the autopilot mode LOC* / V/S.

At 1931:13 hrs, at 1,120 ft AMSL / 936 ft AGL, the PF commanded to initiate a go-around procedure. At the time, CAS was 210 kt and the thrust levers were put into the TOGA position. The sensor of the co-pilots sidestick recorded a value of minus 18° (full nose up deflection).
