Aviation Investigation Final Report

Location:	Atlanta, Georgia	Accident Number:	DCA18LA163
Date & Time:	April 18, 2018, 18:09 Local	Registration:	N806NW
Aircraft:	Airbus A330 323	Aircraft Damage:	Substantial
Defining Event:	Fire/smoke (non-impact)	Injuries:	288 None
Flight Conducted Under:	Part 121: Air carrier - Scheduled

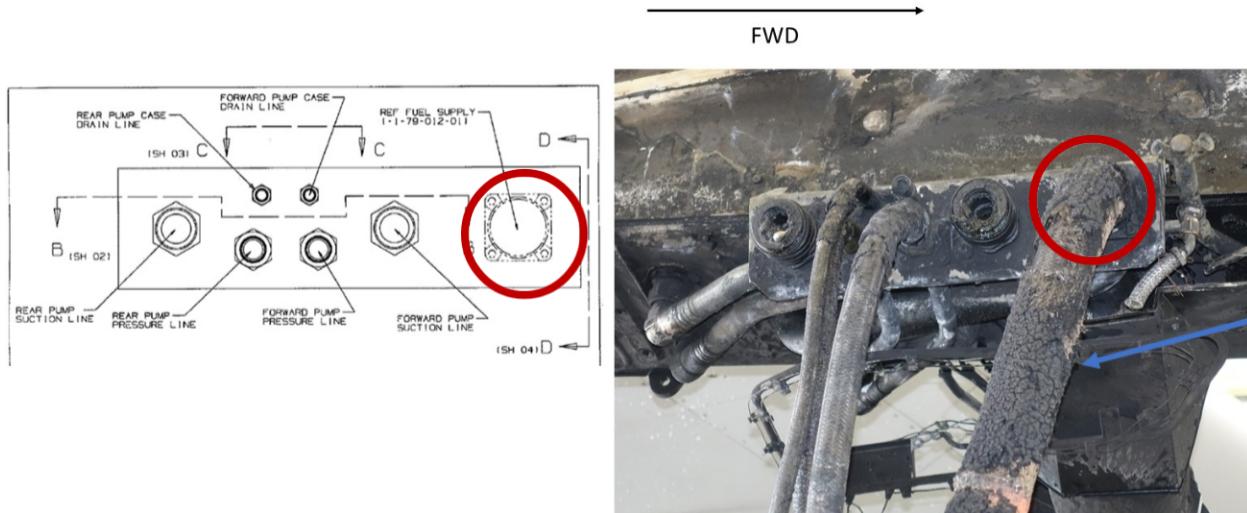
DAL aviation maintenance technicians at Amsterdam Airport Schiphol (AMS), Schiphol, Netherlands, provided written statements that summarized the maintenance actions performed on the airplane on April 15, 2018 (3 days before the accident flight). The technicians noticed that fuel was puddling on the ground under the right engine drain mast during predeparture checks. The cowls were opened, and fuel was observed dripping from the main fuel supply hose (FM-13) to the pylon hydraulic interface panel connection, which are shown in figure 1.

Figure 1. Pylon hydraulic interface panel connections (left) and hardware from the accident engine (right) (Source: left figure is from Pratt and Whitney's "Hydraulic Interface Panel" part drawing).

Note: The red circles show where dripping was first observed. The blue arrow shows the FM-13 hose.

The FM-13 hose upper flange seal was replaced, and a right engine motor leak test was performed. No fuel leaks were observed during the leak test or subsequent postmaintenance/predeparture checks, and the airplane was returned to service.

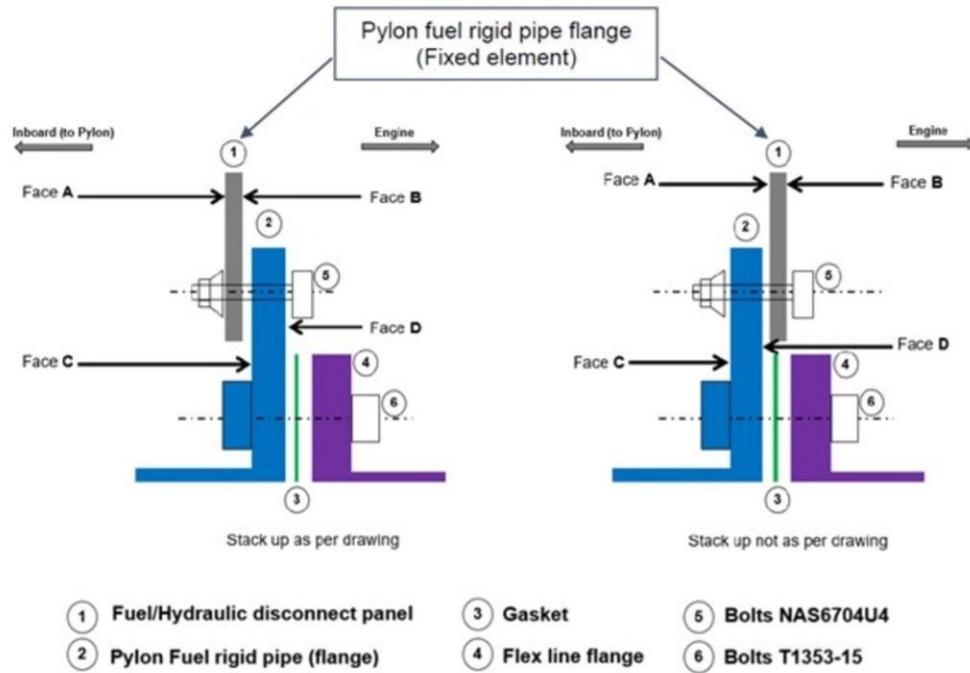
pylon interface panel was installed on the outboard (engine) side of the pylon hydraulic interface panel rather than on the inboard (pylon) side, as shown in figure 2.

Figure 2.: FM-13 hose to rigid fuel pipe connection (Source: Airbus).

Note: The Airbus A330-300 installation drawing appears on the left; the accident configuration appears on the right.

To determine whether additional stress might have been placed on the rigid fuel pipe due to installation position, fluorescent penetrant and eddy current inspections were performed. These inspections did not identify any cracks in the pipe. When a straight-edge ruler was placed against the inboard side of the lower rigid fuel pipe flange, deformation was visible at all four corners.
