Aviation Investigation Final Report

| Location: | Presque Isle, Maine | Accident Number: | DCA19FA089 |
| Date & Time: | March 4, 2019, 11:29 Local | Registration: | N14171 |
| Aircraft: | Embraer EMB145 | Aircraft Damage: | Substantial |

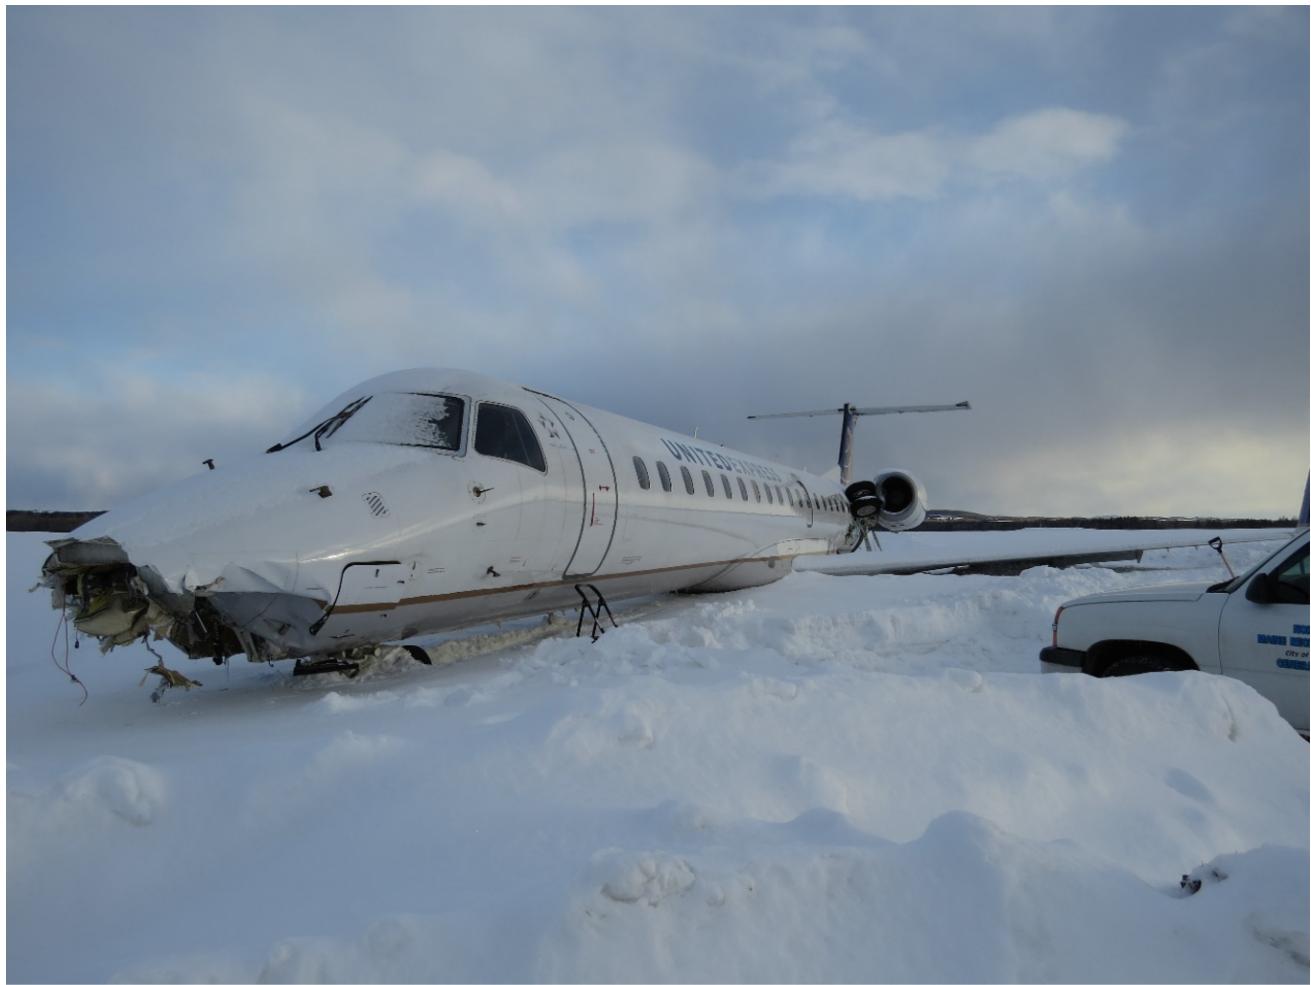
After the main cabin door was opened, the flight attendant noticed that the snow reached the bottom of the belly of the airplane. Firefighters came aboard the airplane; one attended to the first officer, who was injured, and one walked through the cabin to check on passengers. A snow plow created a walkway so that the crewmembers and passengers would not have to walk through the snow after exiting the airplane.

Emergency personnel took the first officer off the airplane, and the flight attendant then directed the passengers to exit the airplane via a ladder that firefighters had brought to the airplane. After the passengers had exited, the flight attendant checked to make sure that no one was left behind, and the captain and the flight attendant then exited the airplane. A bus transported the captain, flight attendant, and passengers to the terminal.

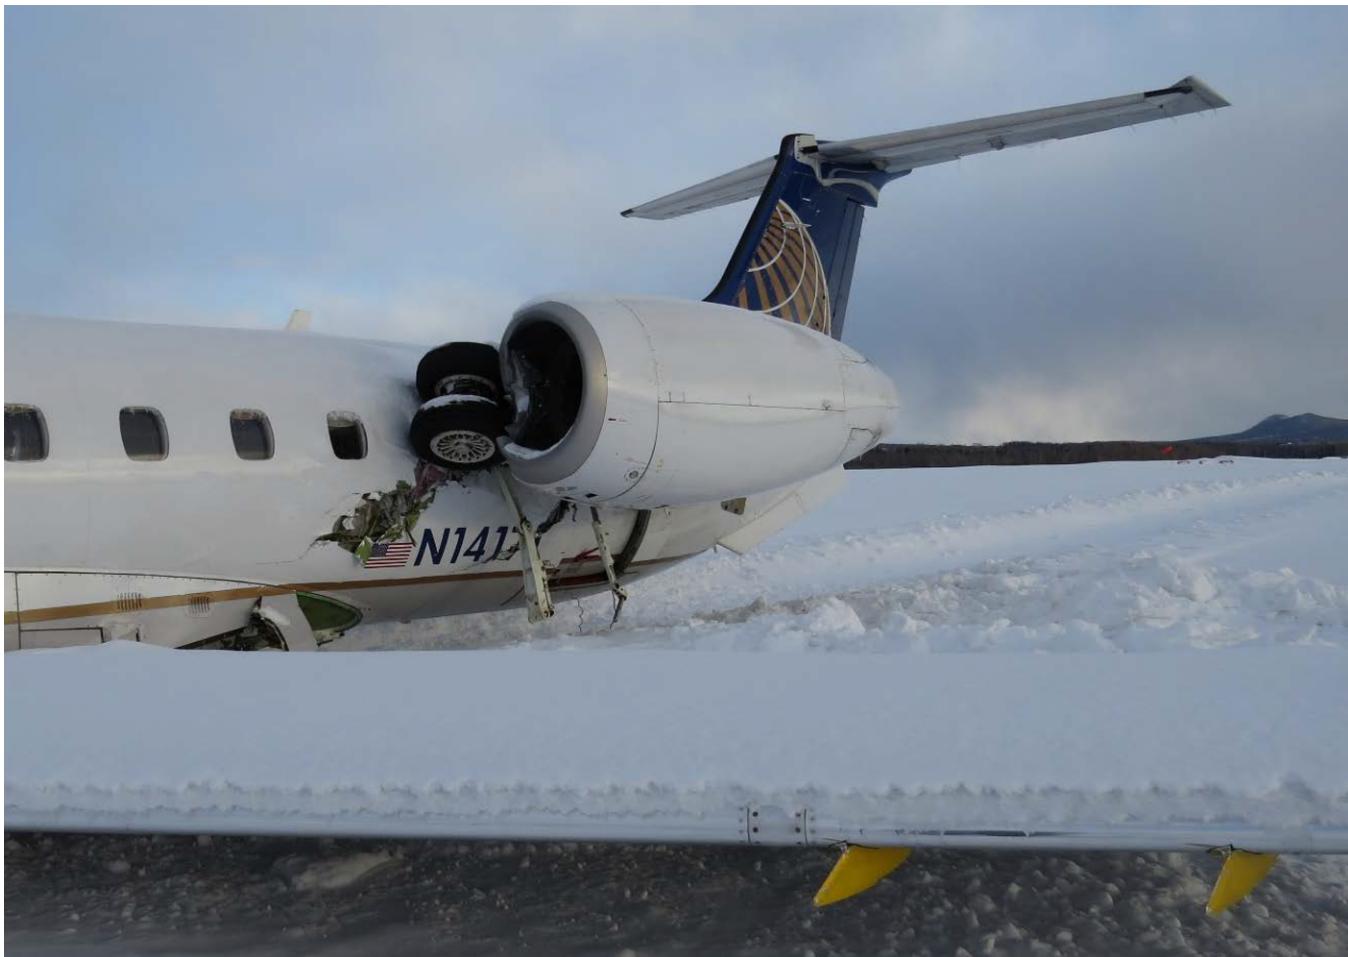
The left main gear was lodged between the left engine nacelle and fuselage. The fuselage structure in the area of the gear was ripped and damaged, and the fuselage around the gear wheels was distorted. The landing gear trunnion had penetrated the left engine gear box.

Figure 2: Left main landing gear lodged between left engine nacelle and the aircraft fuselage
