SERIOUS INCIDENT

Aircraft Type and Registration:	Boeing 737-8K5, G-FDZF	
No & Type of Engines:	2 CFM56-7B27/3 turbofan engines	
Year of Manufacture:	2008 (Serial no: 35138)	
Date & Time (UTC):	11 September 2021 at 1240 hrs	
Location:	Aberdeen Airport	
Type of Flight:	Commercial Air Transport (Passenger)	
Persons on Board:	Crew - 6	Passengers - 67
Injuries:	Crew - None	Passengers - None
Nature of Damage:	None	
Commander's Licence:	Airline Transport Pilot's Licence	
Commander's Age:	56 years	
Commander's Flying Experience:	15,490 hours (of which 1,524 were on type) Last 90 days - 67 hours Last 28 days - 62 hours	
Information Source:	AAIB Field Investigation

Synopsis

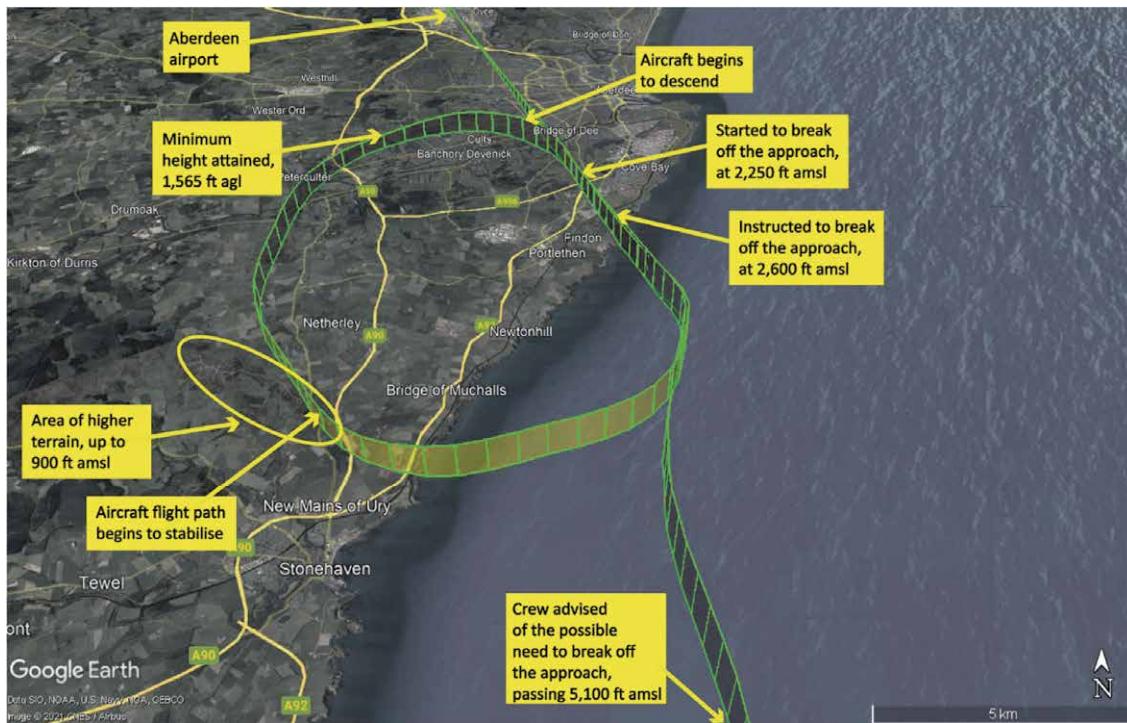
During the manually flown go-around, which was initiated at 2,250 ft amsl, the aircraft initially climbed, but just before it reached the cleared altitude of 3,000 ft amsl it began to descend. It descended to 1,780 ft amsl (1,565 ft agl) with a peak rate of descent of 3,100 fpm, and accelerated to an airspeed of 286 kt (the selected airspeed was 200 kt) before the crew corrected the flightpath. The aircraft descended for a total of 57 seconds before the climb was re-established. It is likely that the crew allowed the aircraft to descend unnoticed having become overloaded by the high workload during the go-around.

Figure 1
G-FDZF's flightpath into Aberdeen and the unintended descent

The aircraft descended from close to 3,000 ft amsl for 57 seconds before a climb was re-established, and this represented a significant deviation from the crew's expected flightpath. The rate of descent peaked at 3,100 ft/min before the aircraft began to climb having descended to 1,565 ft agl, significantly reducing the aircraft's separation from terrain. During the descent and subsequent recovery, there was an uncommanded and undesirable increase in airspeed to 286 kt that was not corrected in a timely manner.

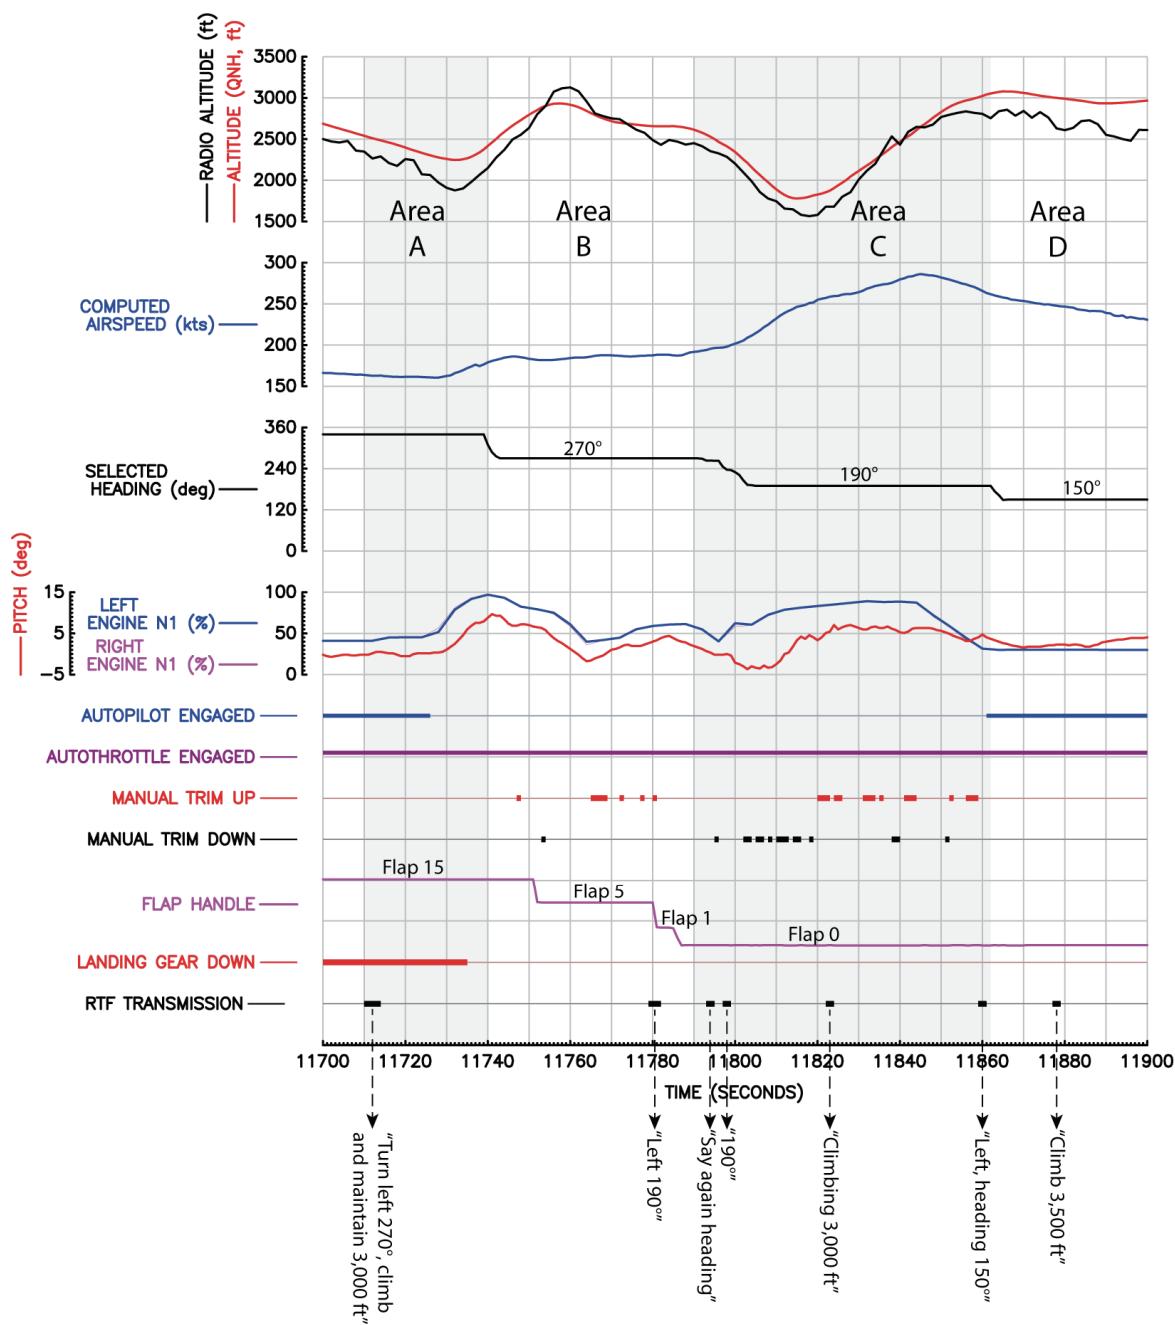
Area A shows the flightpath from when the crew responded to the ATC instruction to break off the approach and shows the disconnection of the autopilot, whilst the autothrottle remained engaged. It shows that the thrust increased automatically towards 97% N₁, the landing gear was retracted, and the aircraft's pitch attitude increased. The aircraft climbed and turned left towards a heading of 270°. The data shows a strong correlation between the engine power setting and changes in the pitch of the aircraft, noting that the flap setting did not change, and that no manual pitch trim inputs are recorded in Area A.

Area B shows that as the aircraft, which was being manually flown, approached the selected altitude of 3,000 ft, the autothrottle reduced the engine power setting and the pitch of the aircraft decreased as the flight director began to command the level-off. As the aircraft passed 2,850 ft amsl, the flaps were retracted from flap 15 to flap 5, and after reaching 2,930 ft amsl the aircraft began to descend. G-FDZF then briefly levelled at 2,650 ft amsl and the flaps were further retracted from Flap 5 to Flap 1. Four seconds later, the flaps were fully retracted and G-FDZF again started to descend.

Figure 2
Flight data for the approach and subsequent unintended descent

Area C shows several radio transmissions from the aircraft, as the crew responded to new headings assigned by ATC, and the lowest altitude reached by the aircraft before a climb was re-established. The climb was initiated at about the same time as the crew replied to ATC's instruction to climb, with the peak airspeed of 286 kt recorded in the climb.

Area D shows the autopilot re-engagement and the flight path of the aircraft beginning to stabilise.

This analysis showed that nose-down, or push, forces were recorded by the control column sensors but that these forces did not adversely affect G-FDZF's climb during the initial part of the go-around. Because a substantial amount of thrust had been applied in the preceding seconds and there were no manual pitch trim inputs, these forces most likely indicate that the aircraft was out of trim.

As G-FDZF accelerated during the unintended descent (Area C of Figure 2), the FDM data was also analysed for this region. This showed that no abnormal nose-down forces were recorded.
