KNKT.18.01.02.04

Aircraft Serious Incident Investigation Report

Airbus A320-200; PK-GLH

Near Waypoint EMARA, Surabaya Airspace

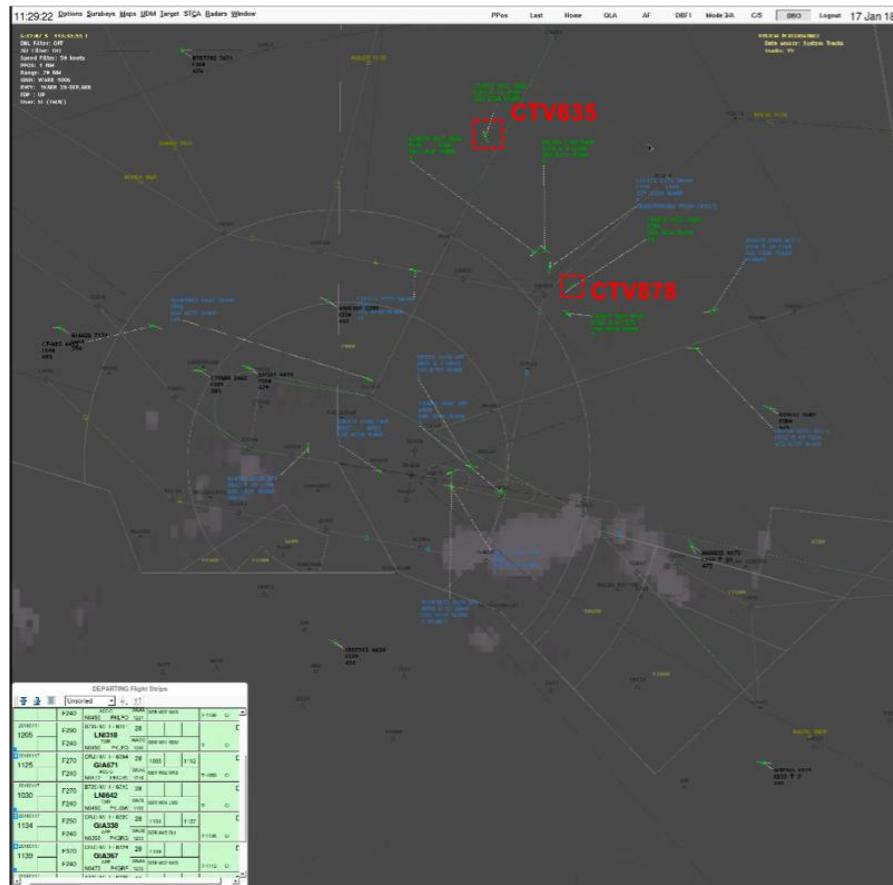
At 1829 LT, the CTV635 pilot advised the controller that the aircraft approached altitude of 21,000 feet. The controller instructed the CTV635 pilot to descend to altitude of 20,000 feet and hold over Waypoint EMARA. At this time, the controller handled five aircraft in total (green label in figure 1) which four aircraft included CTV878 was holding near Waypoint EMARA and the CTV635 about 23 Nm North West of Waypoint EMARA.

Figure 1: The traffic situation when controller instructed CTV635 to descend to FL200
