Aviation Investigation Final Report

Location:	New York, New York	Accident Number:	DCA19LA134
Date & Time:	April 10, 2019, 20:40 Local	Registration:	N114NN
Aircraft:	Airbus A321	Aircraft Damage:	Substantial
Defining Event:	Abnormal runway contact	Injuries:	110 None
Flight Conducted Under:	Part 121: Air carrier - Scheduled

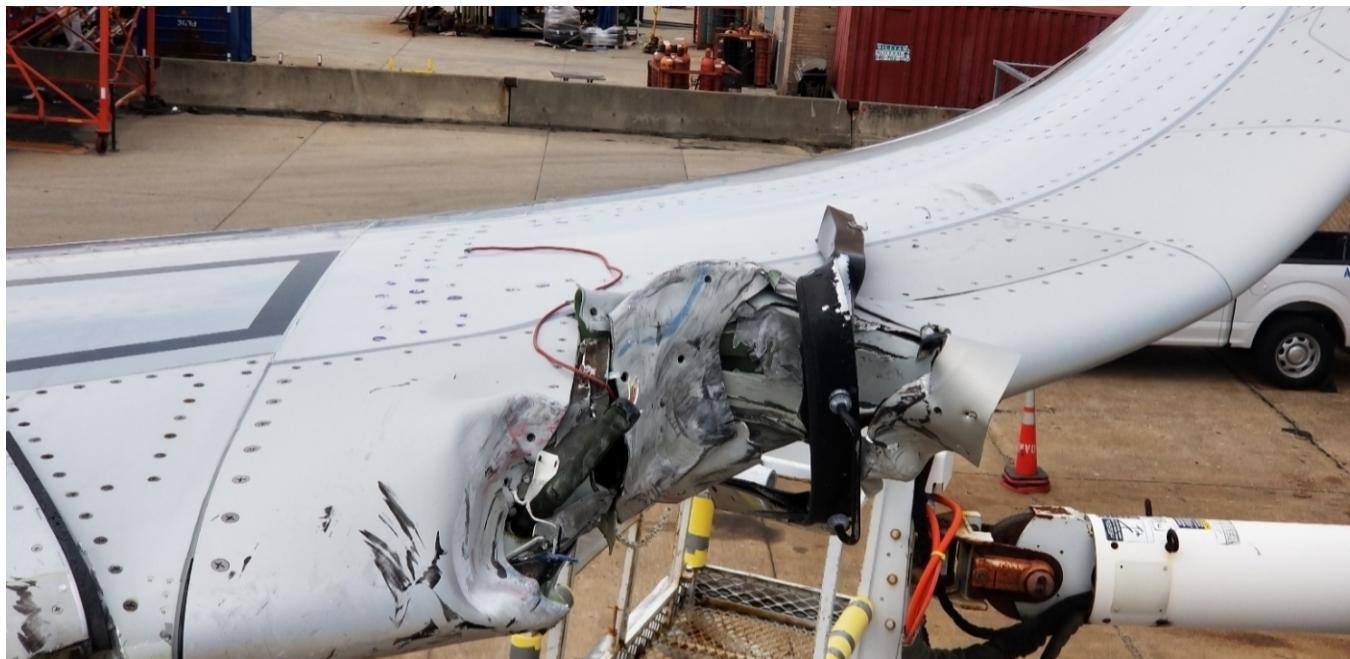
The large left roll angle immediately after liftoff resulted in the left wingtip striking the ground and a runway distance marker, part of which remained imbedded in the wingtip. Airbus engineering simulations performed as part of this investigation demonstrated that the several seconds of near-maximum left rudder generated a rolling moment after the gear had left the ground to impart the left roll rate that the DFDR recorded. No airplane flight control

The captain's excessive left rudder pedal input during the takeoff ground roll, which caused a large heading deviation and a left roll upon rotation that resulted in the left wingtip striking the ground.

American Airlines' examination of the airplane revealed that a portion of the marker support structure was lodged in the left wingtip (see figure 1). The left wing outboard slat, left aileron, left outboard flap, and underside of the left wingtip sharklet were damaged (see figure 2).

Figure 1. Left wingtip damage and portion of distance remaining marker support structure lodged in wingtip (Source: American Airlines).

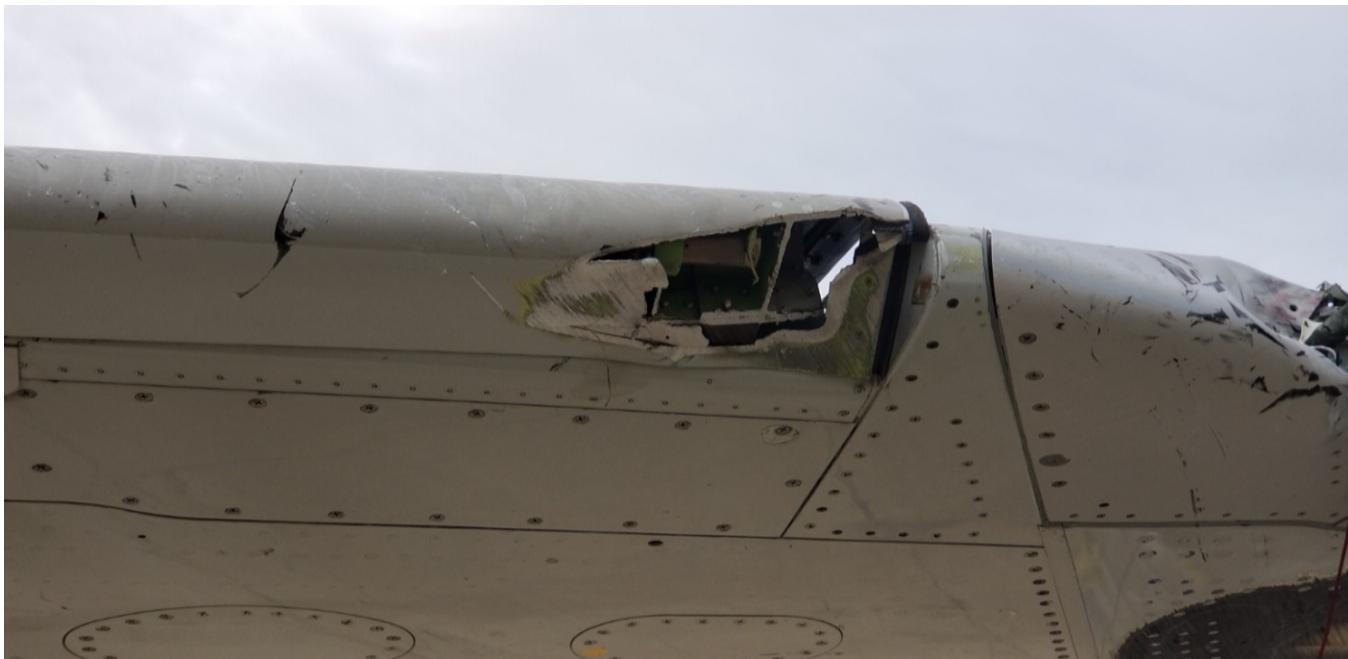
Figure 2. Scrape damage to underside of left wing slat (Source: American Airlines).
