**Incident** to the AIRBUS - A330 - 200  
registered **F-GZCJ**  
operated by Air France  
on 31 December 2020  
en route, FL 380 (Chad)

**Fuel leak en route, diversion, both engines kept in operation up to  
taxiing to parking area.**

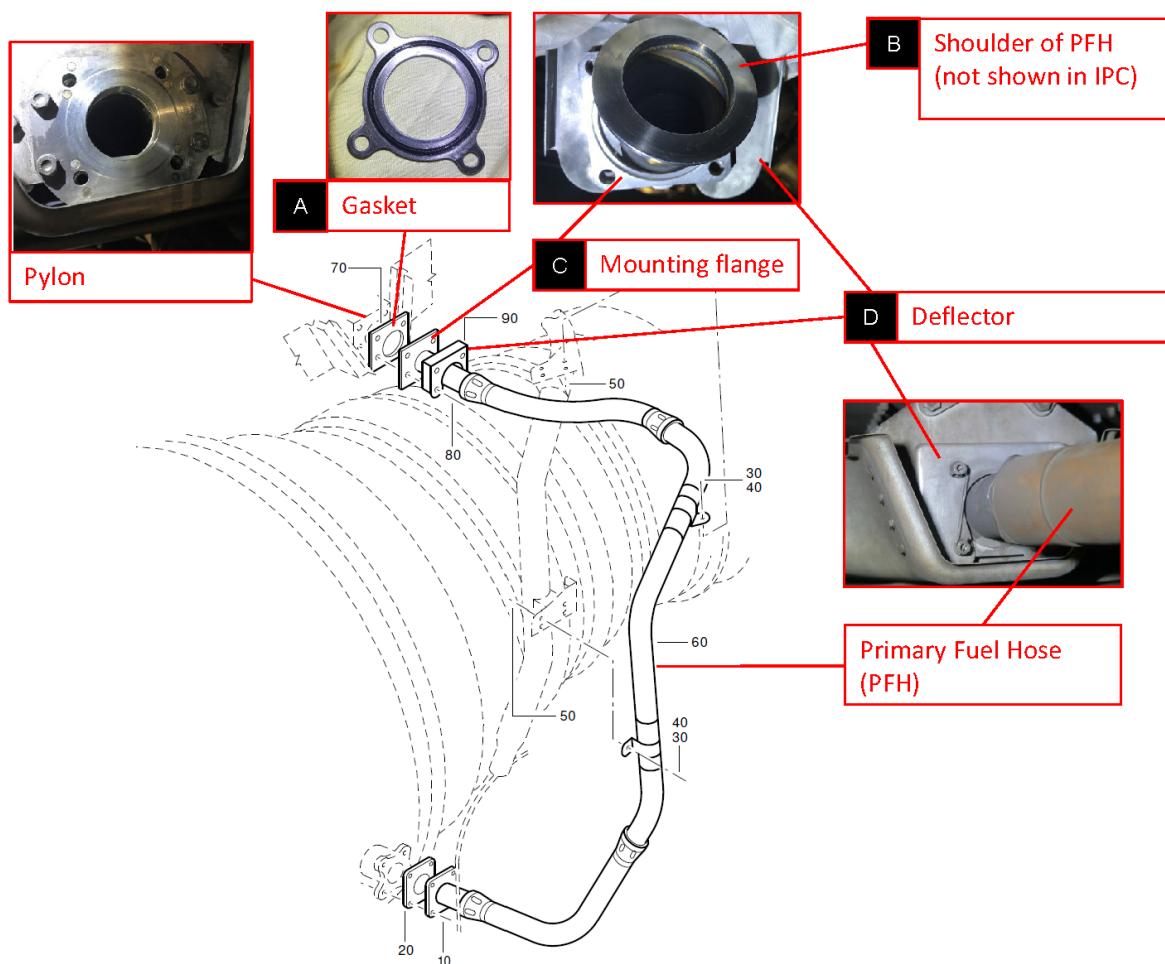
*Figure 3: IPC view of PFH  
(Source: Airbus IPC Figure 73-11-46-20 and BEA annotations)*

The PFH mounting flange is assembled on the engine pylon by superposing the following components:

- A - gasket with an O-ring on each side
- B - shoulder of PFH
- C - mounting flange
- D - deflector which protects against fuel splashes in the event of a leak at this interface.

The PFH shoulder is not shown in the IPC (refer to Figure 3), which may result in some misunderstanding as to how the parts are to be assembled. The AMM instructions do not specify how to check that the PFH shoulder is correctly seated in the mounting flange bore.

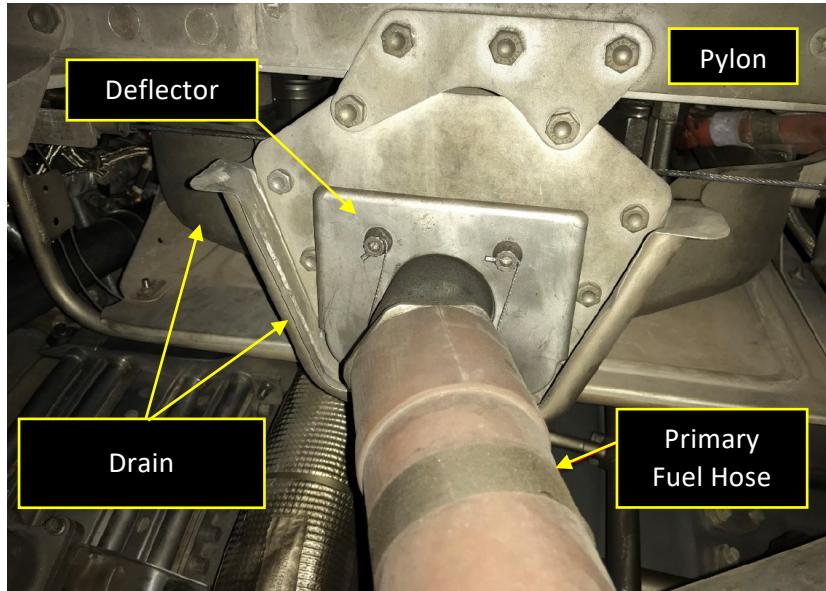
**Figure 10: View of mounting flange of PFH**  
 (Source: BEA)

The subsequent ground maintenance inspections identified a substantial leak in line with the mounting flange of the PFH of engine 1. The purpose of this hose is to bring fuel from the fuel tanks to the engine (refer to paragraph 1.6.5). The mounting flange of this hose forms the interface between the pylon and the engine. It is disassembled each time the engine is removed.

No deformation was observed on the gasket, flange or PFH shoulder during later disassembly and reassembly actions by the company.

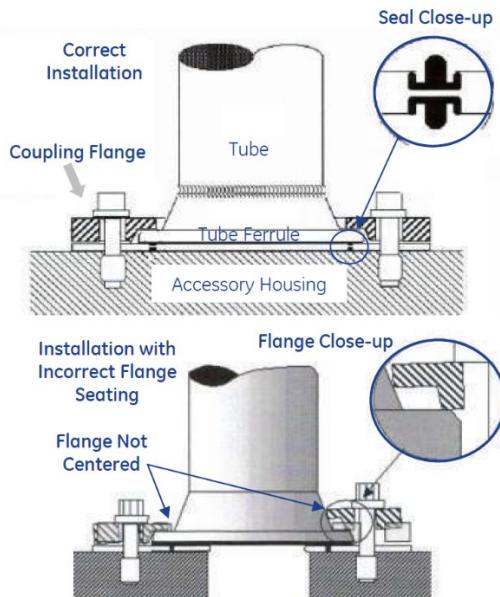
**Figure 11: Incorrect position of flange on tube ferrule**  
 (Source: GE Training Newsletter Issue C F680C21005 • October 2005)

In a Training Newsletter, reference Issue C F680C21005 and dated October 2005, the manufacturer, GE issued recommendations to operators following a leak at the interface between the fuel pump and the Main Engine Control (MEC). This interface is very similar in design to that between the PFH and the engine pylon. GE especially underlined the risk of incorrectly positioning the flange on the tube ferrule (refer to Figure 11). Torquing the bolts after incorrectly positioning the flange can ensure a temporary leaktightness by means of the O-rings. But vibrations can subsequently displace the PFH shoulder in the flange bore (refer to Figure 12), leading to a loss of tightness and as a consequence, to a leak.

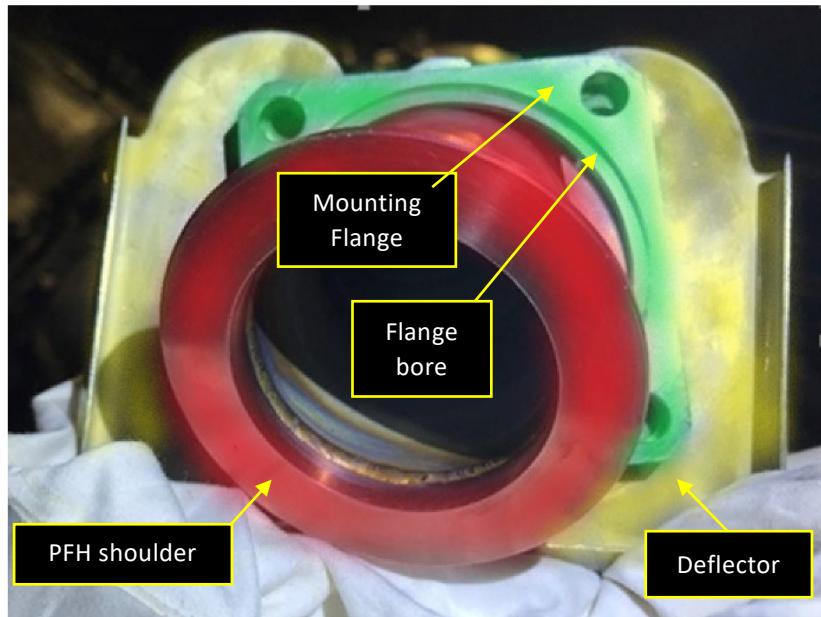
**Figure 12: View of flange bore acting as seat for PFH shoulder**  
 (Source: HAECO)

- The deflector prevents the operator from seeing if the elements of the assembly are aligned. Some technicians indicated that they used an articulated mirror, others checked that the shoulder was correctly seated on the pylon by moving the hose to check that there was no play.
- The hose is not perpendicular to the surface of the pylon (refer to **Figure 10**) as it has an angle which does not help with seeing the alignment of the assembly elements.
