# Aviation Investigation Final Report

<b>Location:</b>	Atlantic City, New Jersey	<b>Incident Number:</b>	ENG22LA002
<b>Date &amp; Time:</b>	October 2, 2021, 17:14 Local	<b>Registration:</b>	N922NK
<b>Aircraft:</b>	Airbus A320-271N	<b>Aircraft Damage:</b>	Minor
<b>Defining Event:</b>	Birdstrike	<b>Injuries:</b>	4 Minor, 108 None
<b>Flight Conducted Under:</b>	Part 121: Air carrier - Scheduled

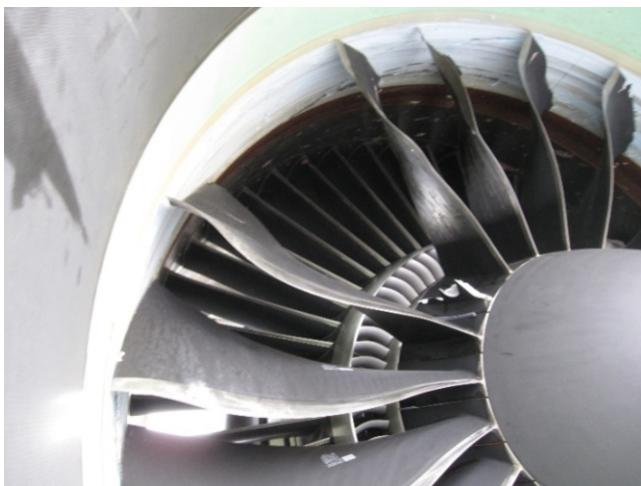
Based on the bird remains and feathers collected and identified by Smithsonian Institution *National Museum of Nature History* Division of Birds - Feather Identification Laboratory, a male immature Blade Eagle was ingested into the right engine striking the fan and causing a single fan blade to fracture near the blade root; the fractured fan blade was contained by the fan case and the remaining fan blades exhibited a combination of leading and trailing edge, as well as blade tip, impact damage, tearing, missing material and bending in the direction opposite rotation. Upon further examination of the engine, it was discovered that two of the thermal management system (TMS) manifold lower aft mounting bracket securing bolts had fractured in shear overstress allowing the bracket to swivel/rotate radially outward. This is one of three mounting brackets that secure the TMS manifold to the engine and prevents excessive moment of the TMS manifold during operation. Along with the broken/sheared TMS lower aft bracket bolts, a crack was visible on the CP-09 fuel line that initiated in fatigue; the CP-09 fuel line is attached to the TMS and contains high pressure fuel. The crack in the CP-09 fuel line was due to necking down of the material as the fuel tube bent and stretched (elongated) under the vibration/cyclic loads after the bird strike and not as a manufacturing issue.

On scene examination of the engine revealed one fan blade was fractured above the blade platform near the root (essentially a complete fan blade airfoil release) (**PHOTO 1**) and a portion of the fractured fan blade airfoil was found wedged in the fan case fan blade rub strip thermally conforming liner at about the 9:00 o'clock position aft looking forward; there were no uncontainments, breaches, tears, or holes through the fan case assembly. The root portion of the fractured fan blade stayed slotted in the fan disk hub and the fracture surface had a shiny and clean appearance. Several fan blades in both the leading and trailing directions from the fractured blade exhibited pronounced and considerable airfoil bending from about 50% span to the tip creating an "S"-shaped bend; all fan blade airfoils exhibited a combination of impact damage, tears, missing material and bending in the direction opposite rotation (**PHOTO 2**). A large quantity of snarge remained on the forward acoustic liner predominantly at the bottom of the fan case assembly and at multiple locations on the fan exit guide vanes. Additional samples were taken and sent to the Smithsonian Institute Feather Identification Laboratory in Washington DC for analysis.

Photo 1: Fractured Fan Blade at Platform

Based on past IAE PW1100 geared turbofan engine bird strike events involving medium flocking birds, IAE has proposed design changes to the fan blade. The redesign will incorporate thickening of the fan blade leading edge root, modifying the fan blade leading edge sheath to account for the thicker leading edge root, increased bonding area for the modified leading edge sheath, and changes to the blade platform geometry. IAE projects that the redesigned fan blade will see fleet incorporation in the third-quarter of 2023. To prevent overload of the TMS mounts in the event of a fan blade out scenario, IAE is in the process of redesigning the TMS mount structure by adding more bolts to both the upper and lower aft mounts and considering modifications to the mount structure itself for improved load distribution. The intent is to mitigate the fire risk, as observed on this event, by preventing movement of the TMS,

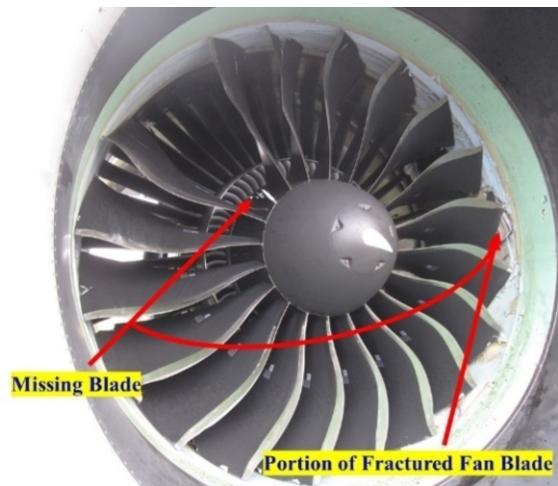
Photo 2: Additional Fan Blade Damage

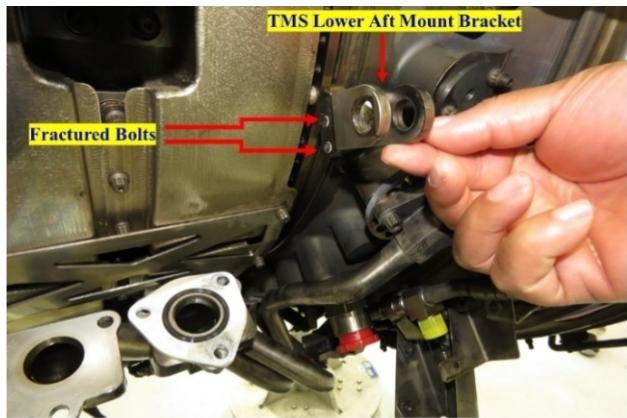
The TMS manifold lower aft mounting bracket securing bolts fractured due to the high impact and vibration loads because of the fan blade release after the bird strike. Subsequently the TMS manifold was allowed to move radially back and forward from the engine in response to the engine vibrations that were recorded on the flight data recorder to be in excess of the 10 cockpit units which is the highest value that the flight data recorder will record. The CP-09 fuel line flexed, bent, and stretched under the cyclical radial motion of the TMS manifold until it cracked due to fatigue spraying high pressure fuel onto the hot engine cases igniting an undercowl fire.

During the engine exam at Columbus Engine Center, it was discovered that two bolts on the TMS manifold lower aft link (support bracket) had fractured (**PHOTO 3**) allowing the manifold to move relative to the engine. Also discovered was a cracked CP-09 fuel tube which runs along the underside of the engine from the fuel manifold on the engine right side to the TMS manifold at approximately the engine 9:00 o'clock position (**PHOTO 4**). The CP-09 fuel tube, along with the three TMS manifold mount support brackets/links, and their associated bolts were shipped to the Pratt & Whitney materials laboratory in East Hartford, Connecticut for evaluation.

**Photo 3: TMS Manifold Lower Aft Bracket with Fractured Bolts**

and subsequent necking and cyclic loading on the CP-09 fuel tube. Final design details, and timing of incorporation is unknown at the time of this report.

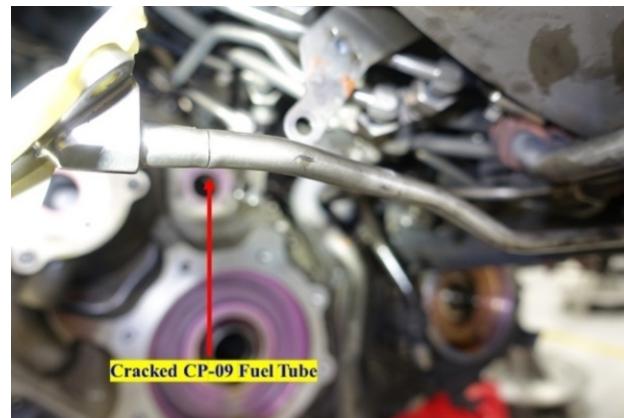
**Photo 4: Cracked CP-09 Fuel Tube (installed)**

Metallurgical evaluation of the CP-09 fuel tube found the material composition to be consistent with the manufacturing print. The fuel tube also exhibited a transgranular fatigue region that progressed through the wall thickness from the outer diameter, with multiple fatigue origins along the outer diameter, and necked down/reduced cross-section wall thickness at the fracture location. According to the P&W materials laboratory, the reduced cross-section wall thickness in the vicinity of the fracture was thought to be due to necking down of the material as the fuel tube bent and stretched (elongated) following the fracture of the TMS mount bolts after the bird strike, and not as a manufacturing issue. Consequently, as the TMS continued to experience vibration/cyclic loading due to the fan blade out, the tube fractured at this yielded location. Metallurgical evaluation of the two fractured bolts from the TMS manifold upper link found the material composition to be consistent with the manufacturing print and the fracture surface exhibited dimple fracture features indicative of over-stress.

Airbus and IAE conducted an analysis of potential ignition sources for the fuel leak coming from the fractured CP-09 fuel tube; the two most likely sources would be hot main landing gear wheel brakes or hot engine cases. It was concluded that: 1) the main landing gear braking temperatures did reach a temperature to ignite fuel, 2) that the drip from the bottom of the nacelle was not sufficiently close to the main landing gear brakes to ignite the fuel vapor, and 3) even if the fuel vapor could reach the brakes, it was unlikely to be at a concentration sufficient for combustion. Therefore, the main landing gear wheel brakes were not considered the ignition source of the engine fire. IAE looked at the various engine case temperatures to determine if any of those would be at temperatures to ignite the leaking fuel from the fractured CP-09 fuel tube. Based on their calculations, IAE estimated that the turbine intermediate case, the low pressure turbine case, and the turbine exhaust case (all downstream of the fractured CP-09 fuel tube) were all at temperatures sufficient to support hot surface ignition of the leaking fuel.
