Investigation Report

Date: 28 April 2018

Location: Bremgarten Special Airfield

State File Number: BFU18-0476-EX

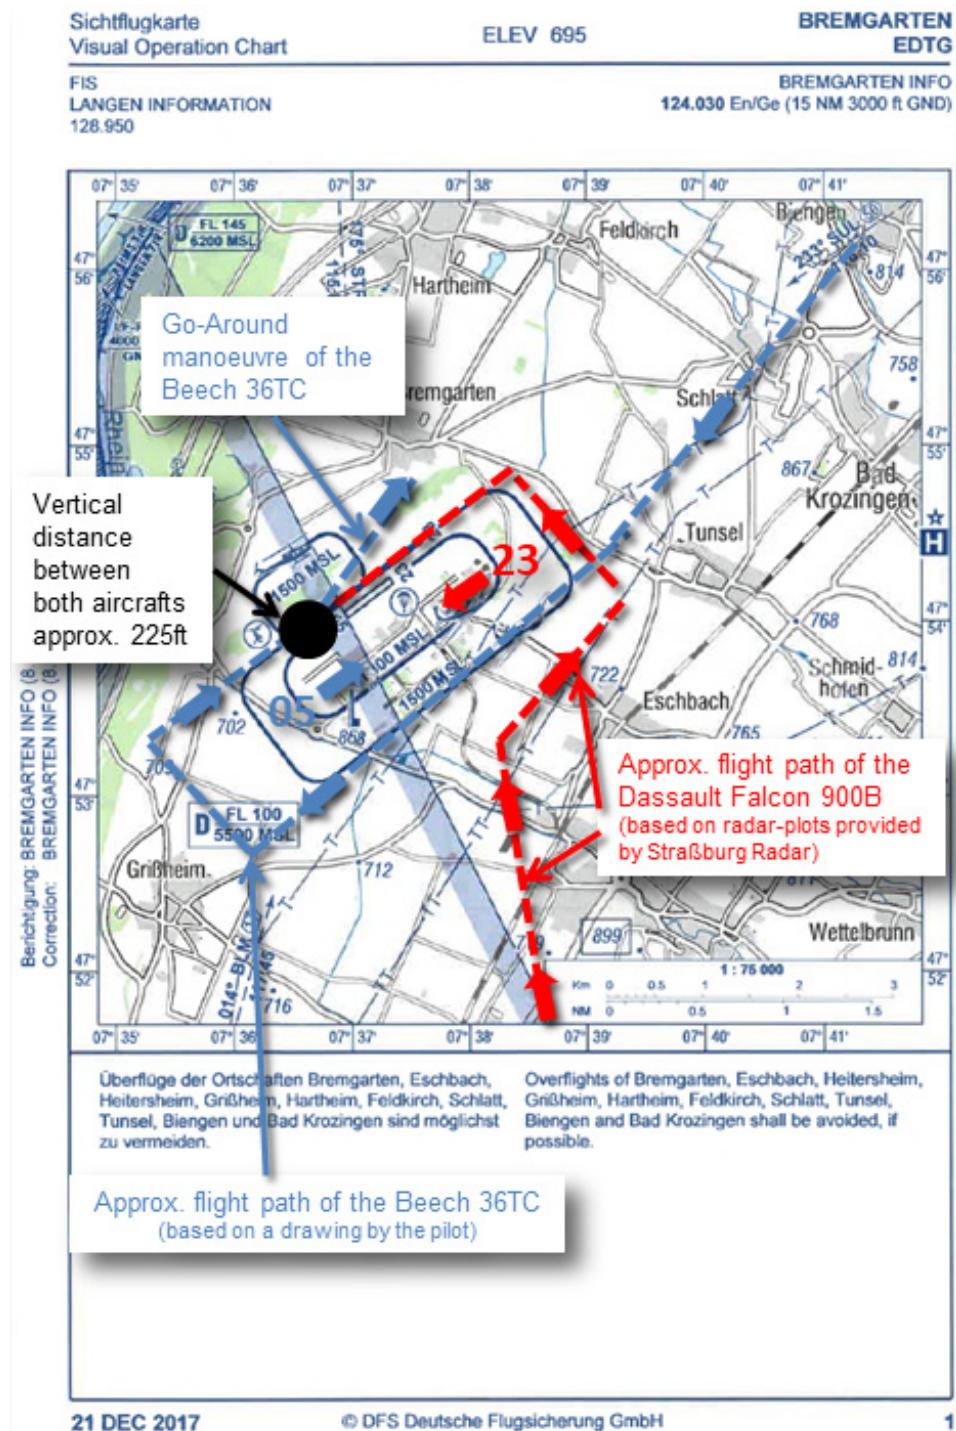
Fig. 1: Aerodrome chart with approximate flight paths of both airplanes

Figure 1 shows the aerodrome chart (AIP, of 12 December 2017) of Bremgarten Special Airfield and the approximate flight paths of both aircraft. It is based on the written description of the Beech 36TC pilot and the radar data of the Falcon 900B, which the air navigation service provider at Strasbourg, France, had recorded.
