Investigation Report

Type: Boeing 777F

State File Number: BFU22-0927-1X

After a Boeing 777F began taxiing on taxiway N-North of Frankfurt Main Airport, several empty airfreight containers were blown from pallet trailers at parking position F234 by the jet blast.

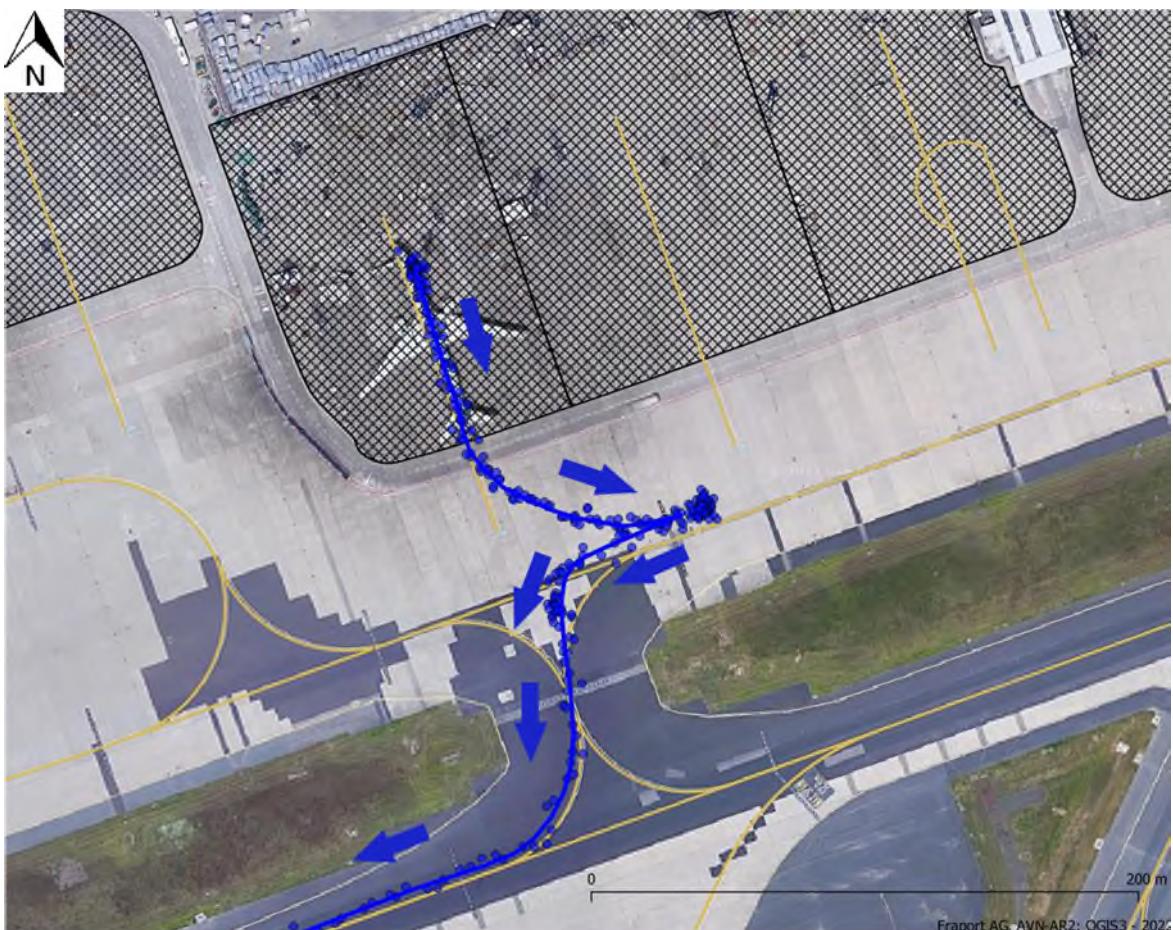
Fig. 2: Ground radar trace

At the time of the clearance, the Boeing 777F was abreast of parking position F234 on taxiway N-North (Fig. 2). The PIC stated that he began to taxi and then realised that a complete left-hand turn by 90° into taxiway N17 was not possible because he had to stay clear of N. Therefore, he stopped about half way and waited for another taxi clearance. After he had received the taxi clearance for taxiway N and runway 18 he began taxiing. He had used the thrust required for taxiing. He had not paid attention to the engine thrust. Neither he nor his other two colleagues had noticed any excessive thrust. To begin taxiing, the thrust of the right engine was increased. The left engine remained in IDLE. The reason the PIC stated was that earlier the aircraft had been stopped in a curve with the nose landing gear turned left and it now had to taxi again. Unconsciously he probably initially increased the right engine thrust in order to resolve the situation.

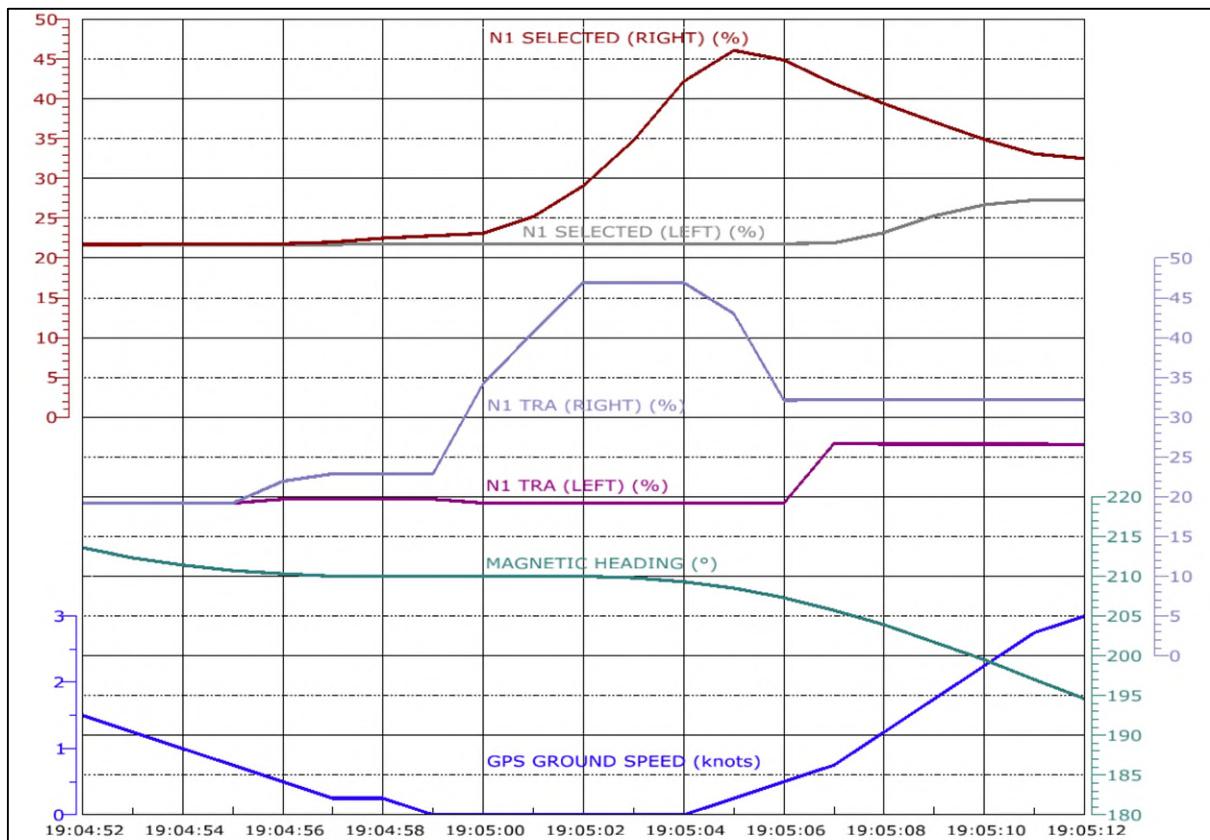
Fig. 3: Selected QAR data

According to the available Quick Access Recorder (QAR)² data (Fig. 3), at 1904:55 hrs, the Boeing 777F stood with its nose pointing towards 210°. At the time, the thrust lever of the right engine was pushed forward from IDLE to 47% N1³ within 7 seconds, while the thrust lever of the left engine remained in IDLE. Once the right engine had reached 42% N1 at 1905:04 hrs, the aircraft began to move and turned left into taxiway N17. At the time, the right thrust lever was pulled back from 42% N1 to 32% N1 within 2 seconds. At 1905:05 hrs, N1 reached a maximum of 46% and then decreased within 7 seconds to 32%. The Boeing 777F was still turning left into runway N17. At 1907:06 hrs, about 2 seconds after the aircraft had begun to move, the left thrust lever was pushed forward from IDLE to 27% N1 and starting at 1905:07 hrs, N1 of the left engine increased within 4 seconds from IDLE to 27%.

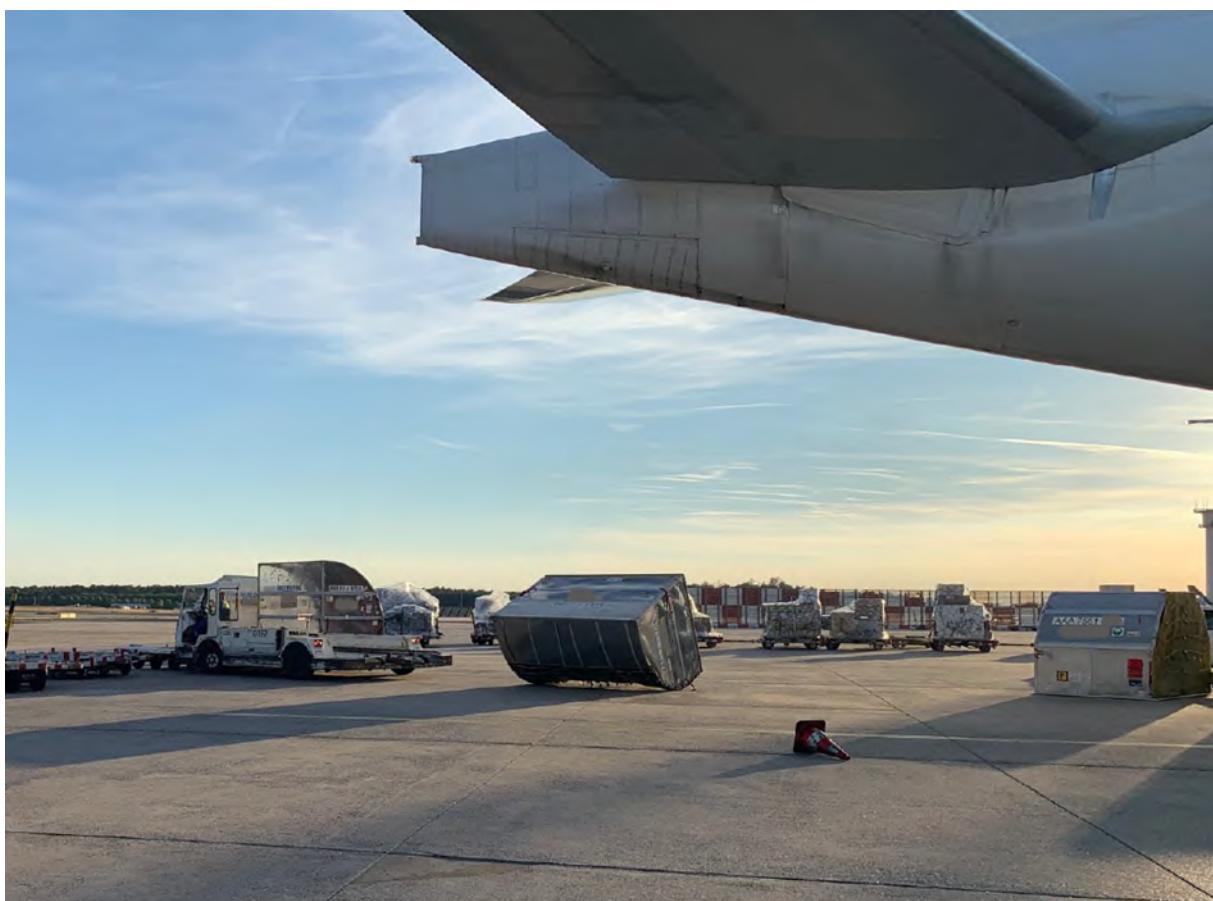
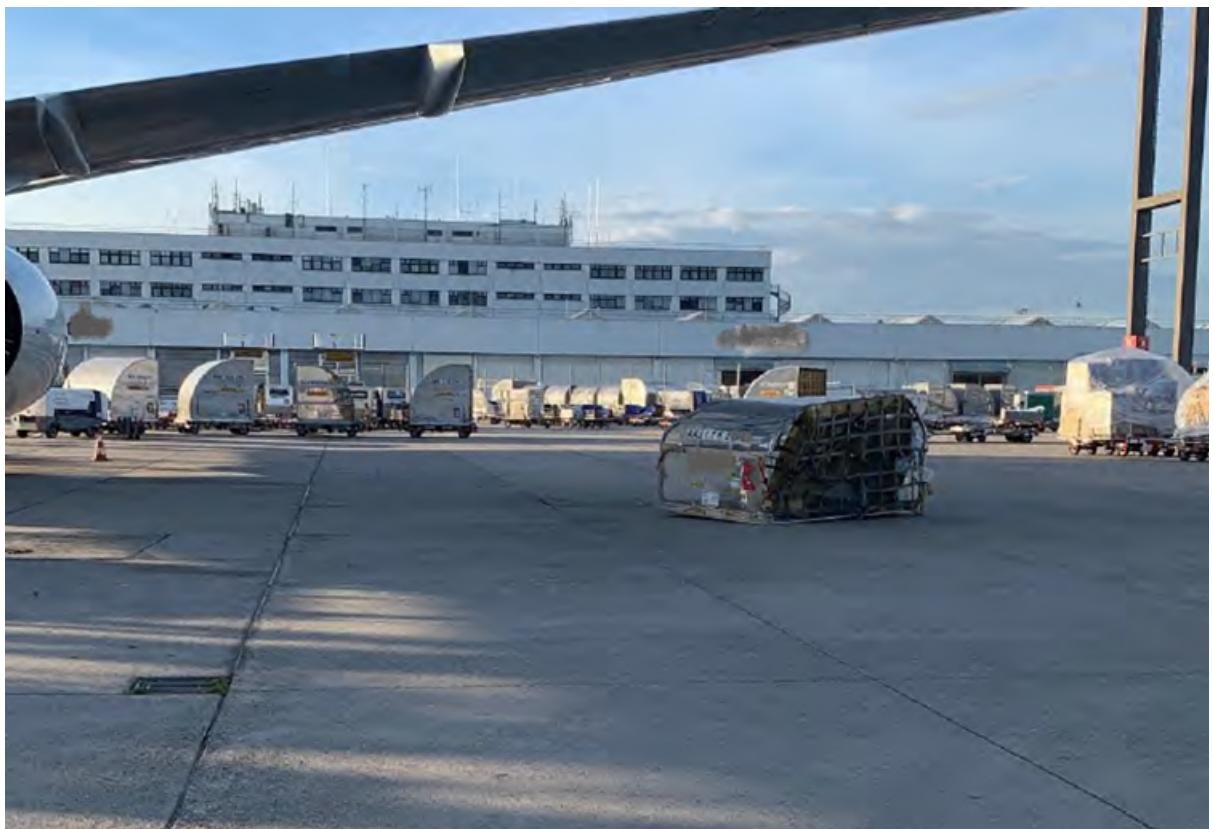
Aircraft were not damaged. The containers which were blown from the pallet cars and the transfer trolley were damaged and scattered around parking position F234 (Fig. 4 and 5).

Fig. 4: Parking position F234, view direction west, with one of the scattered containers

Fig. 5: Parking position F234, view direction North, one of the containers is lying beneath the right wing

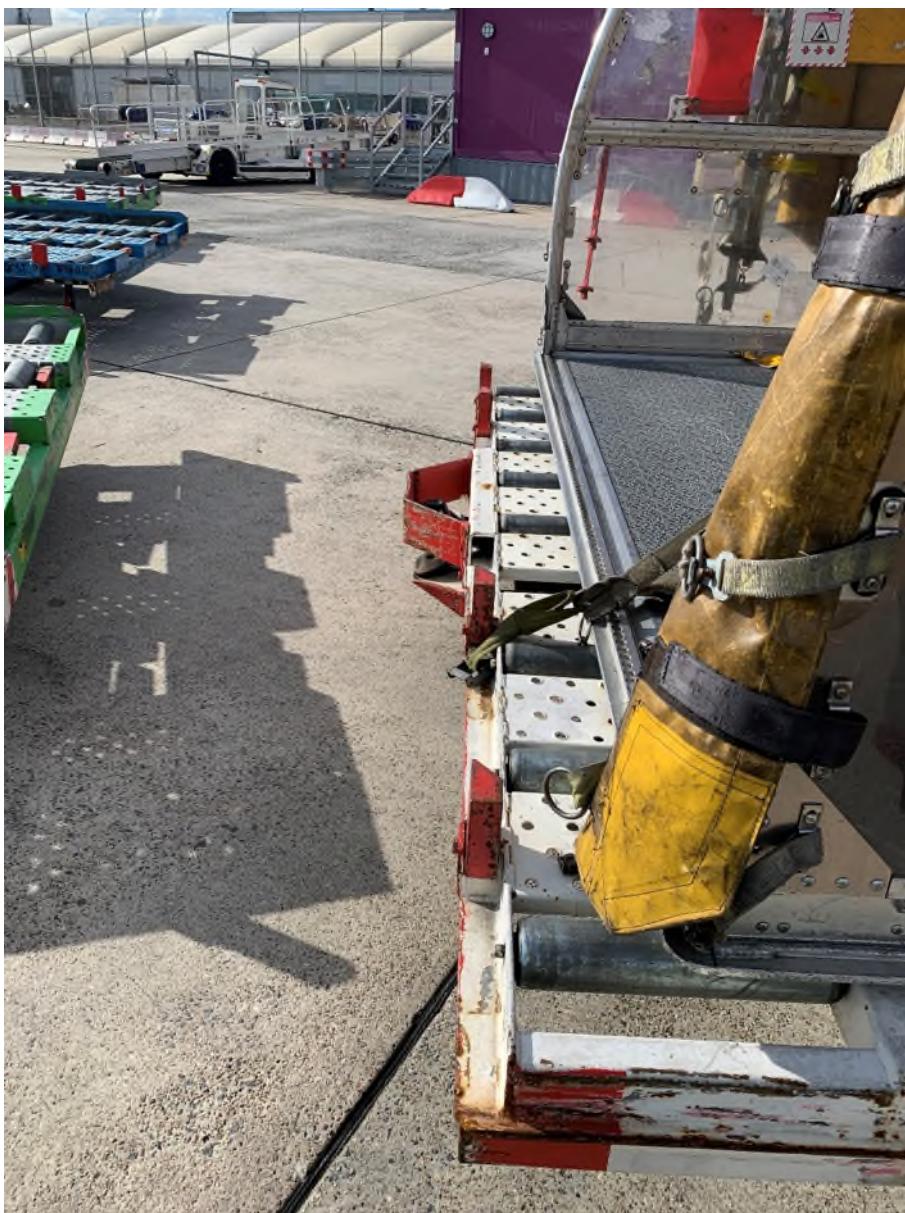
Fig. 7: Example of a pallet car with open safety locks

Pallet cars were used to transport freight containers. Hinged safety locks prevented the containers from sliding around during transport (Fig. 6 and 7). According to witnesses' statements, these safety locks were open at the time of the occurrence.

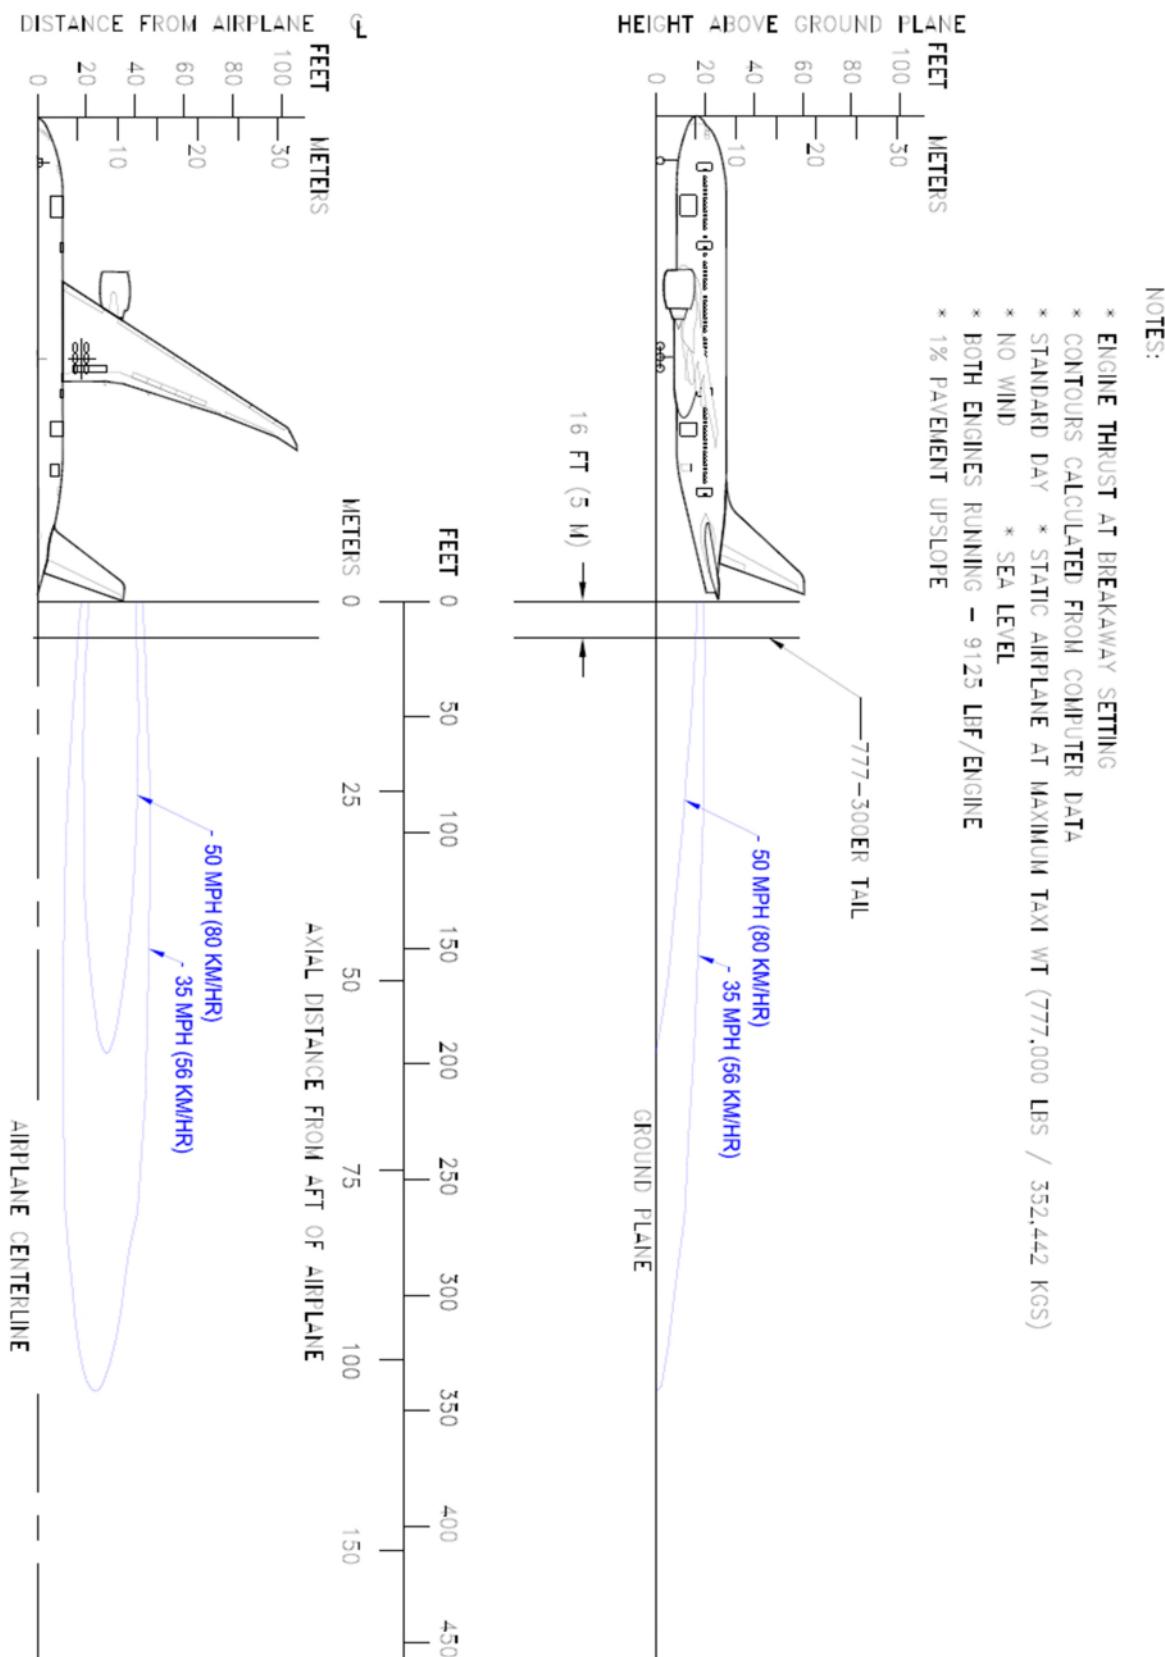
Fig. 8: Predicted Jet Engine Exhaust Velocity Contours - Breakaway Thrust: Model 777-200LR, -300ER, 777F

When the aircraft type involved begins to taxi wind speeds of up to 80 km/h occur up to about 60 m from the aircraft (Fig. 8). These values are based on the use of both engines. If only one engine is used, the rpm required is significantly higher, which subsequently results in higher wind speeds behind the aircraft.
