Safety Investigation Report - Final

Accident File No. 31-18

Collision between two aircraft during pushback

Date	28.3.2018
Between	
Aircraft	BOEING 767
Registration	4X-EAK
And	
Aircraft	BOEING 737
Registration	D-ABLB
Location of event	Taxiway M, LLBG

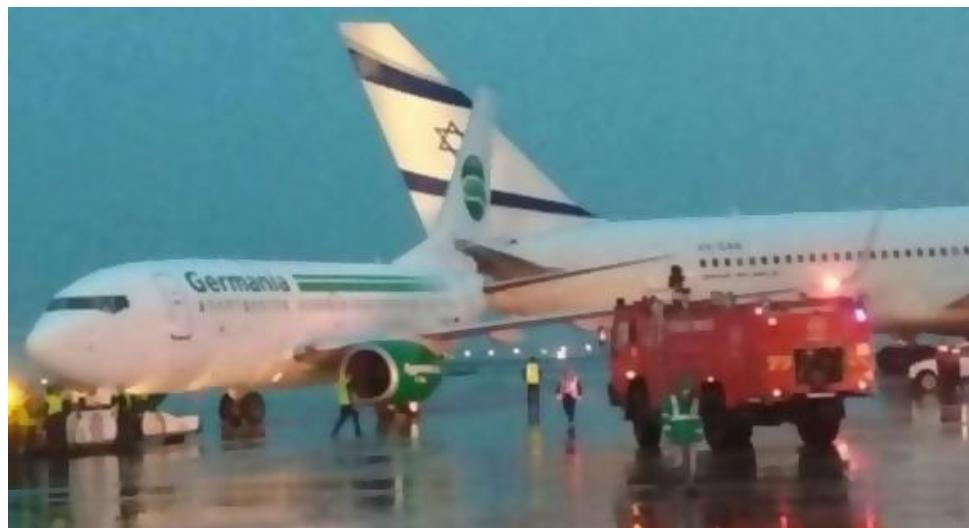
Both aircraft after the accident

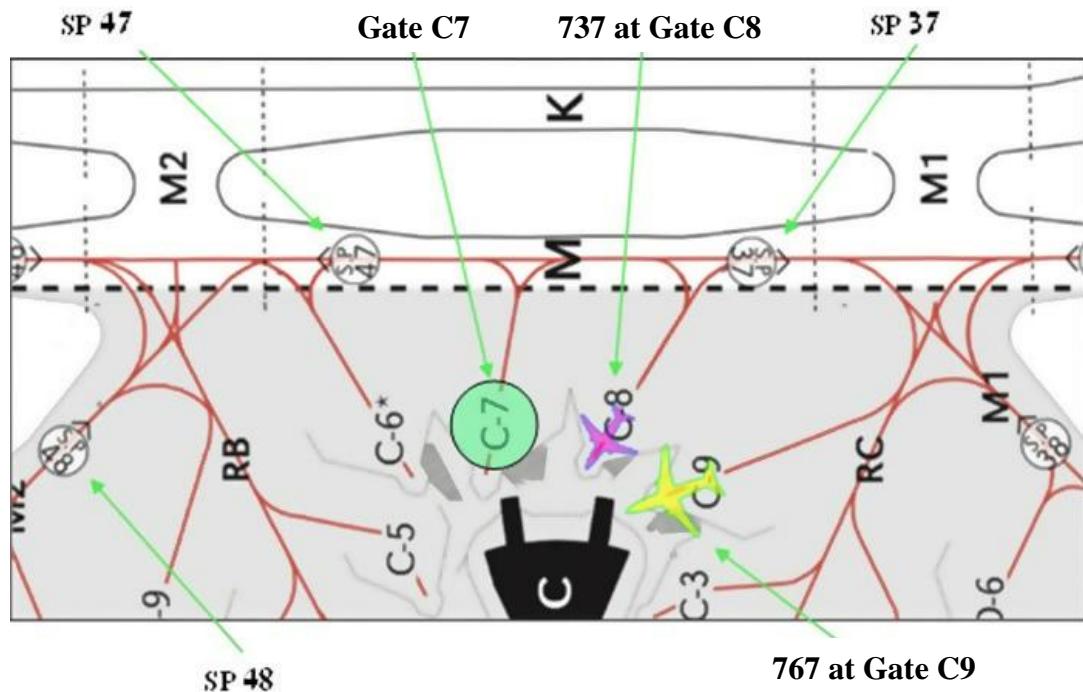
Accident site

The 767 a/c was slowly pushed back along taxiway M and at the same time the 737 a/c was slowly pushed back towards taxiway M in order to line up on it with its tail directed to the east, and subsequently be towed westbound to start-up position 47, facing west.

When the 767 a/c had 14 meters remaining to start-up position 37 the tails collided, and both airplanes stopped with their tails intertwined. The 767 a/c's horizontal stabilizer and elevator penetrated the 737 a/c's vertical stabilizer and rudder.

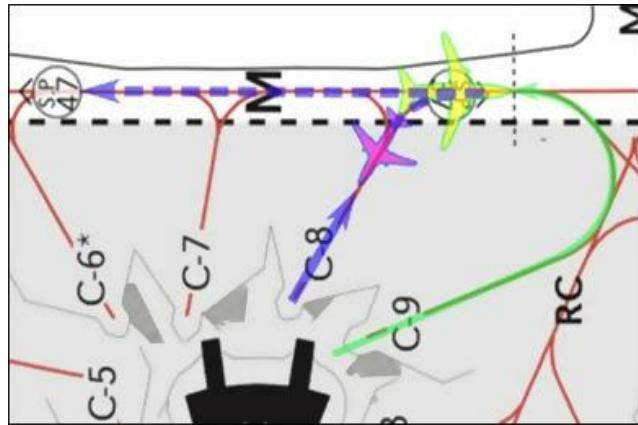
3. Site of tails collision - 767 a/c towards end of pushback and 737 a/c towards starting the turn

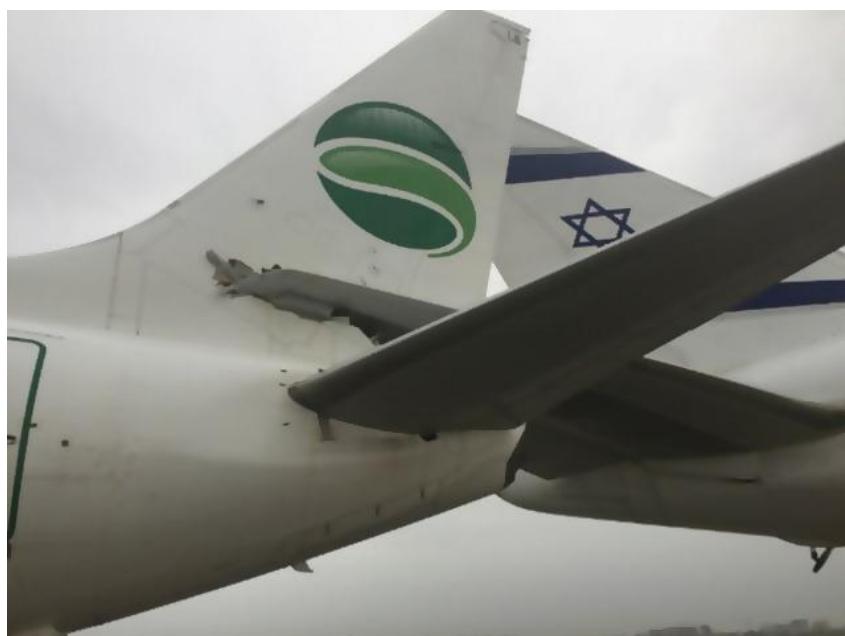
The aircraft were found with their tails intertwined. The 767 a/c's horizontal stabilizer and elevator have penetrated the 737 a/c's vertical stabilizer and rudder. The investigating team did not examine the amount of damage and left it to the companies' engineers Vis a Vis the aircraft manufacturer.

Aircraft tail sections intertwined after the accident

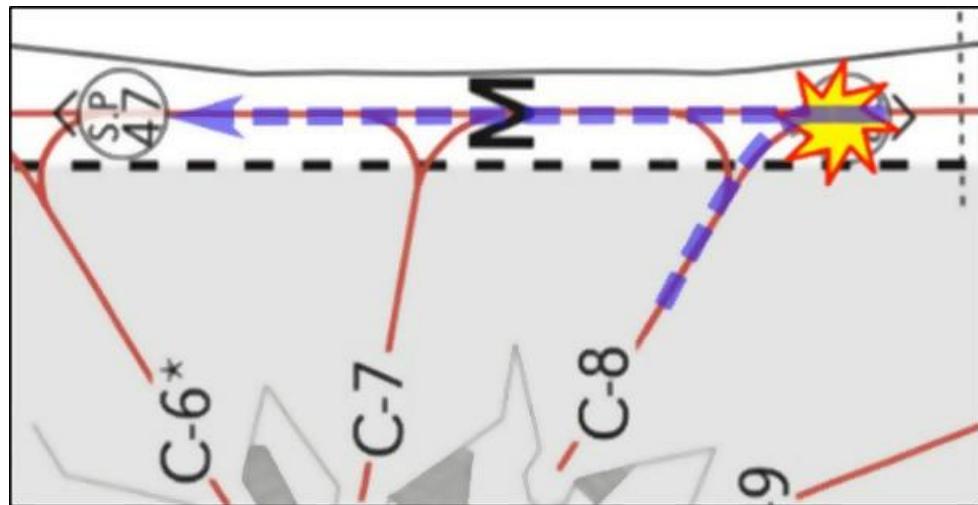
Potential conflict during pushback from C8 to SP47

The illustration demonstrates that when pushing from C8 to SP47 there is a conflict with SP37 if an aircraft is located there, since the tail is intruding SP37 and the aircraft starting at SP37 is blocking the turning point.

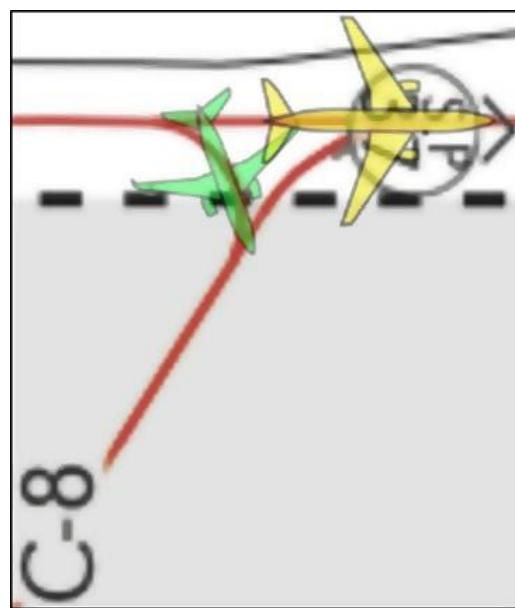
Potential conflict in pushback from C8 to SP48

Pushback to SP48 does not require a heading change, just a turn, but can bring the pushed aircraft to hazardous proximity to the aircraft starting at SP37.

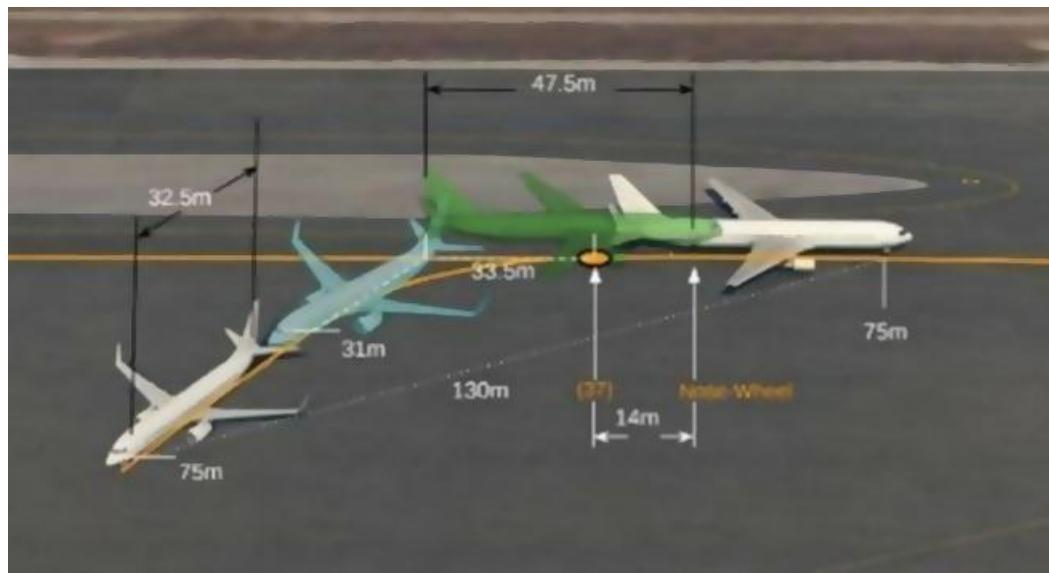
Graphic illustration of the event's final stage

With 14 meters remaining for the B767 a/c to reach the start-up position and stop, and with the 737 a/c about to turn for lining up and its tail penetrating taxiway M, the 737 a/c's tow driver briefly noticed a white silhouette.

The ramp supervisor noticed the other airplane about 2 seconds before the collision but did not fully comprehend it and all he managed to say at the final second was "airplane".
