## UPDATE TO PRELIMINARY REPORT ON ACCIDENT AT TURØY, NEAR BERGEN, NORWAY ON 29 APRIL 2016, INVOLVING AIRBUS HELICOPTERS H225, LN-OJF OPERATED BY CHC HELIKOPTER SERVICE AS

- Type and reg.: Airbus Helicopters H225, LN-OJF

## PRELIMINARY REPORT 1 JUNE 2016

## PRELIMINARY REPORT 28 JUNE 2016

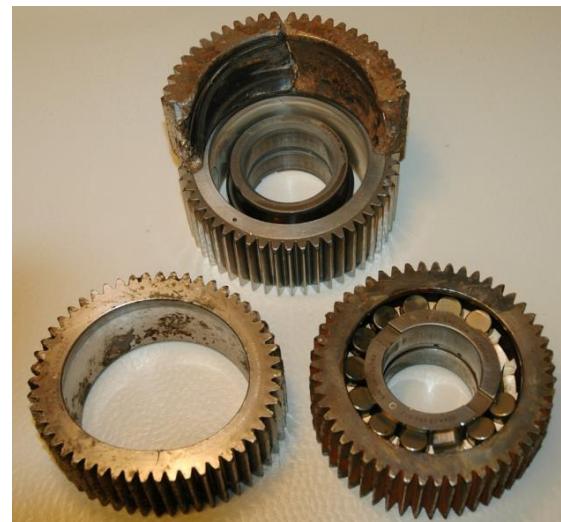
Figure 6: Parts from second stage planet gear.  
(The fractured gear is placed on top of a sample gear that was not involved in the accident.)  
Photo: AIBN

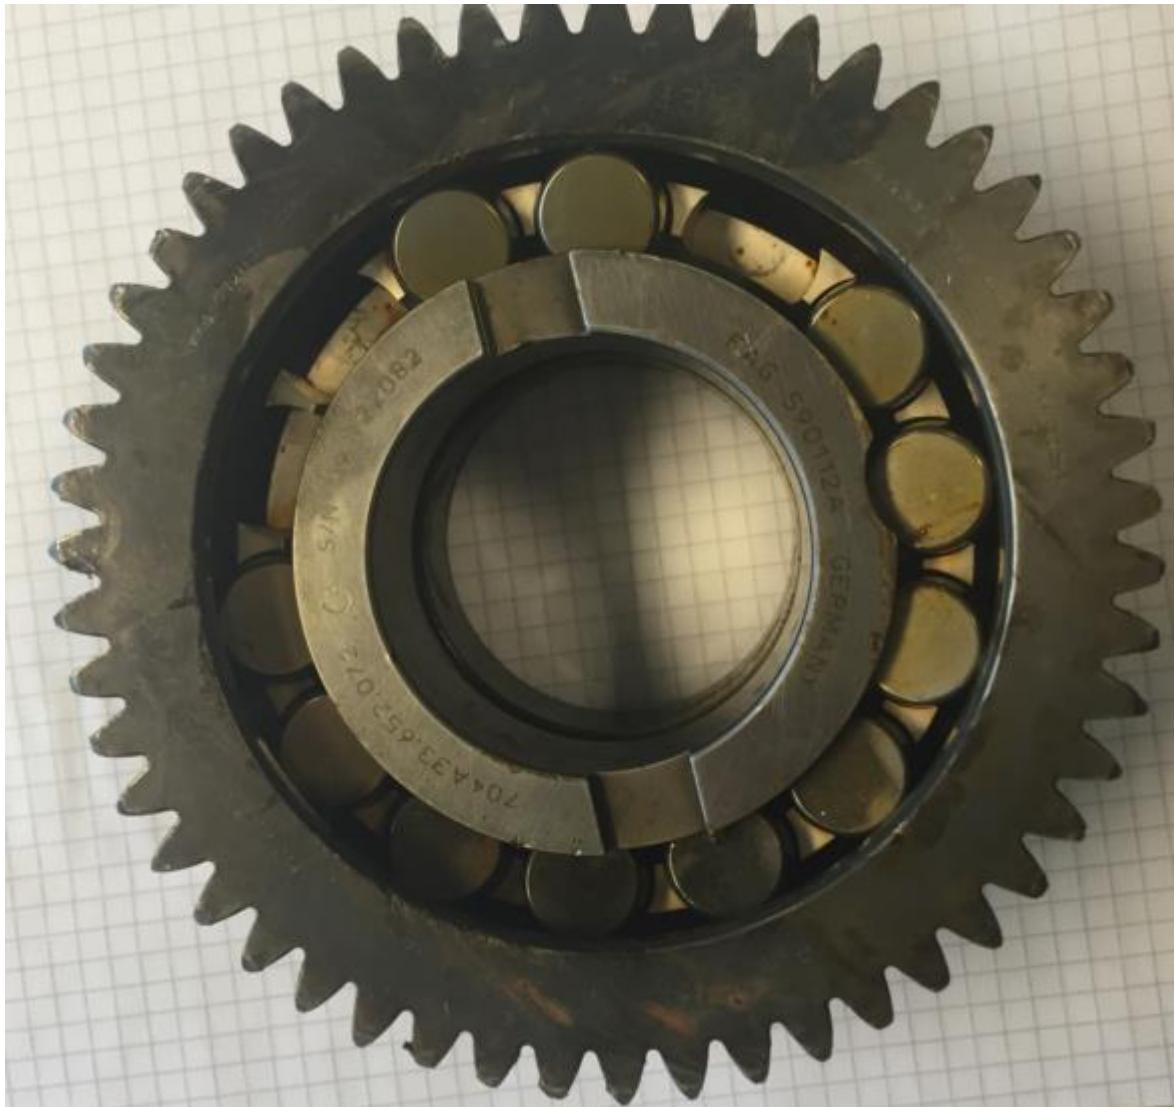
Figure 1: Second stage planet gear (as found with three rollers missing). Photo: AIBN

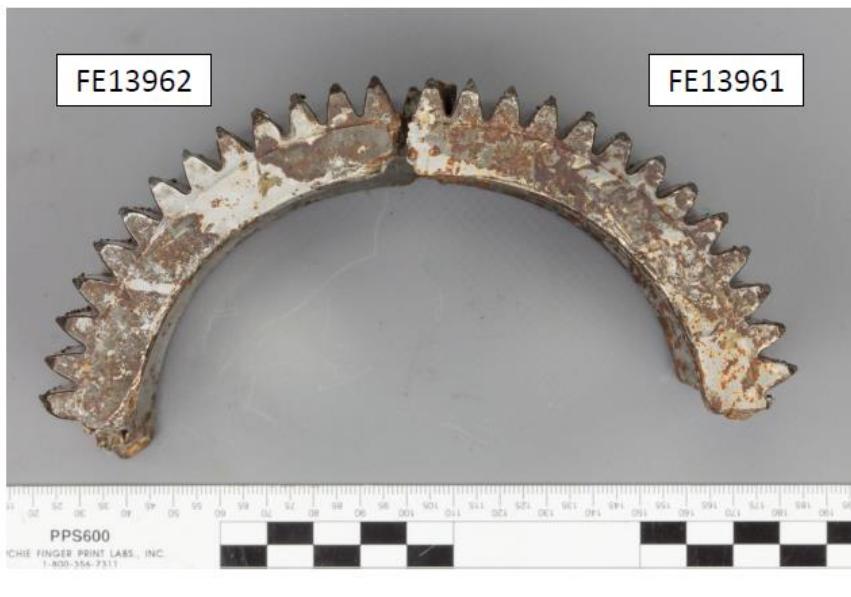
**Fractured 2<sup>nd</sup> Stage Planet Gears  
Samples FE13961 and FE13962**

Among the recovered parts were two pieces which together form approximately half a second stage planet gear (ref. Figure 2). Examinations of these parts have revealed features strongly consistent with fatigue. The fatigue appears to have its origin in the outer race of the bearing (inside of the gear), propagating towards the web of the gear teeth. There is sign of spalling in front of the fracture surface.

*Figure 2: The two pieces of the second stage planet gear prepared for metallurgical examinations.  
Photo: QinetiQ*

Recent metallurgical findings have revealed features strongly consistent with fatigue in the outer race of a second stage planet gear in the epicyclic module of the MGB. It cannot be ruled out that this signifies a possible safety issue that can affect other MGBs of the same type. The nature of the catastrophic failure of the LN-OJF main rotor system indicates that the current means to detect a failure in advance are not effective.

The AIBN therefore recommends that EASA take immediate action to ensure the safety of the Airbus Helicopters H225 Main Gear Box.

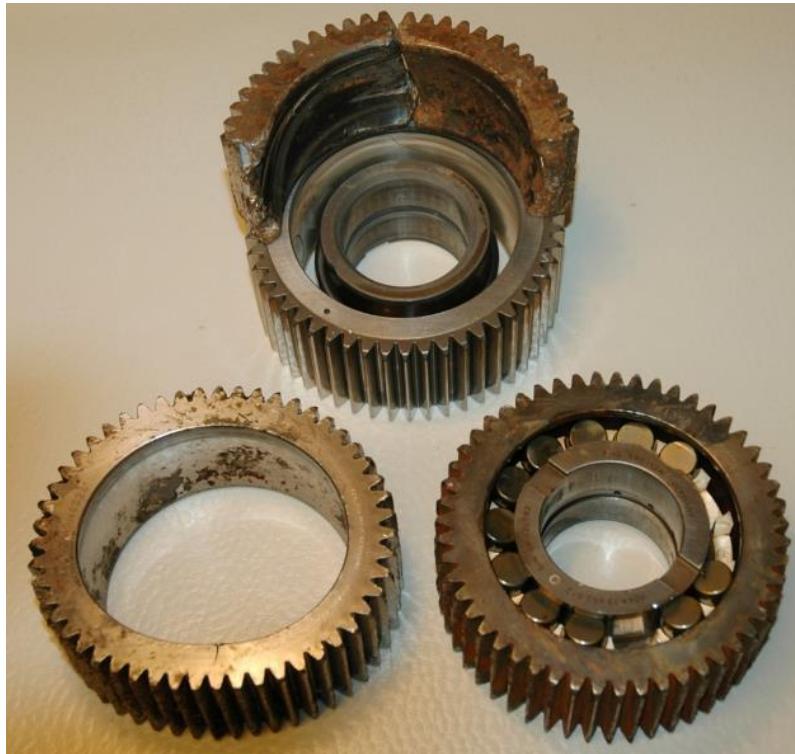
Figure 2: Planet gear parts from second stage epicyclic reduction gear module. (The fractured gear is on top of a sample gear that was not involved in the accident.) Photo: AIBN

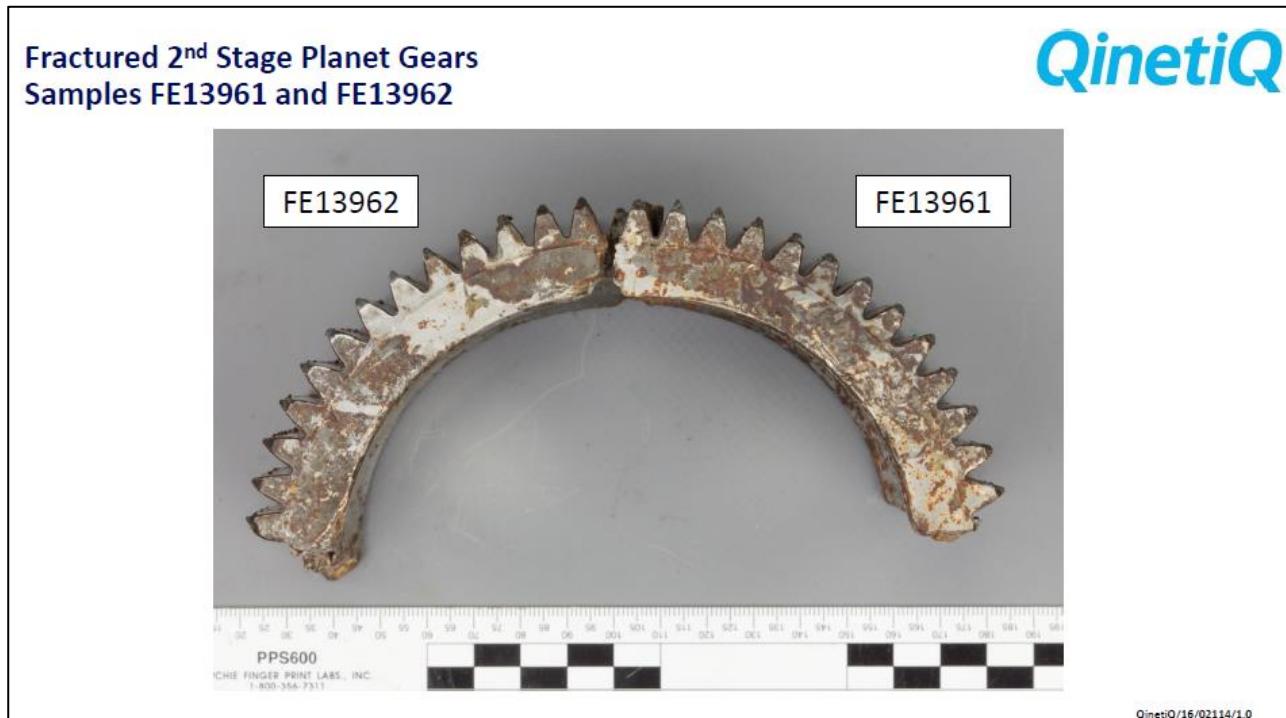
Two pieces of the recovered parts have been of particular interest. Together they make up approximately half of a second stage planet gear P/N 332A32.3335.07, S/N 10-1292 (ref. Figure 4). Examinations of these parts show that one of the fracture surfaces can be described as being close to 100% fatigue (ref. Figure 5).

Figure 4: The two pieces of the second stage planet gear prepared for metallurgical examinations. The fracture surface with fatigue is to the right in the figure. Photo: QinetiQ

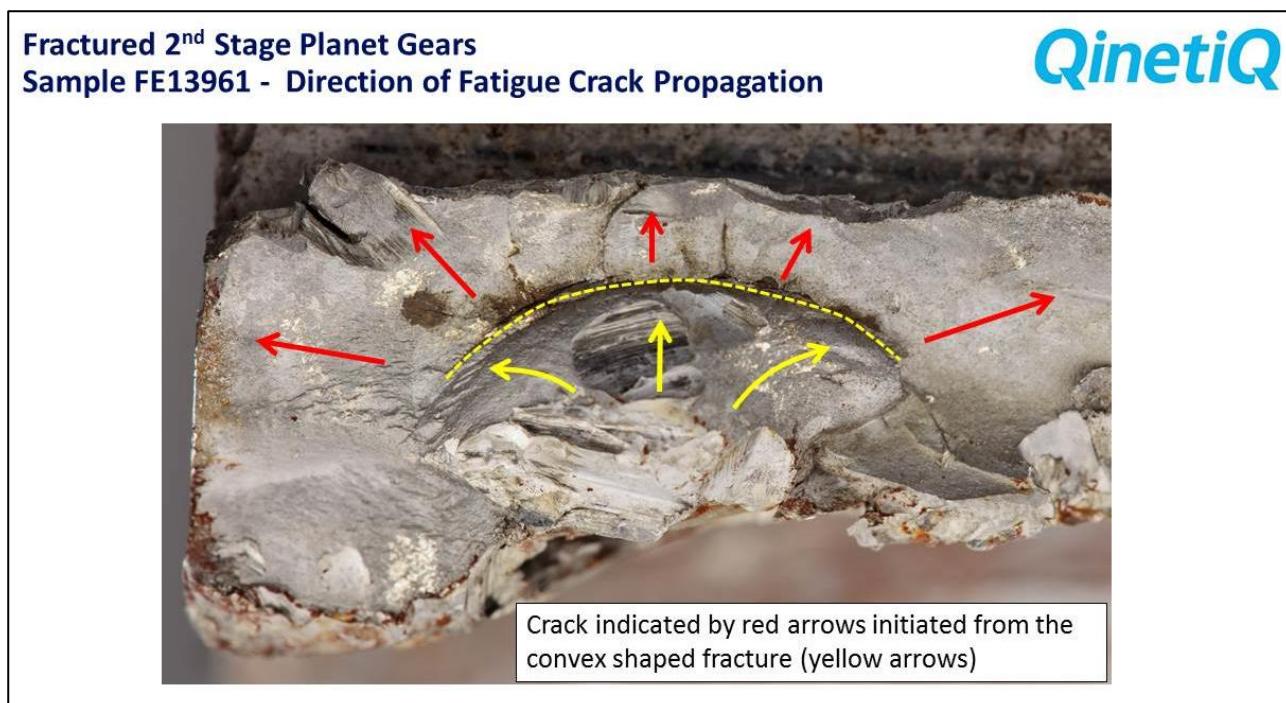
Figure 5: Close-up of the fracture surface initiated on the inner surface (outer race). Multiple cracks propagating from major crack around convex fracture surface. Photo: QinetiQ

The fatigue appears to have its origin in the outer race of the bearing (inside of the gear), propagating towards the web of the gear teeth. In order to examine the fatigued part before performing any destructive testing, the piece was inspected using x-ray computed tomography (CT)

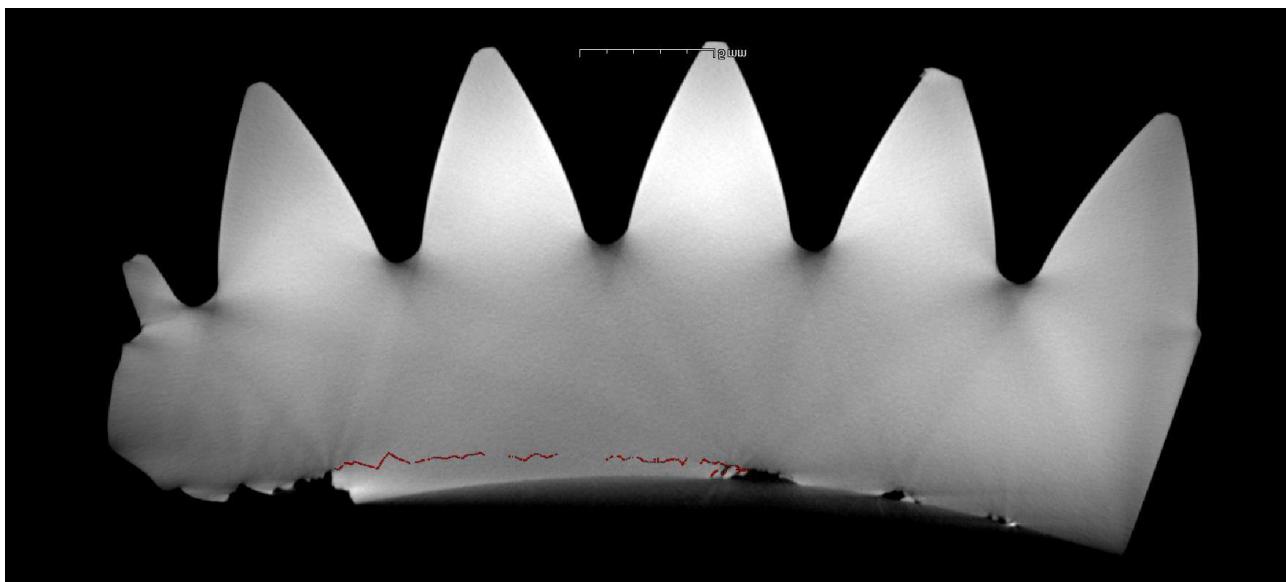
scans. The scans showed several cracks below the surface of the outer race. One crack runs below the surface between areas of surface damage (spalling) (ref. Figure 6).

Figure 6: An example from the CT scan showing a subsurface crack propagating from the right hand spalling all the way to the left. The red colour is a frame-by-frame mapping performed by hand to highlight the crack. Photo: University of Southampton
