AIRCRAFT ACCIDENT REPORT 1/2023

Report on the accident to
Leonardo AW169, G-VSKP
at King Power Stadium, Leicester
on 27 October 2018

Air Accidents Investigation Branch

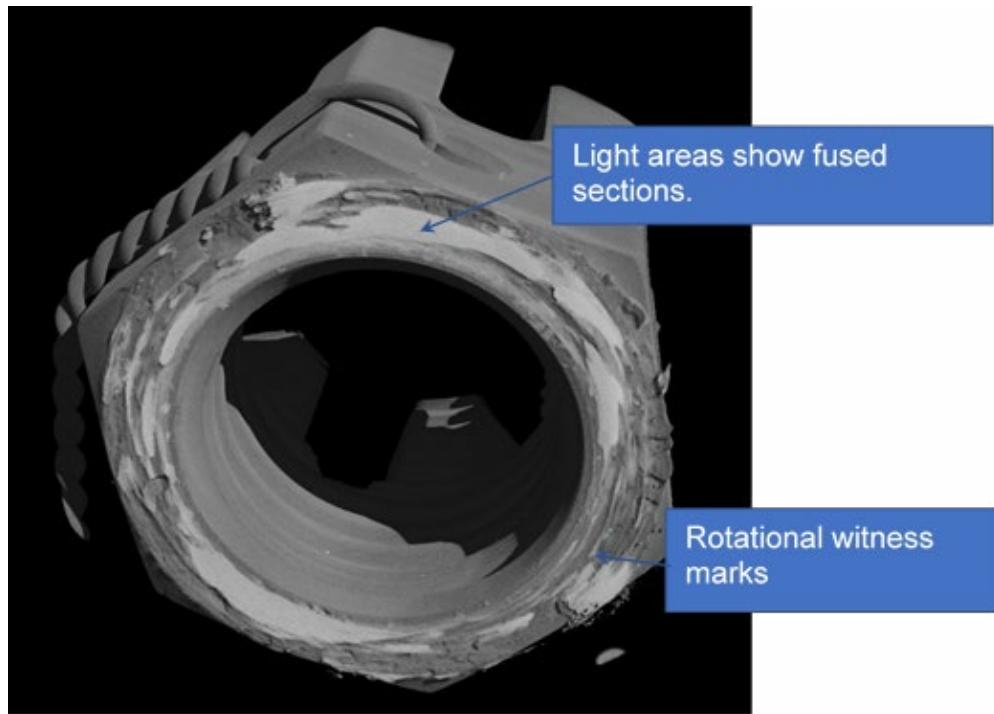
Figure 26
Virtual cut through join between the nut and pin carrier

Use of a stereo microscope to view the component, identified wear debris between the nut and the pin carrier and deformation of the nut consistent with softening of the material. The inspection also confirmed the presence of an impression mark on the edge of one of the castellations on the nut, consistent with the size and shape of a split pin. The pin carrier and nut were then scanned using an X-ray Computed Tomography (CT) Scanner based at the facilities of μ -VIS X-ray Imaging Centre at the University of Southampton. This passes X-rays through components from different angles to produce multiple cross-sectional images, which are then combined as a 3-D model. The model allowed the interface between the two components to be 'virtually sectioned'. This confirmed areas of fusion and evidence of rotation (Figure 26).

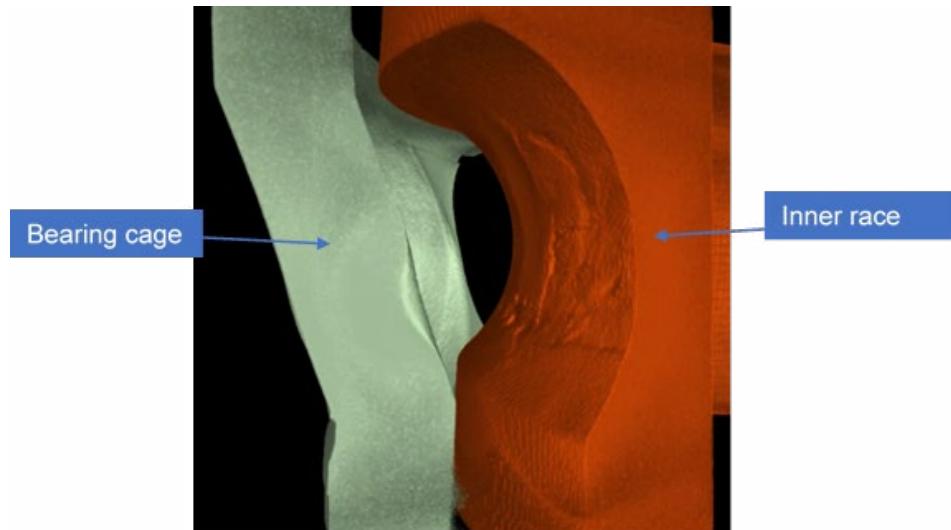
Figure 31
CT imagery of duplex bearing inboard inner ring surface damage

51 The misalignment of the inboard inner race was an unavoidable consequence of the extraction process from the wreckage.

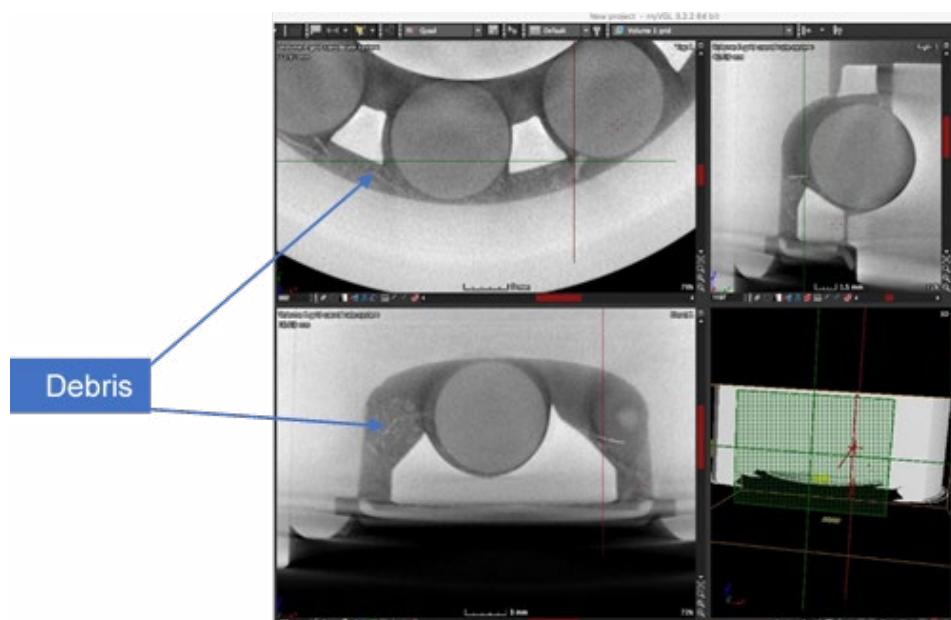
Figure 32
Scan images of duplex bearing showing debris accumulation

The scan also showed evidence of debris accumulating in the bearing raceways (Figure 32).

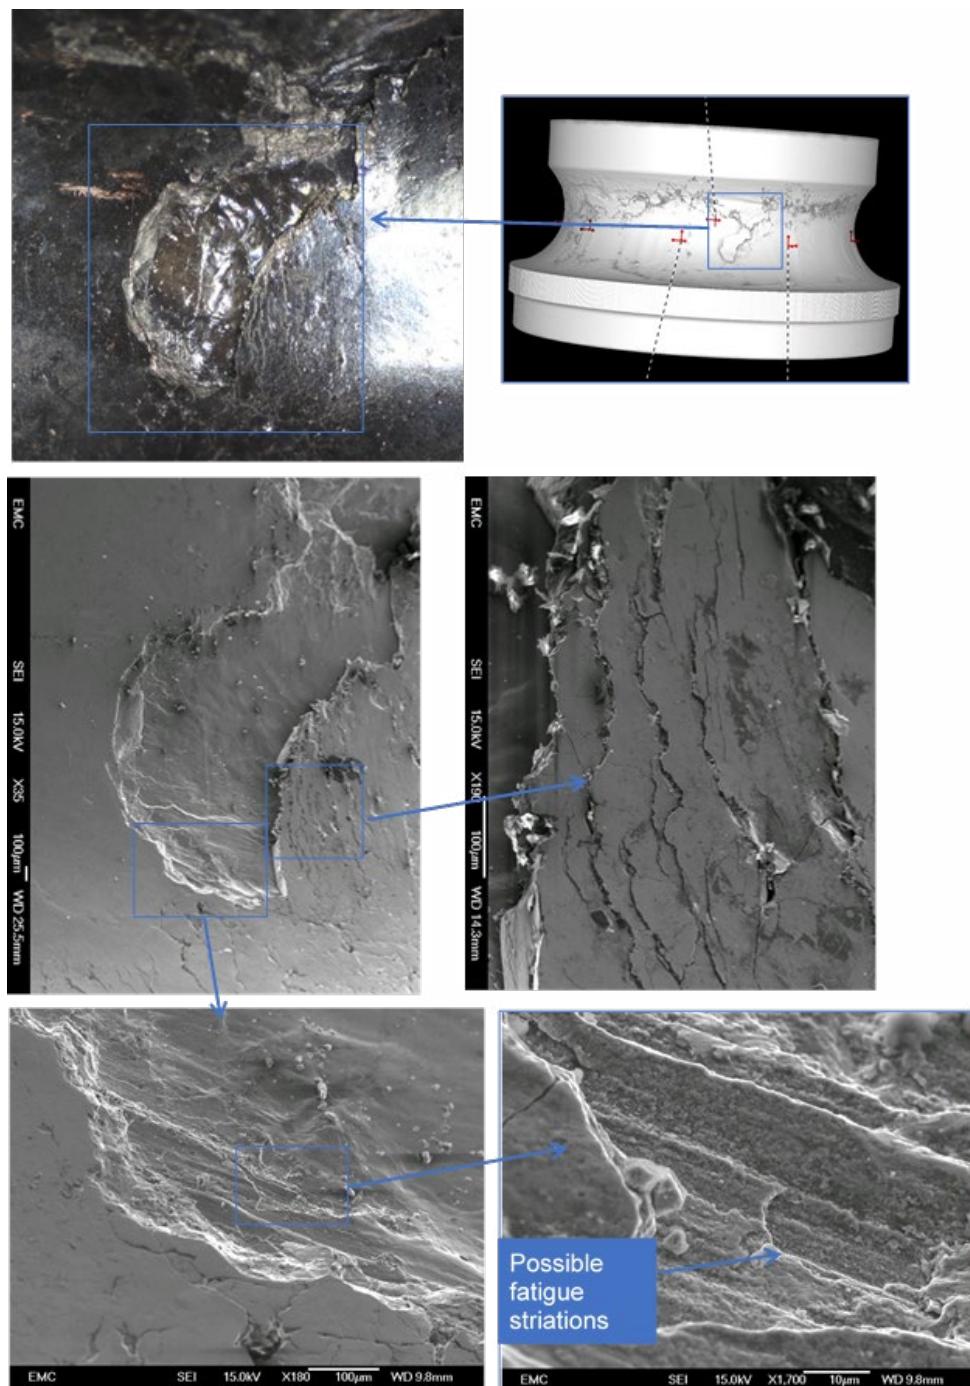
Figure 35

SEM images showing the large pit with fatigue and secondary cracking

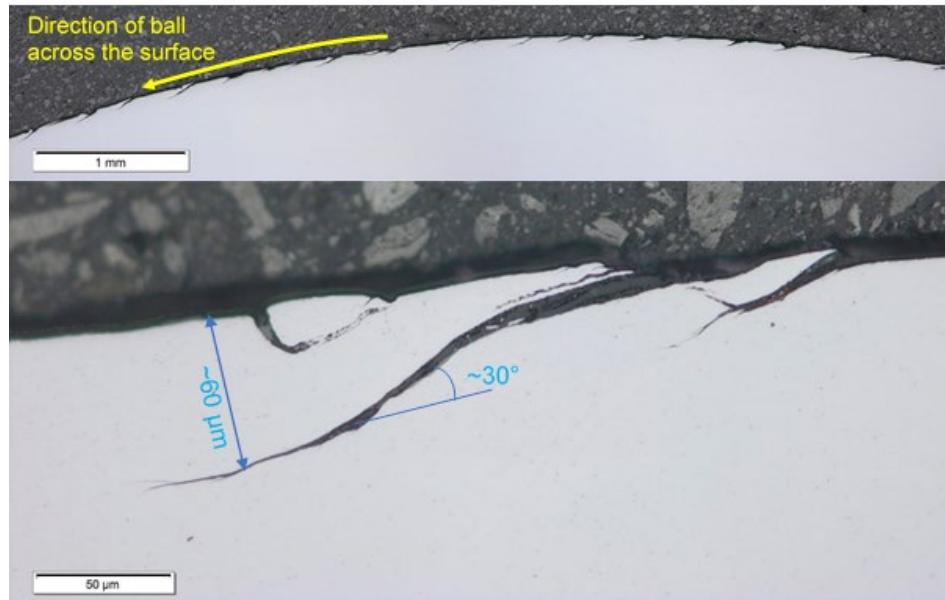
Figure 36

The outboard row inner race was typified by repeating inclined cracks. The cracks had a depth and angle typical of a rolling contact fatigue damage mechanism and had initiated from the surface, with material released at the initiation point of the cracks. (Figure 36).

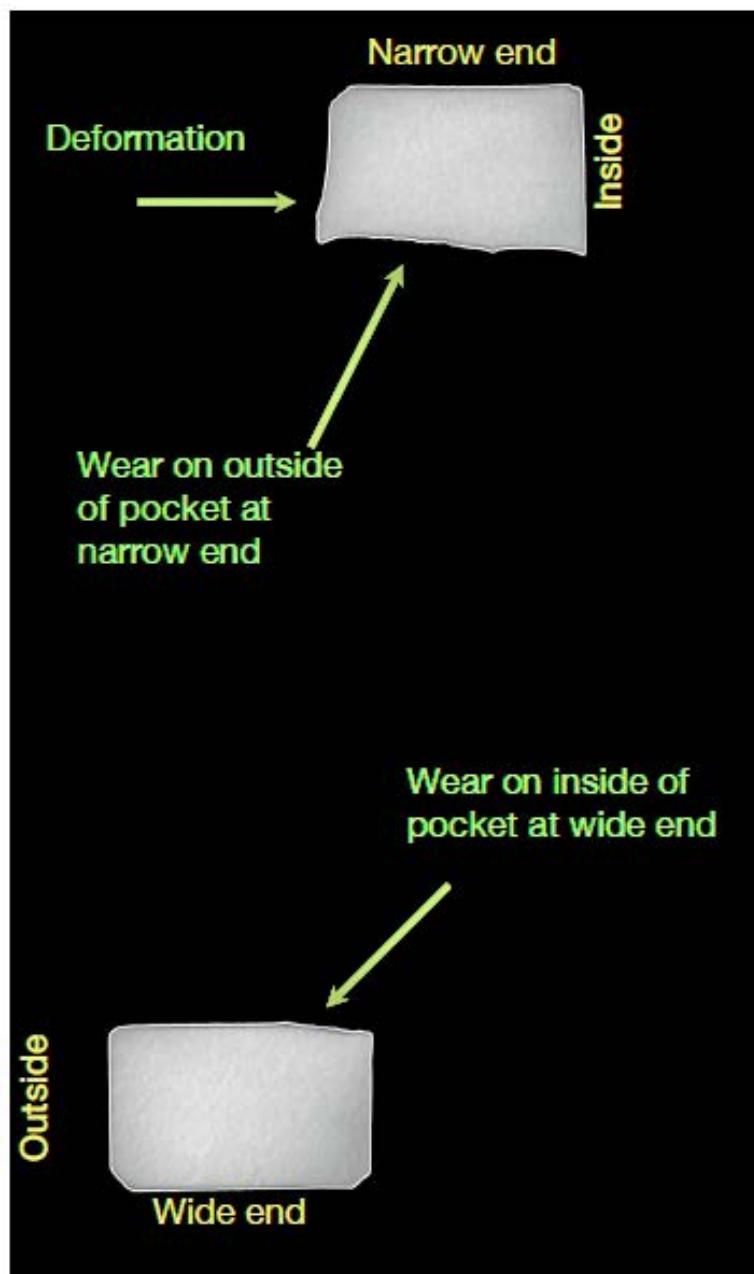
Figure 41

cages (Figure 41 and 42), but also a wear lip on the inner running surface of the wide end of the cages (Figure 43). On the inboard cage there was also a wear scar on the outside of the narrow end of the cage (Figure 44).

CT scan cross section of pocket on inboard cage showing wear on the top and bottom surfaces

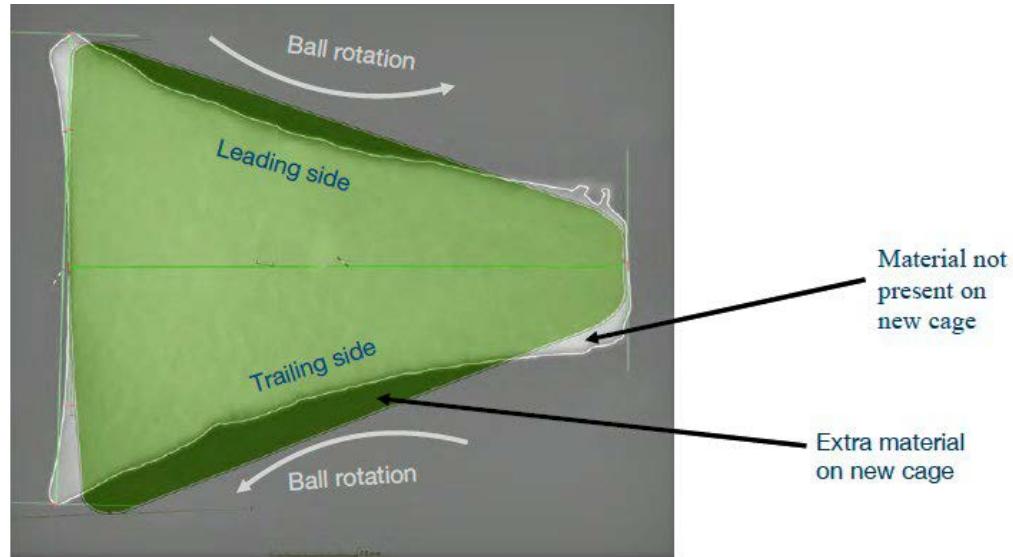
Figure 42

Material removal and displacement relative to a new cage (shown in green) on the cage section between ball pockets

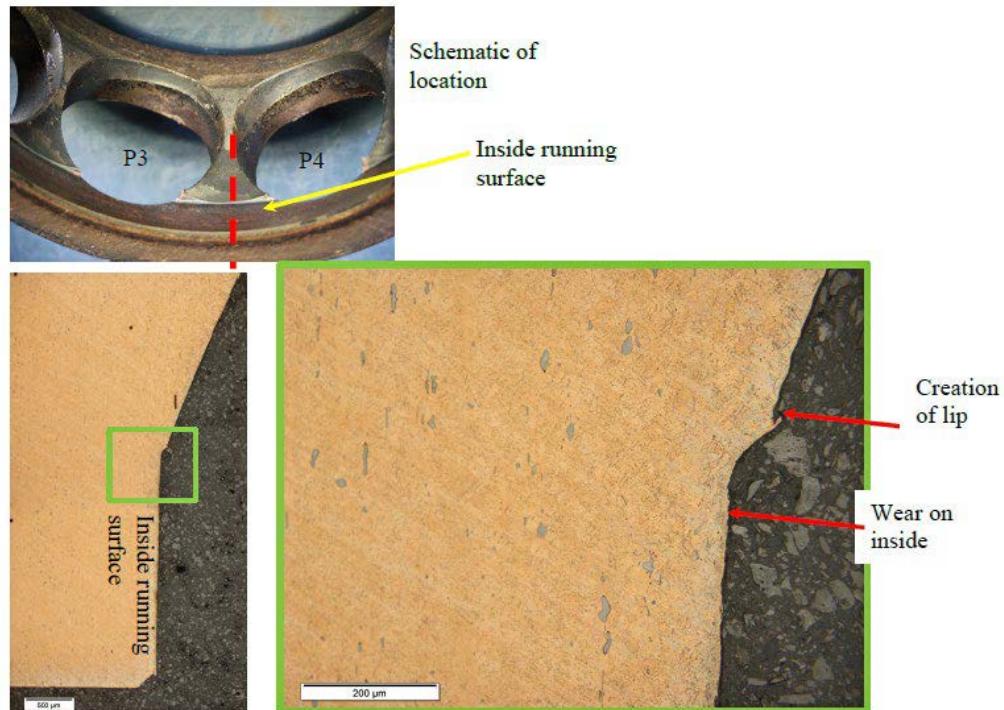
Figure 43

Optical and SEM images of wear on the inside of the wide end of the outboard cage

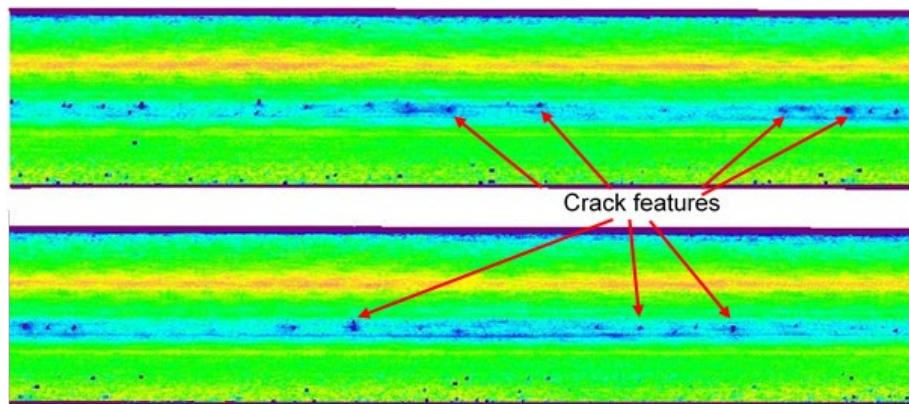
Figure 46

The races were then scanned using the non-contact optical scanning technique (RedLux OmniLux). This allowed the identification of raised features in the worn running path on the inboard inner race (Figure 46).

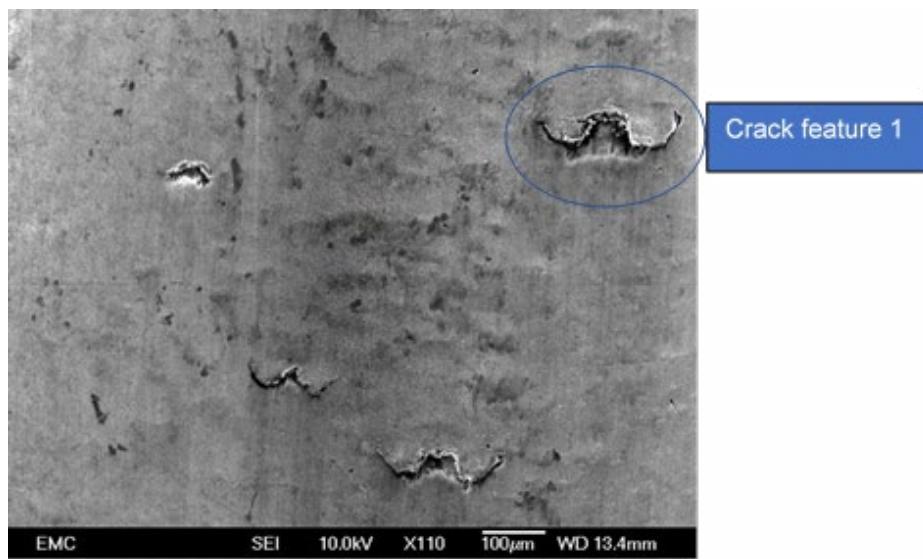
Figure 47

SEM image of inboard inner race showing variation in crack sizes

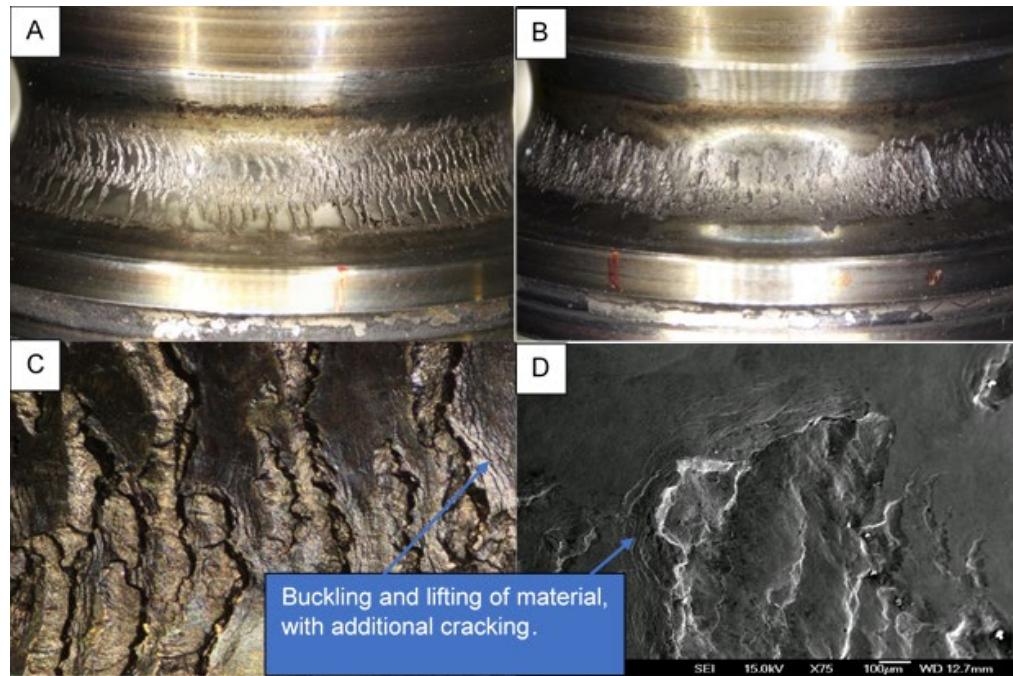
Figure 51

Initial inspection showed burnt grease residue and heavy damage to both the inner races. Two balls from the outboard race exhibited spalling damage, with the other balls showing evidence of crazing. The cage from the inboard row was cracked completely through in one location and partially cracked in another. There was also wear in various ball pockets from contact with the balls. The bearing components were CT scanned and cleaned, before being inspected by optical macroscope (Figure 51).

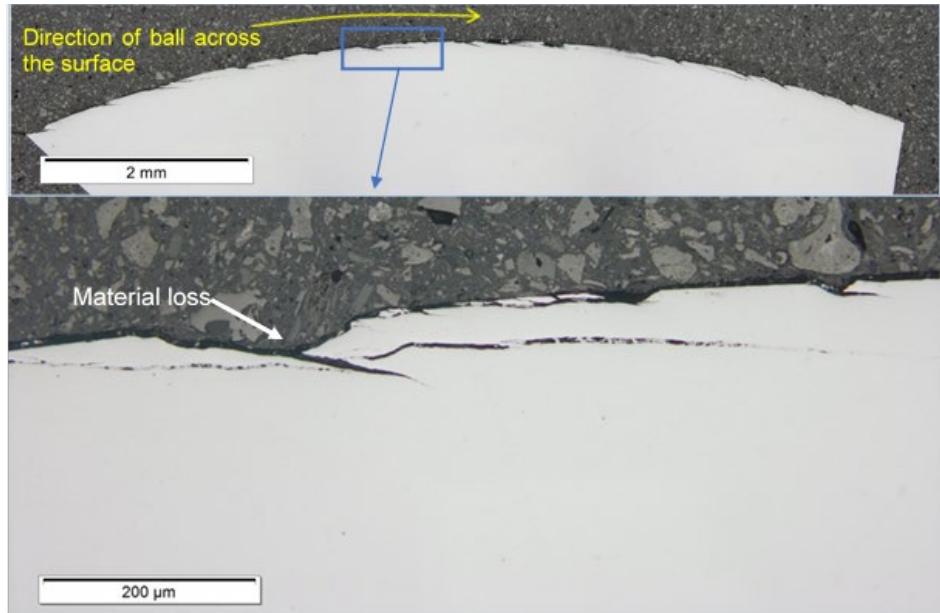
**Figure 52**

Microscope view of circumferential section from inboard inner race showing angled, surface initiated cracking with material loss

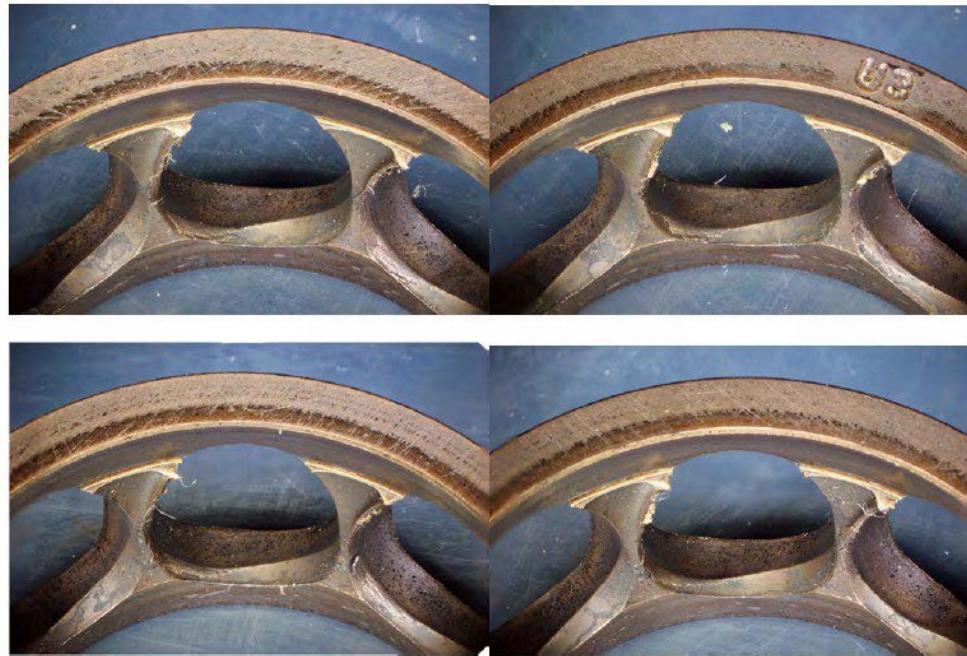
Figure 54

The inboard cage had two fractures in pockets on the narrow end and one on the wide end, but remained in one piece. Both the cages from this bearing had a wear lip on the inside surface of the wide end of the cage (Figure 54).

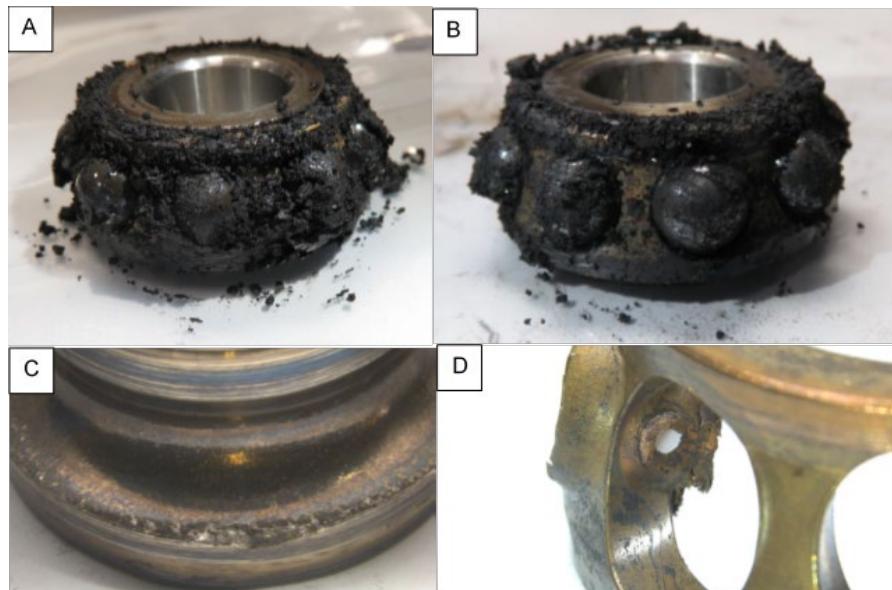
**Figure 55**

When the bearing was opened, it was found to have significant damage over the whole running surface of the bearing on the inboard row, inner and outer races (Figure 55). Material had been displaced from a wear path the same radius as the radius of the balls and pushed up above the shoulder of the race (Figure 56).

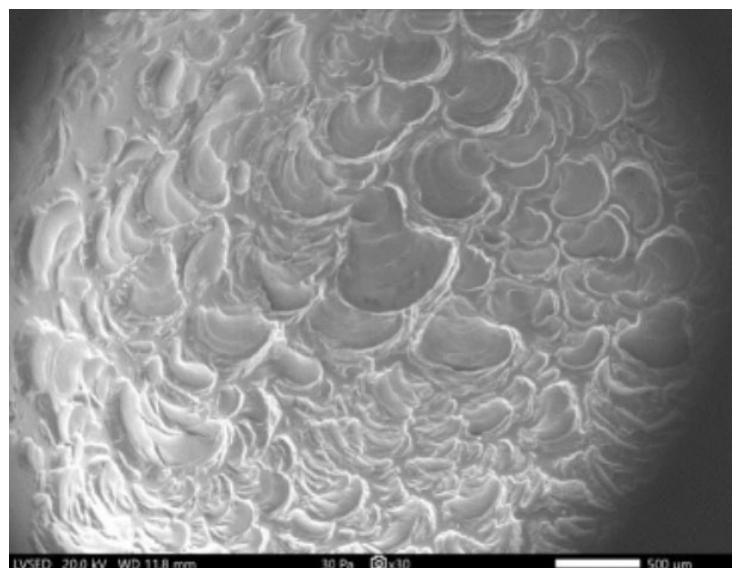
The ball had spalled over 50% of its surface area. The bearing manufacturer's report stated that although the estimated initiation point of the spalling was identified, the cause could not be determined (Figure 57). The helicopter manufacturer's laboratory investigation report stated that a 3D particle was identified embedded in the spalled area of the ball. EDAX analysis of the particle suggested it was iron oxide, which the report identified was used as an additive during the sintering⁵⁸ and/or hipping⁵⁹ process. The bearing manufacturer refuted this, stating that iron oxide is not used in either of these processes and that the material was likely adhered debris rather than an inclusion. The helicopter manufacturer's report stated the particle was 'embedded' with ball material partially covering it. They considered it likely that this particle was originally below the surface of the ball material.

Figure 57
Magnified view of the spalling on the surface of the ball

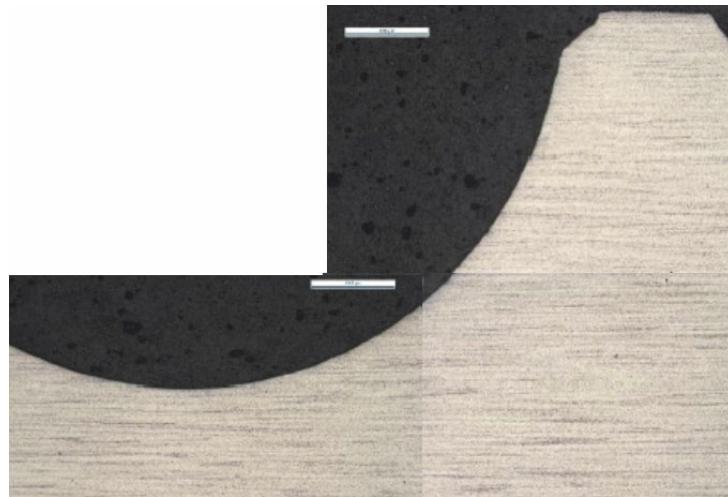
Figure 58

Inboard inner race radial section with no evidence of DER

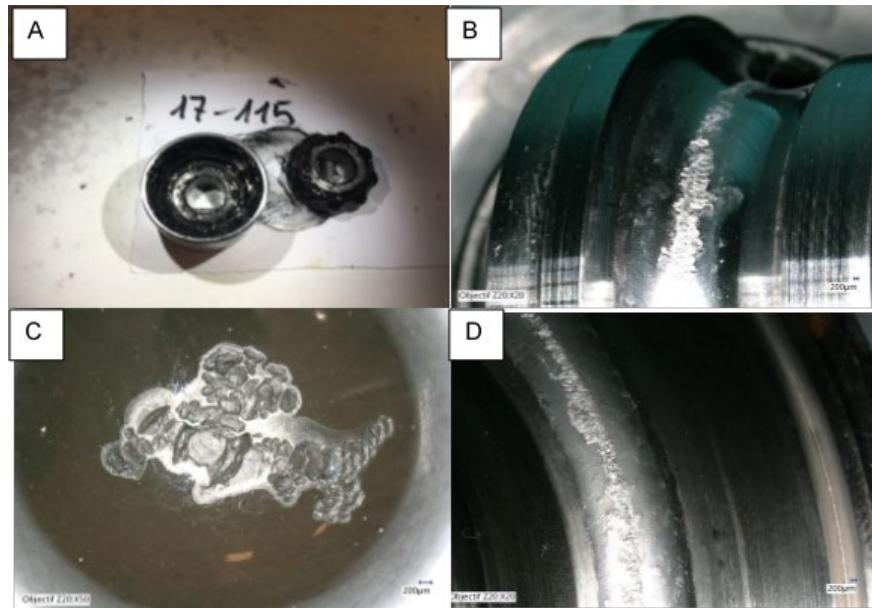
Figure 60

The inner and outer race on one side of the bearing was found to be damaged with significant spalling and material loss on both the races and on one of the balls (Figure 60).

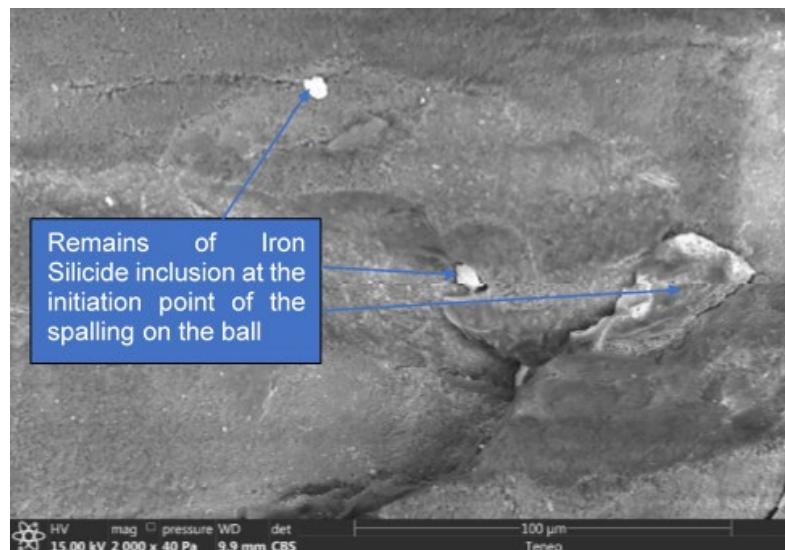
Forensic investigation by the bearing manufacturer confirmed that the ball had spalled due to a large iron silicide inclusion in the ceramic material (Figure 61).

Figure 61
Remains of inclusion on the spalled ball

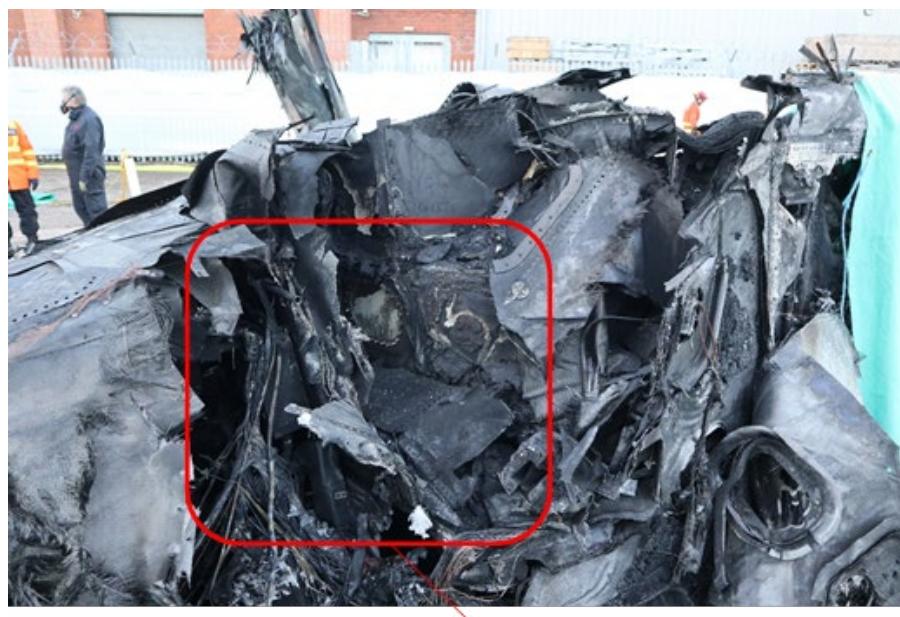
Damage observed to the lower fuselage of the helicopter showed evidence of buckling and failure in the region directly below the main fuel tanks. It was consistent with this section of the fuselage striking the raised step on the accident site. Examination of the damage showed evidence that parts of the fuselage structure had been driven into the fuel tank structure as a result of impact forces (Figure 63).

Figure 63
Lower fuselage and fuel tank damage

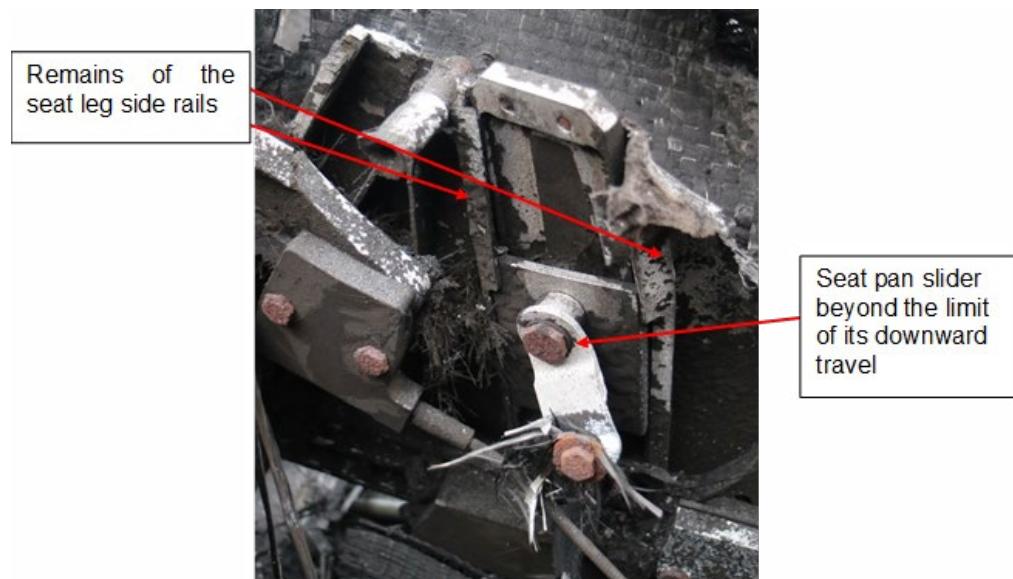
Figure 64

After recovery of the helicopter to the AAIB, an examination of the helicopter's cabin was carried out to locate the cockpit and passenger seat impact absorption features and to determine if they had operated correctly during the accident. Due to the damage caused by the post-impact fire it was not possible to identify specific components of the two cockpit seats. The four rearward facing seats in the passenger cabin had been extensively damaged, but the lower sections of the seats remained in-situ. The level of damage to the seats did not allow reference to the stroke index marks to determine if the seat impact absorption systems had operated. However, examination of the position of the seat pan sliders within the seat leg rails, confirmed that the impact absorption system of the two outboard seats had operated and seat pan slides had exceeded the limit of their downward travel (Figure 64).

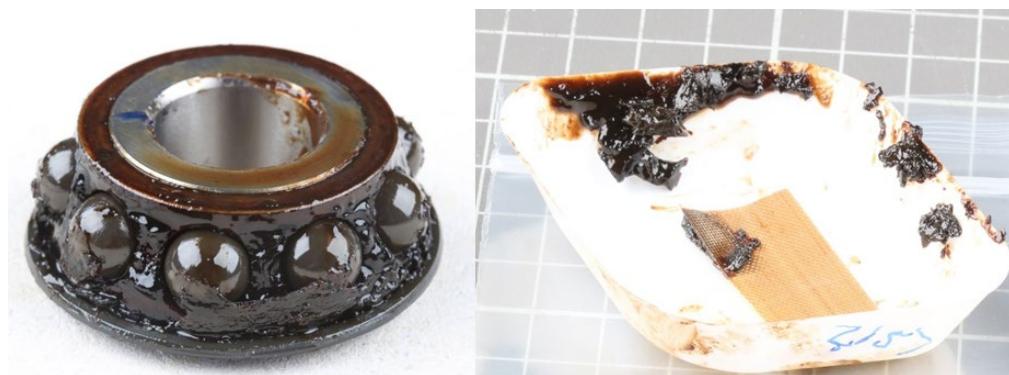
Figure 65

The grease was found to be black in colour, with some separation of the oil and the matrix. It had also become sticky and lumpy in consistency, indicating a change of condition due to ageing (Figure 65).

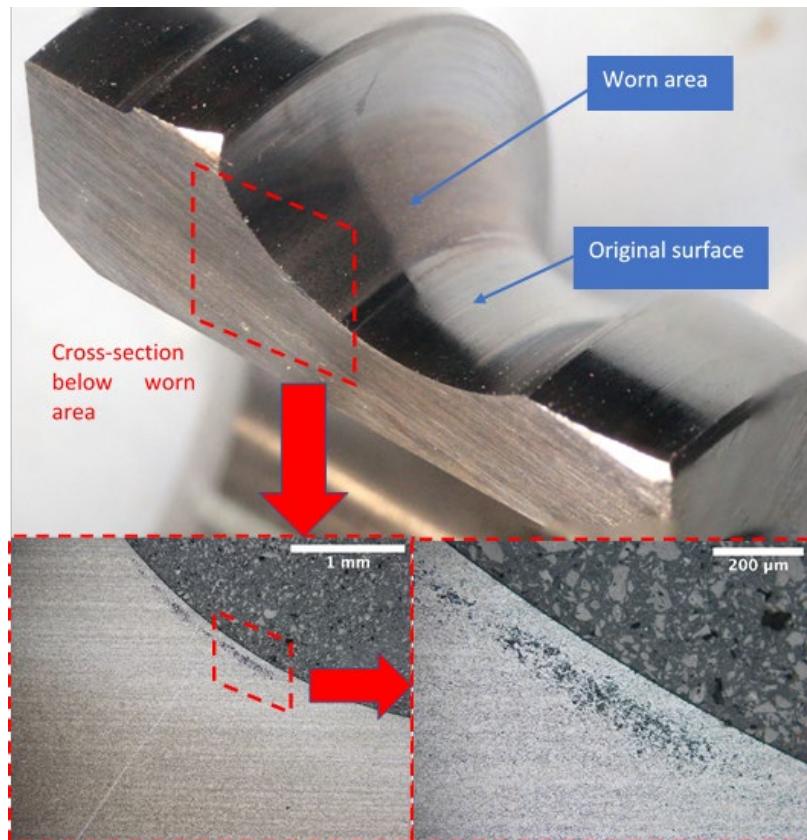
Figure 67

material properties change on any of the races. The inboard race of the loaded side of the bearing did, however, exhibit a DER below the race surface, where the wear line showed the balls had been running (Figure 67).

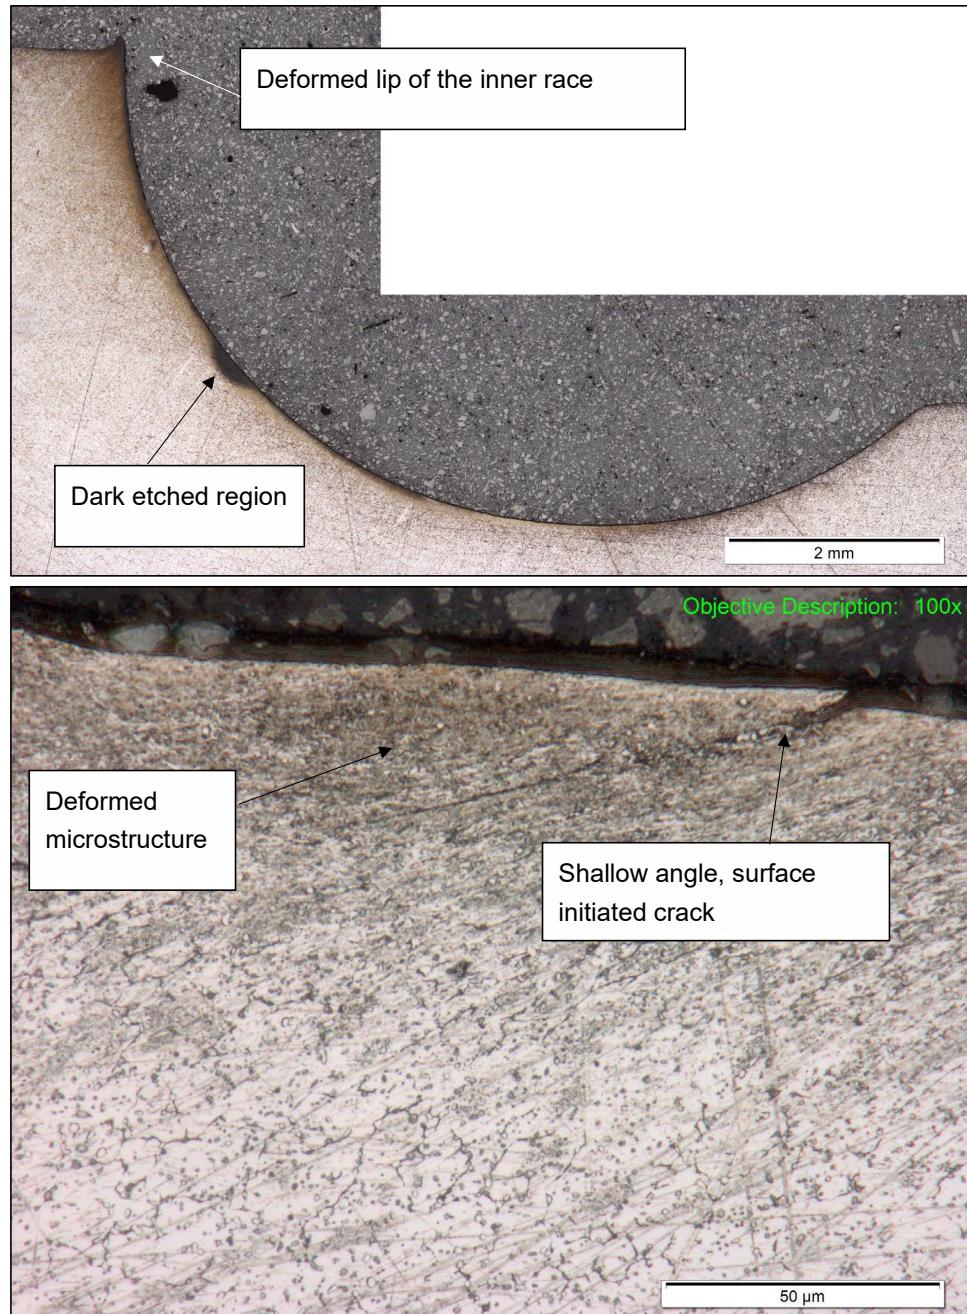
Figure 80
Outboard inner race radial section showing DER and circumferential section showing surface initiated crack
