Aviation Investigation Final Report

Location:	Boston, Massachusetts	Incident Number:	DCA23LA192
Date & Time:	February 27, 2023, 18:54 Local	Registration:	N280LJ (A1); N179JB (A2)
Aircraft:	LEARJET INC 60 (A1); Embraer ERJ 190-100 IGW (A2)	Aircraft Damage:	None (A1); None (A2)
Defining Event:	Runway incursion veh/AC/person	Injuries:	N/A (A1); N/A (A2)
Flight Conducted Under:	Part 91: General aviation - Positioning (A1); Part 121: Air carrier - Scheduled (A2)

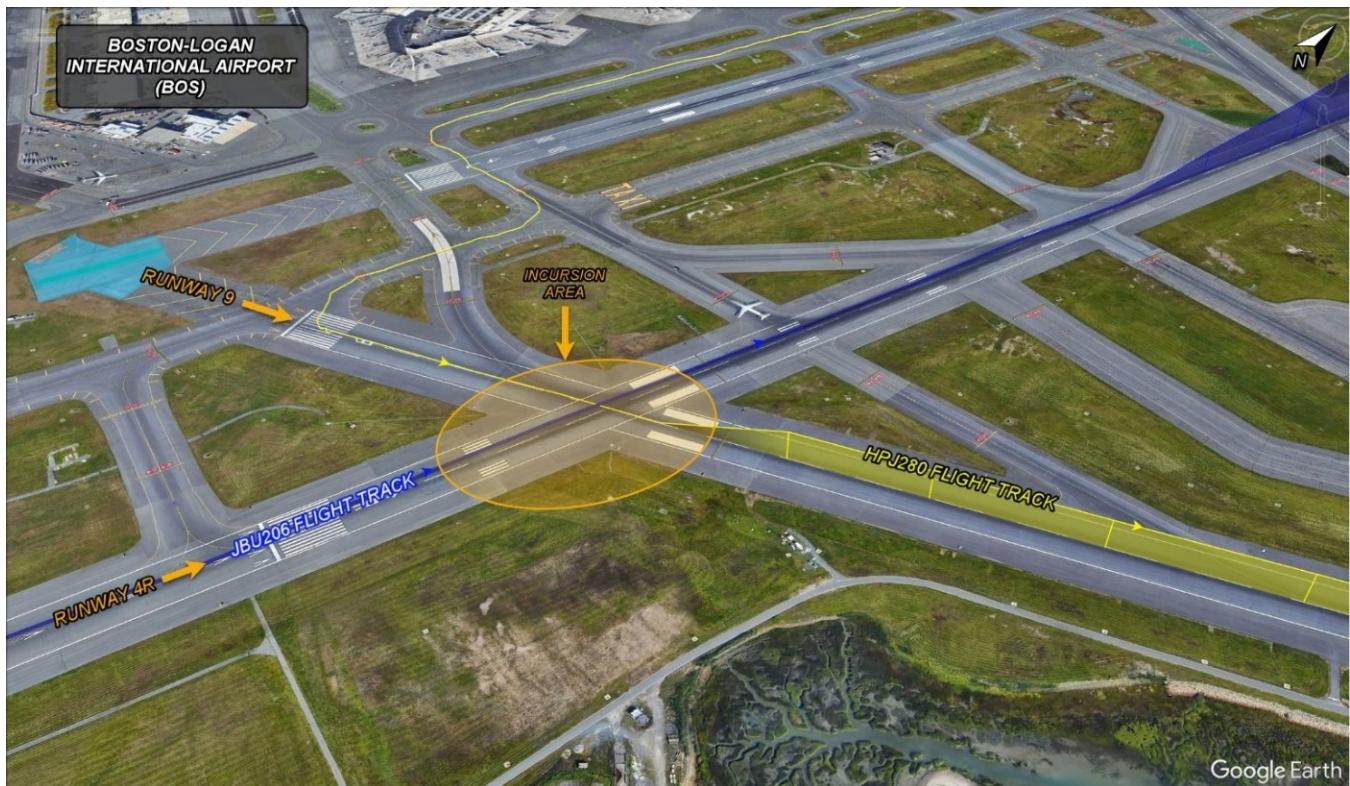
JBU206's flight crew initiated a go-around while over runway 04R, prior to reaching the intersection with runway 09. The closest proximity between both airplanes occurred when JBU206 was about 30ft AGL during the landing flare, close to the point where both runways intersected, see figure 1. A video file taken by the occupant of the flight deck observer seat was provided to the NTSB and a screen capture from the video is shown in figure 2.

Figure 1. Flight tracks of both JetBlue (JBU206) and Hop-a-Jet (HPJ280) with yellow circle indicating incursion area.

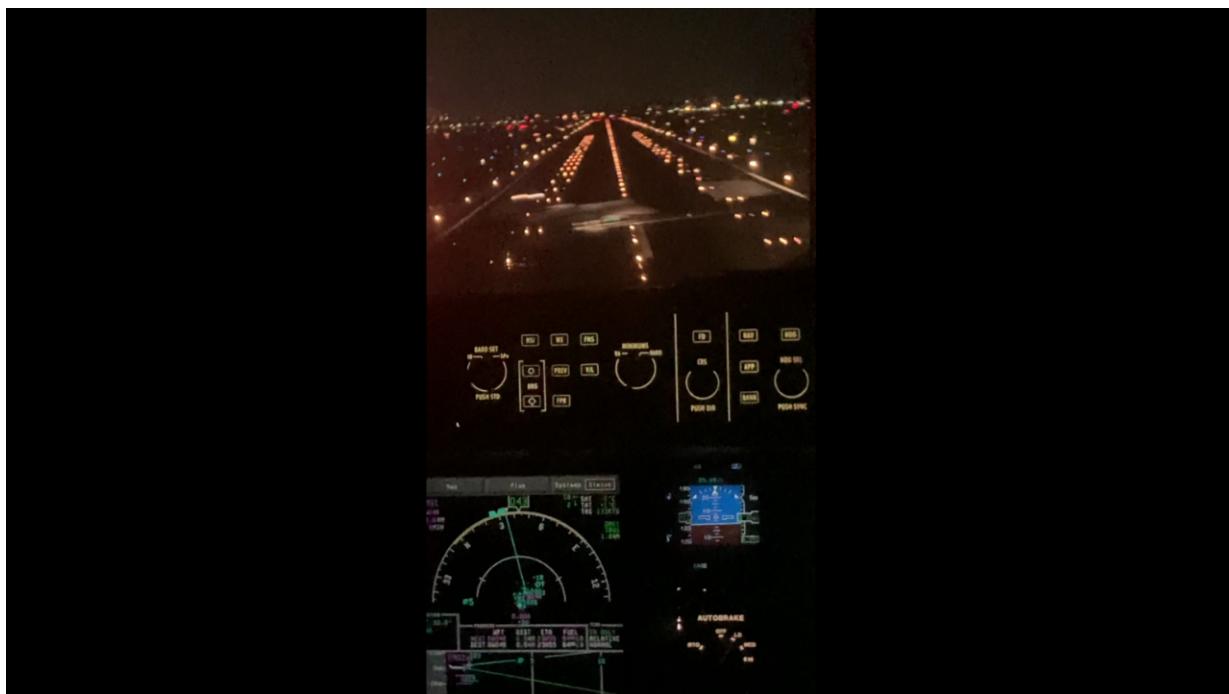
Figure 2: Screen capture from jump-seat occupant's video recording showing Lear 60 crossing runway centerline.
