Aviation Investigation Final Report

| Location: | Tulsa, Oklahoma | Incident Number: | DCA22LA126 |
| Date & Time: | June 8, 2022, 04:15 Local | Registration: | N949FD |
| Aircraft: | Boeing 757-236 | Aircraft Damage: | None |

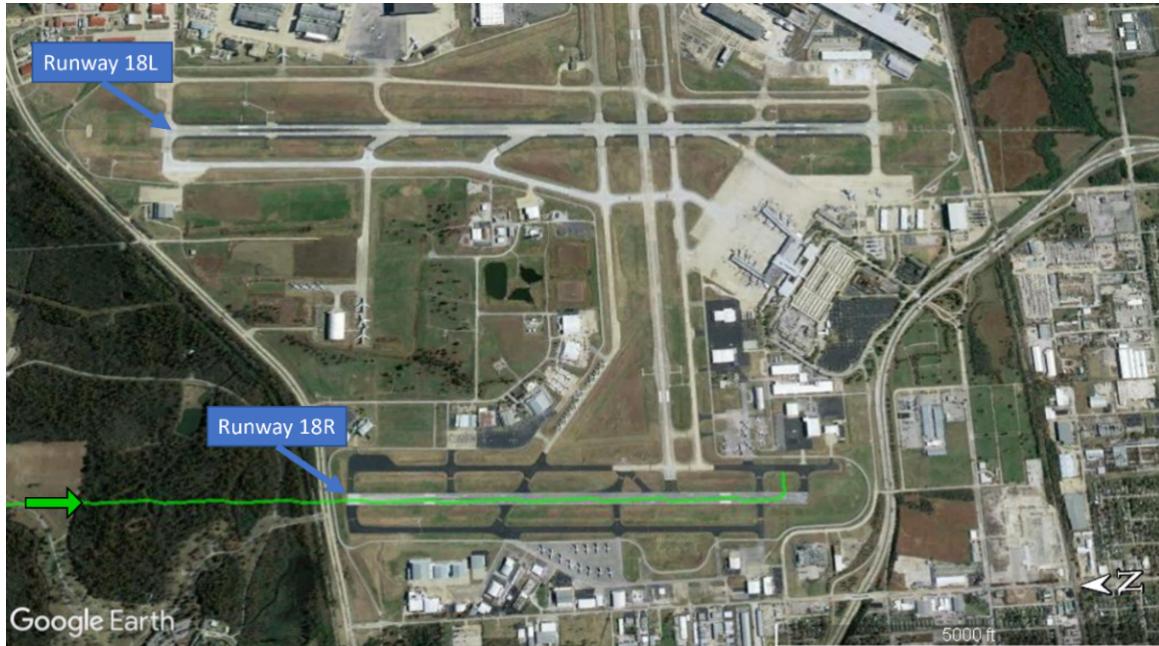
As the Federal Express (FedEx) flight 1170 flight crew approached the Tulsa International Airport (TUL), they mis-identified runway 18R as runway 18L and continued their approach and landing on runway 18R. After touchdown and hearing the “3000 feet remaining” call from the automated runway awareness and advisory system (RAAS), the captain recognized they had landed on the incorrect runway, applied heavy braking and was able to exit the runway at the final taxiway.

Figure 1. Final approach screenshot illustrating flight alignment with runway 18R.

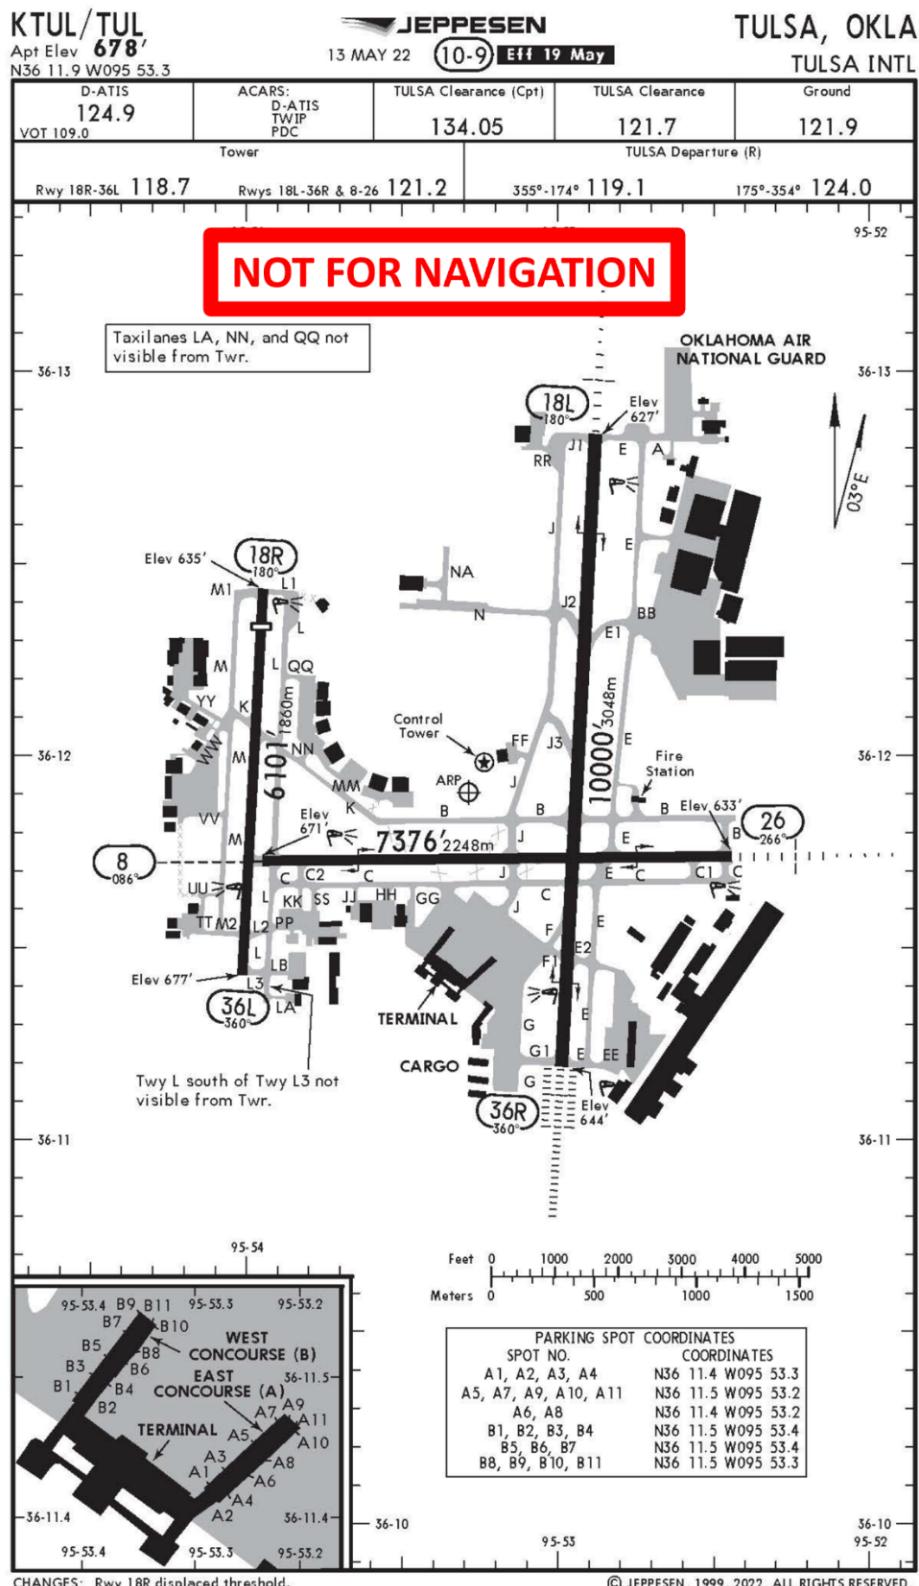
At the time of the incident, TUL, had three paved runway surfaces designated as 18L/36R, 18R/36L, and 8/26. The intended landing runway 18L was 10,000 ft long and 150 ft wide, with precision instrument markings. It had high-intensity edge lights, centerline lights, a 4-light PAPI on the left side of the runway, and medium intensity approach lighting system (MALSR) approach lights. The actual landing runway 18R was 6,101 ft long and 150 ft wide with precision instrument markings and a 600-foot displaced threshold. It had high-intensity edge lights, a 4-light PAPI located on the left side of the runway, and runway end identifier lights.

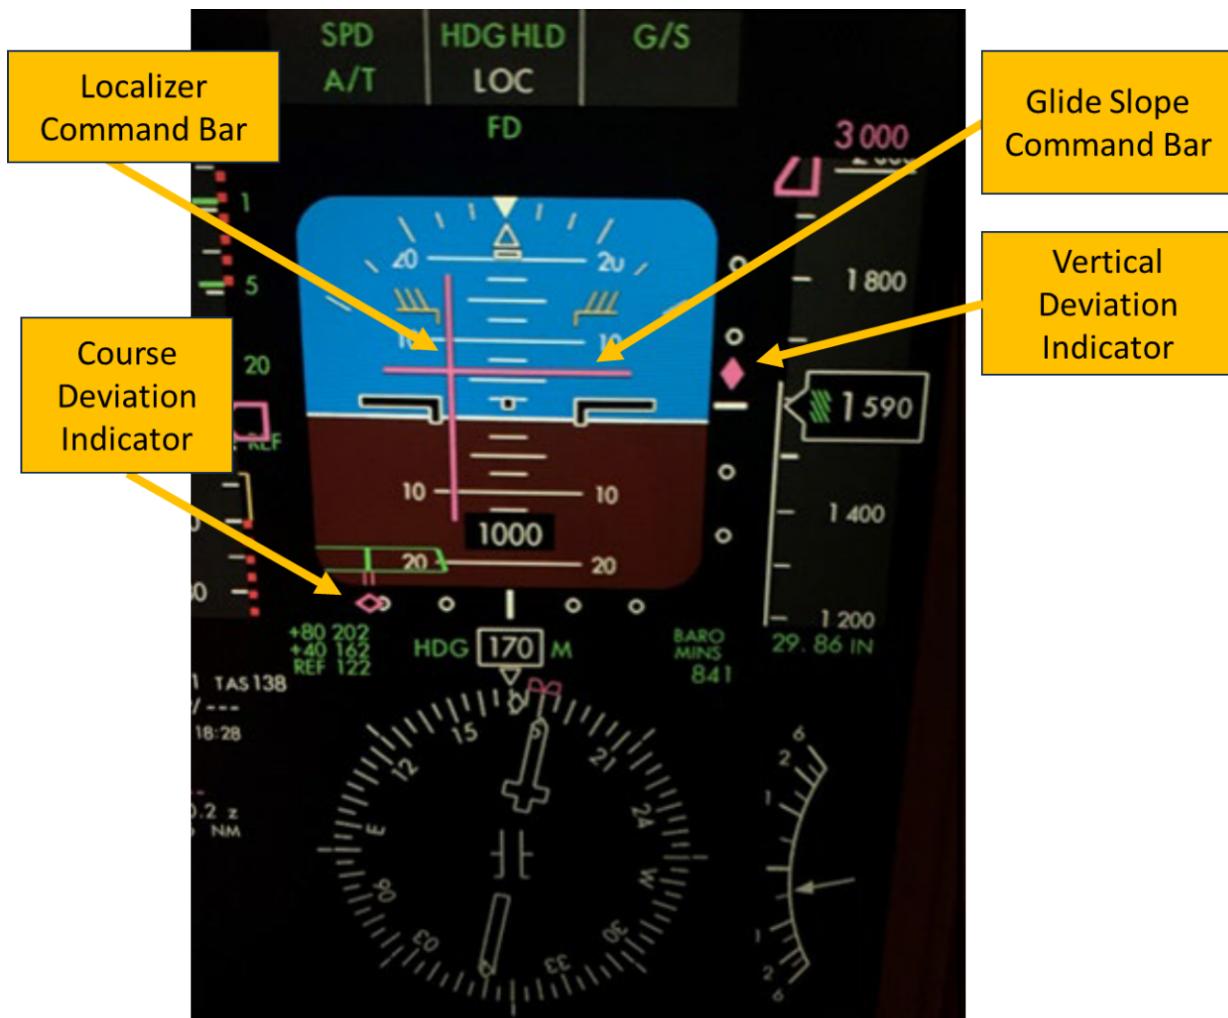
The Operational Factors/Human Performance group conducted a simulator evaluation in one of the operator's B757 simulators. During the evaluation, the simulator was placed on a right downwind leg west of the airport for an approach to runway 18R and 18L. The simulator navigation was programmed in accordance with the operator's policies and procedures provided for an ILS to runway 18L. During the visual approach to runway 18R the PFD (figure 3) and HUD (figure 4), indicated that the aircraft was to the right of course and below the glideslope.

Figure 3. Simulator PFD as viewed approaching runway 18R. (yellow labels added for clarity)

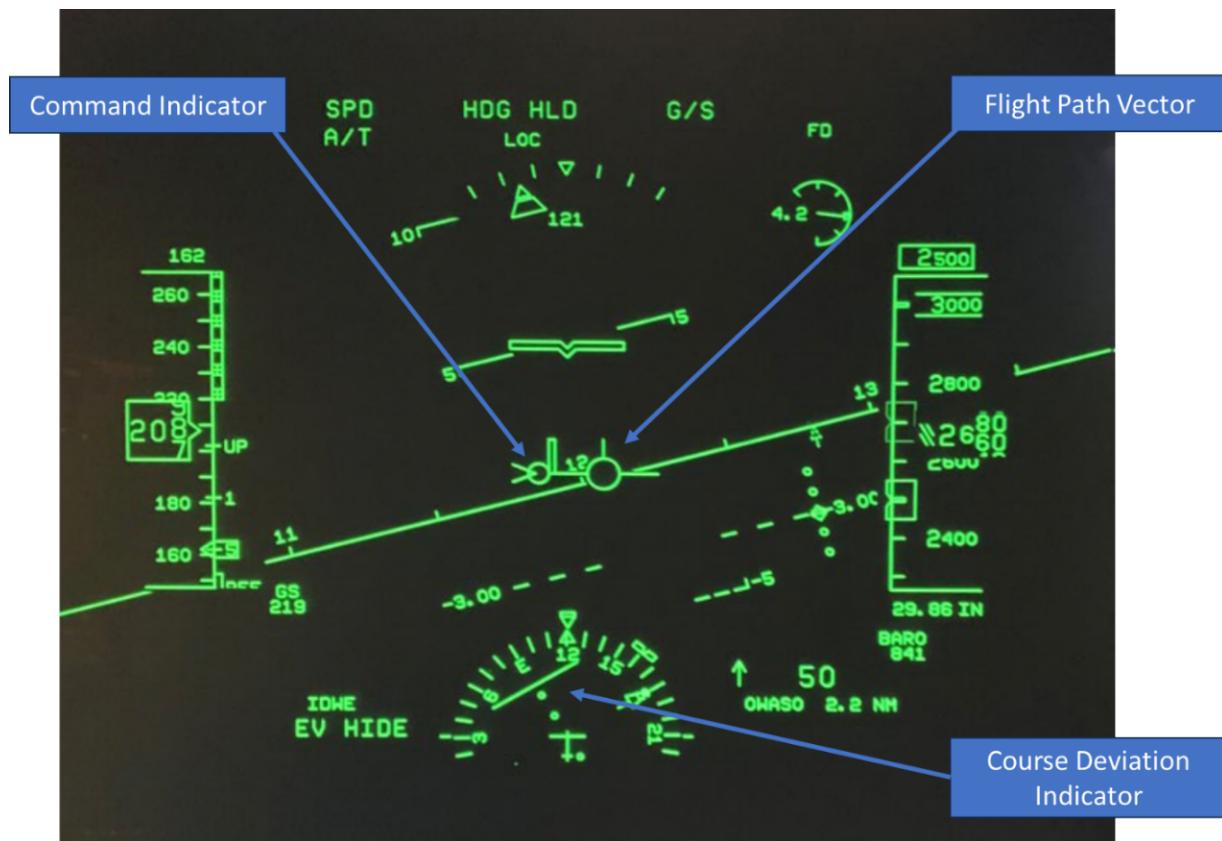
Figure 4 shows the HUD display from the operator's panel in a FedEx B-757 simulator. The depiction was consistent with that shown on the captain's HUD in the simulator. The image in figure 4 was taken while the simulator was in right turn from base to final for runway 18R. The identifier IDWE located in the lower left side of the display is associated with the identifier for the runway 18L localizer. The course deviation indicator for the localizer is on the left side of the horizontal situation indicator at the bottom of the display. The course deviation indicator and offset between the flight path indicator and command indicator show that the target runway is further to the left than the aircraft's actual path.

Figure 4. HUD display from the operator's panel in the FedEx B-757 simulator. (blue labels added for clarity)
