# Aviation Investigation Final Report

| <b>Location:</b> | Kahului, Hawaii | <b>Incident Number:</b> | DCA23LA172 |
| <b>Aircraft:</b> | Boeing 777 | <b>Aircraft Damage:</b> | None |

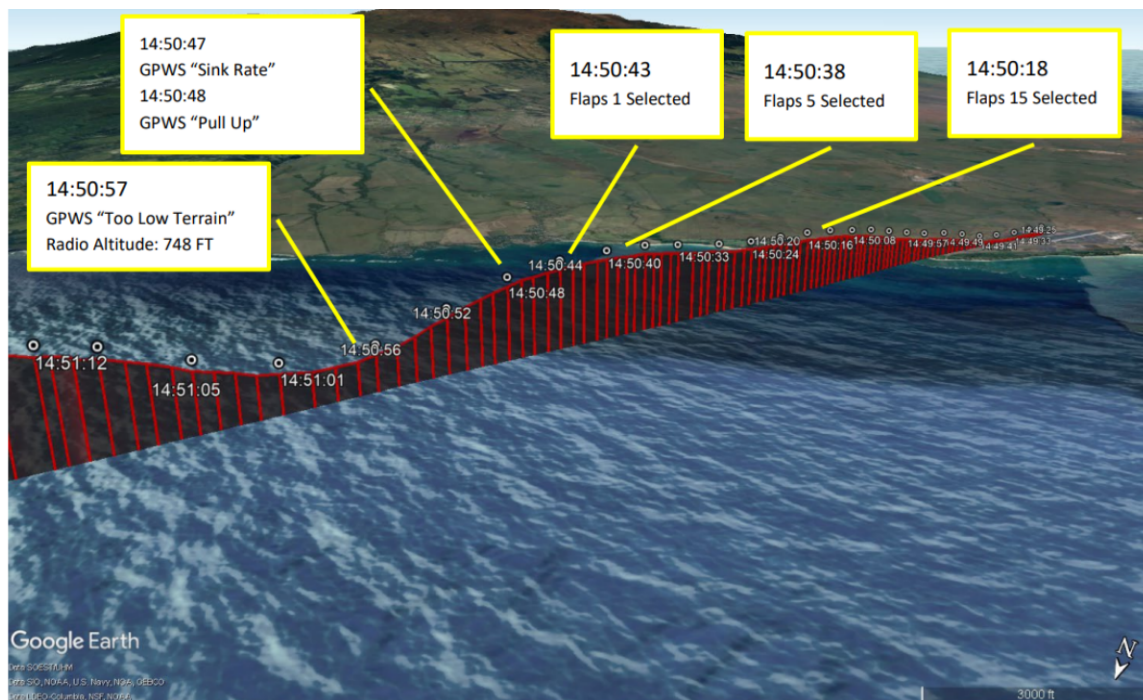
Figure 1- Flight Track with Annotations

United flight 1722 lost altitude about 1 minute after departure while in instrument meteorological conditions, which included heavy rain. The airplane descended from 2,100 ft to about 748 ft above the water before the crew recovered from the descent. No injuries were reported, and the airplane was not damaged. The NTSB was not originally notified of the event, since it did not meet the requirements of Title 49 *Code of Federal Regulations* Part 830.5. However, the NTSB learned of the event about 2 months later and chose to open an investigation. By that time, both the cockpit voice and flight data recorder durations had been exceeded. The investigation utilized flight crew statements and other records as information sources.

Figure 1 shows a perspective view of the flight track.
