Aviation Investigation Final Report

Location:	Pittsburgh, Pennsylvania	Incident Number:	DCA22LA133
Date & Time:	June 21, 2022, 09:45 Local	Registration:	N37513
Aircraft:	Boeing 737-9	Aircraft Damage:	None
Defining Event:	Wrong surface or wrong airport	Injuries:	174 None
Flight Conducted Under:	Part 121: Air carrier - Scheduled

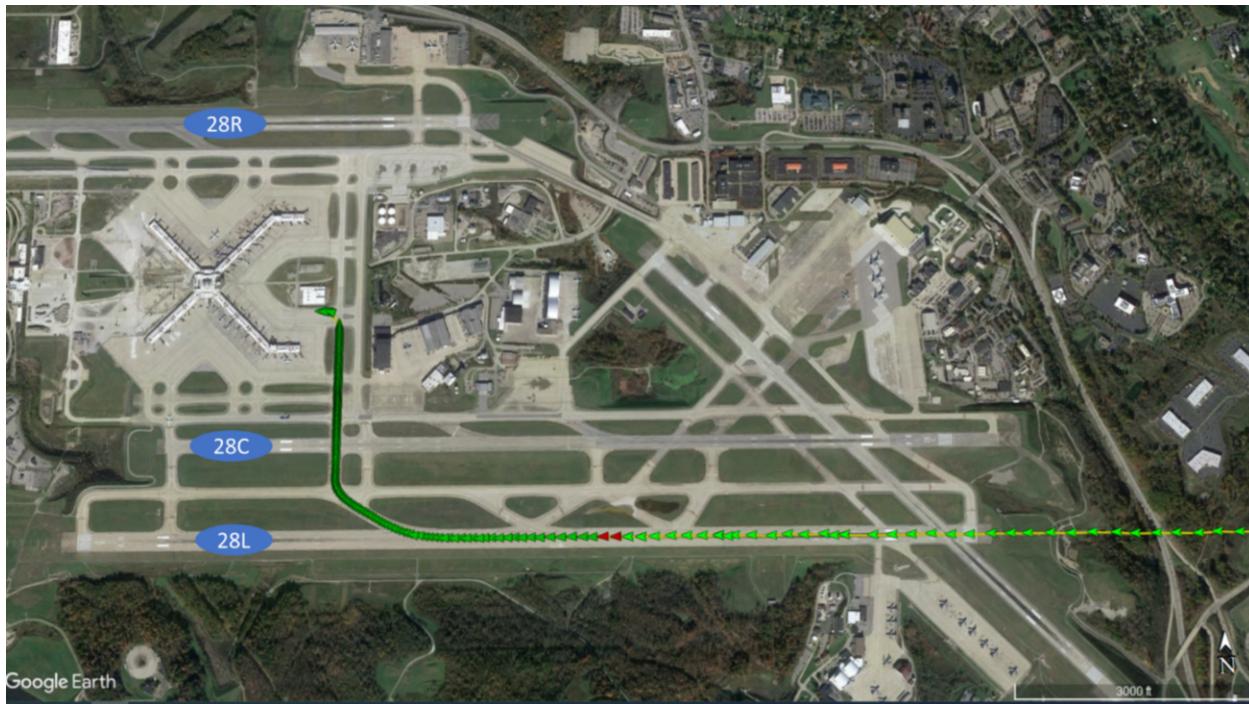
About 2 miles from the runway threshold, the first officer contacted the tower controller to confirm that the airplane was cleared to land on runway 28C, and the controller provided confirmation. The airplane then aligned with and landed on runway 28L instead of runway 28C at 0944:42 and subsequently turned right to exit the runway. The figure below is a Google Earth screenshot that is overlaid with automatic dependent surveillance-broadcast ground tracks showing the incident flight aligned with and landing on runway 28L.
