The unknown risk of a flash flood

Safety Forum – June 19th 2024

Cpt Frank BAETENS
Safety Manager – TUI Airlines Belgium

- To reveal the consequences of flash floods on aviation operations
 - by demonstrating the facts of a real incident
 - the subsequent investigation carried out
- Presentation of a TUI fly Belgium B737-700 incident *“Collision with obstacle on runway after landing”*, where the aircraft suffered damage after hitting debris upon landing onto OUD RWY 13 (September 2nd 2023).

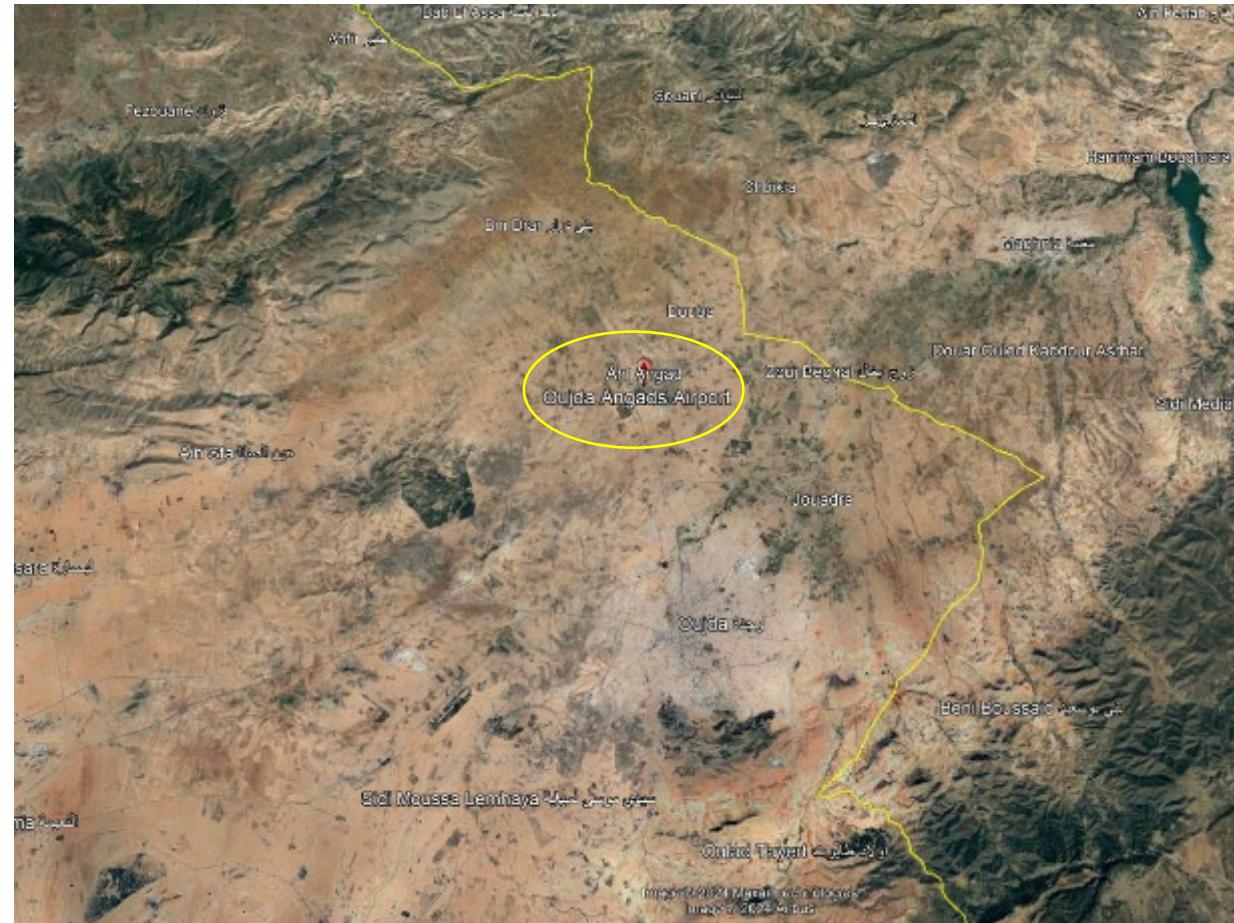
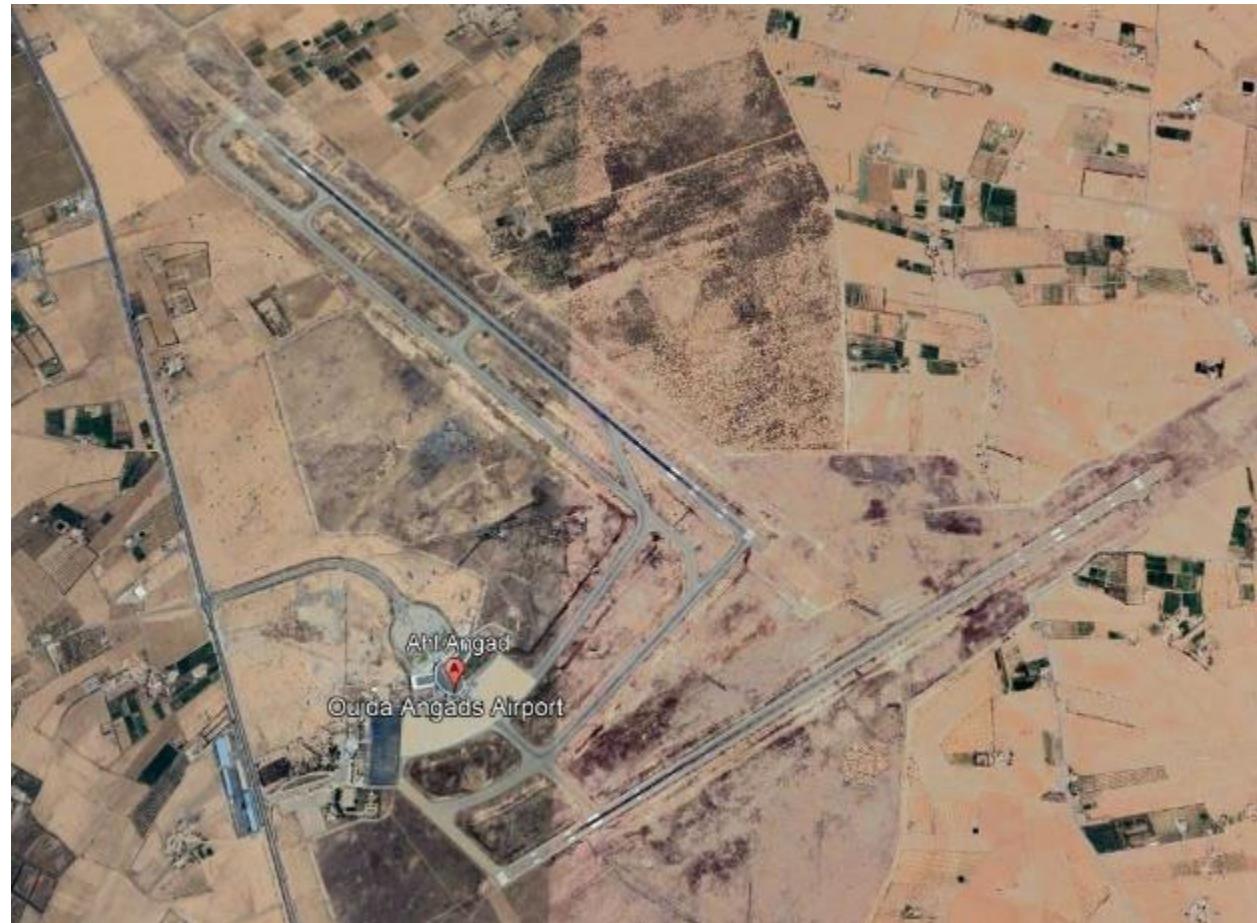
Airport lay out

OUD airport is situated in the northeast of Morocco, located near mountains that separate Morocco from Algeria.

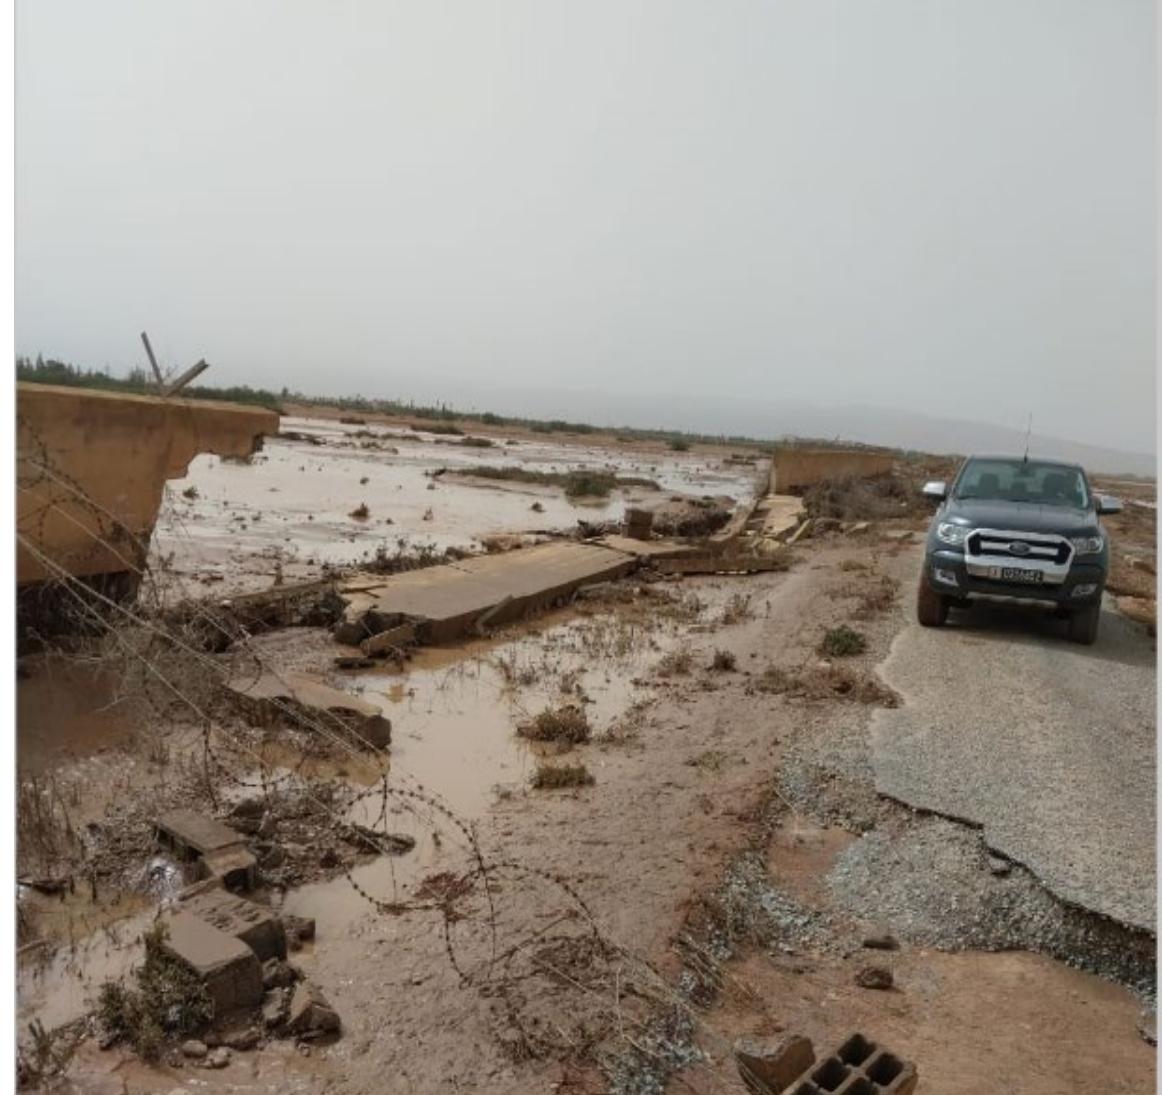
- The drainage system can process the excess of water under normal circumstances.
- At the time of the event, an enormous amount of water had come down from the mountains, in addition to the water that was caused by heavy rainfall.
- Concrete walls and pavements appeared to be demolished.

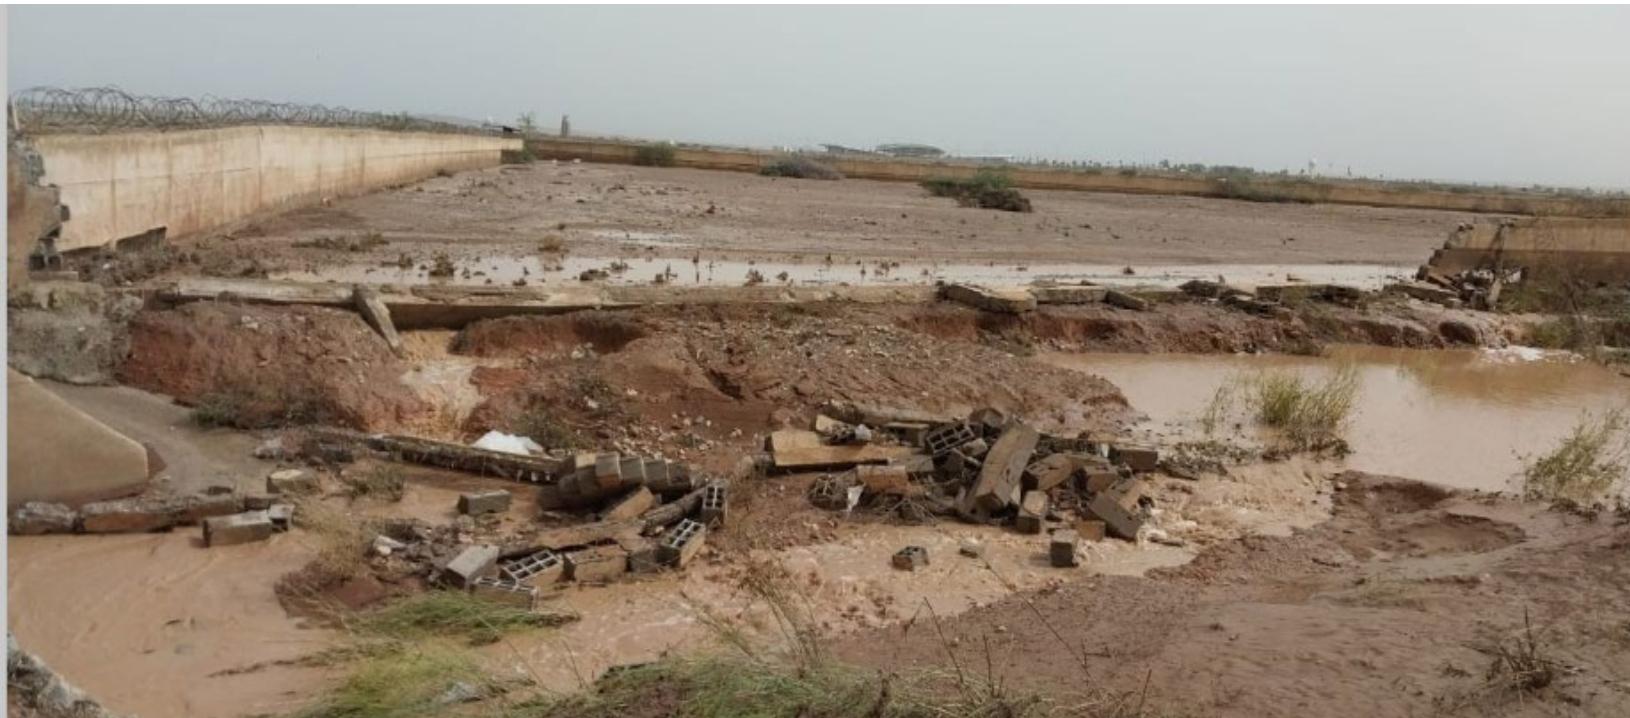
- The airport and surroundings drainage system could no longer absorb this amount of water.
- A massive amount of water caused a flash flood over the runway just before our landing aircraft (21:43 UTC).
- The perimeter wall was destructed close to the touchdown point of RWY 13.
