Separation occurrence involving Boeing 737, VH-VZM, and Boeing 737, VH-VZW

Sydney Airport, New South Wales, on 29 April 2023

ATSB Transport Safety Report
Aviation Occurrence Investigation (Short)
AO-2023-022
Final – 31 January 2024

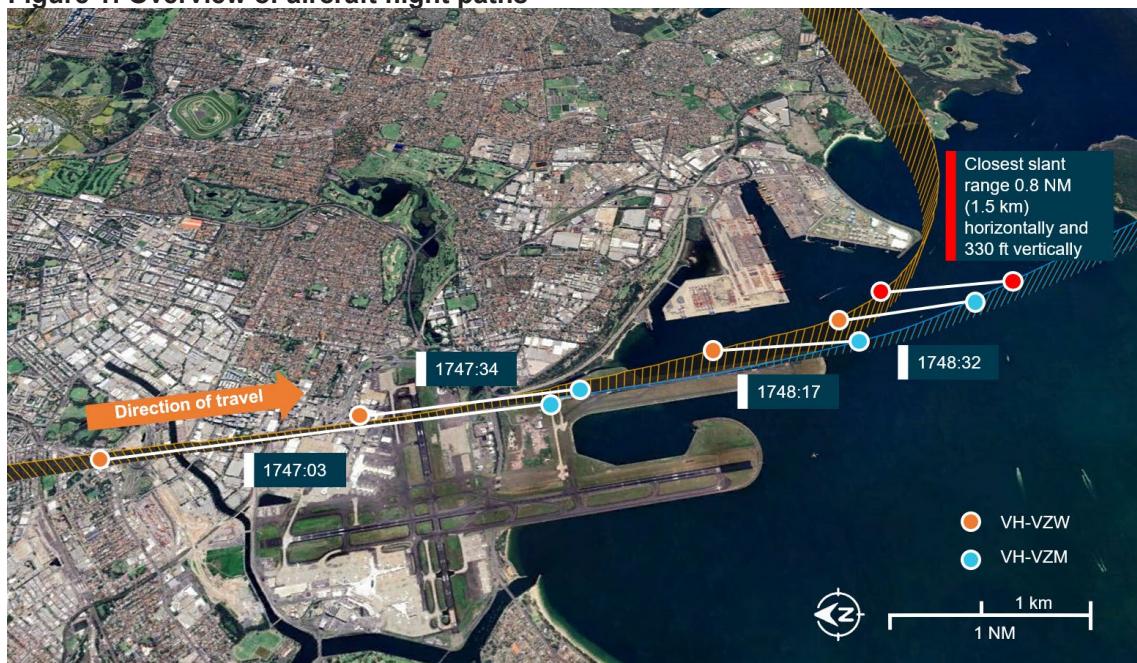
Figure 1: Overview of aircraft flight paths

At 1748:38, the closest slant range between the 2 aircraft occurred, with separation reducing to 0.8 NM (1.5 km) horizontally and 330 ft vertically (Figure 1). Neither crew had visual contact with the other aircraft and no TCAS resolution advisory⁹ or traffic advisory¹⁰ was triggered. The controllers had both aircraft in sight throughout the occurrence, and the ATSB later assessed that the visual and surveillance information available to the controllers in the tower, accounting for the possibility of visual errors, was sufficient for visual separation¹¹ to be maintained.

White lines link the locations of the two aircraft at the same point in time.

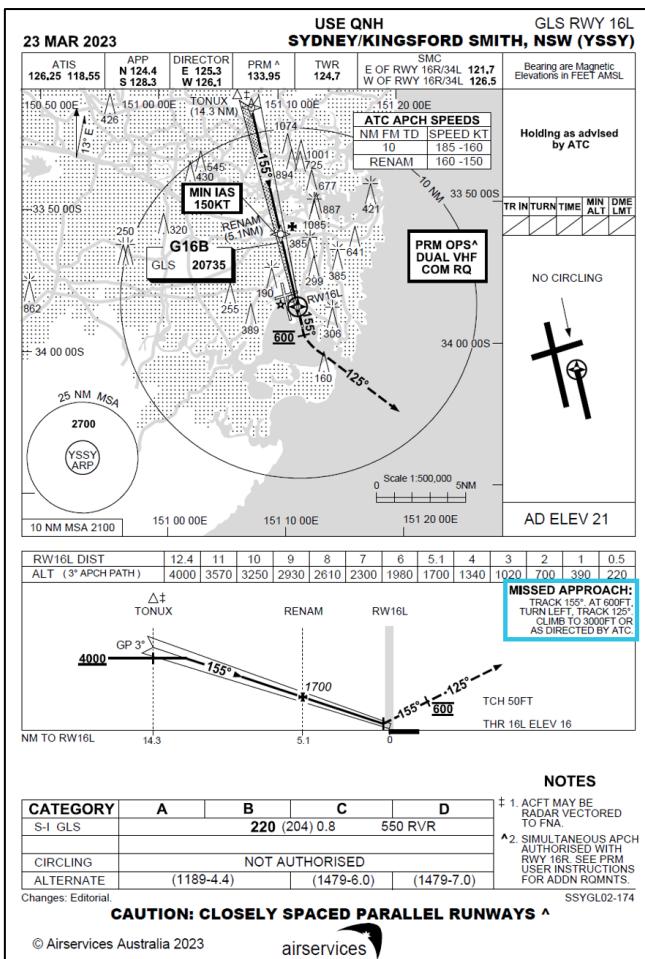
Figure 2: Sydney GLS runway 16L approach chart with missed approach requirements (blue box)

A missed approach procedure provides instrument flight rules¹⁵ aircraft with terrain and obstacle clearance along the missed approach path during a go-around. The flight crew of VH-VZW were flying a GBAS landing system (GLS) approach for runway 16L. In the event of a go-around, the missed approach procedure required a flight crew to initially climb to 600 ft and then execute a left turn onto a heading of 125° (Figure 1). The crew were then required to climb to 3,000 ft or as directed by air traffic control.
