**Havarikommissionen**

## Report 2022-150

**Serious incident to CS-TNV (Airbus A320-214) in Copenhagen/Kastrup (EKCH) on 8-4-2022**

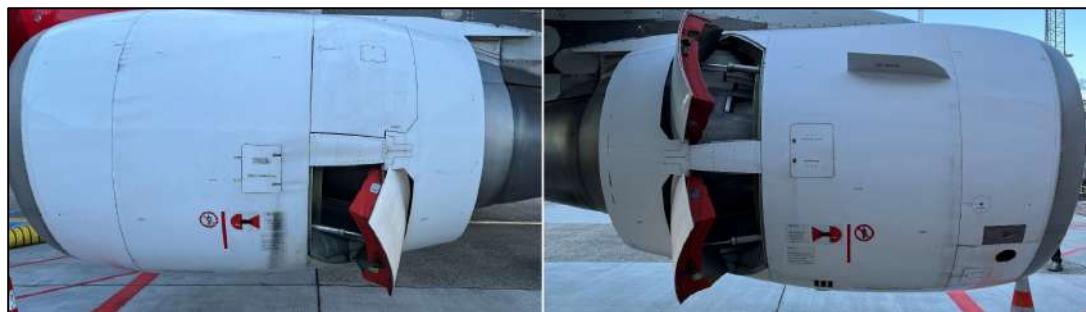
Figure 15. Engine #1 seen from the LH and RH side

The initial inspection on the aircraft stand revealed that engine #1 LH upper blocker door PDL was unlocked, but the actuator secondary lock remained locked i.e. the LH upper blocker door could not be moved to full deployment. The remaining three blocker doors were all fully deployed.

Visual inspections revealed only one small defect on the LH upper door latch roller which was seized. Functional tests of the thrust reverser system with and without engine running showed normal behaviour and no faults.

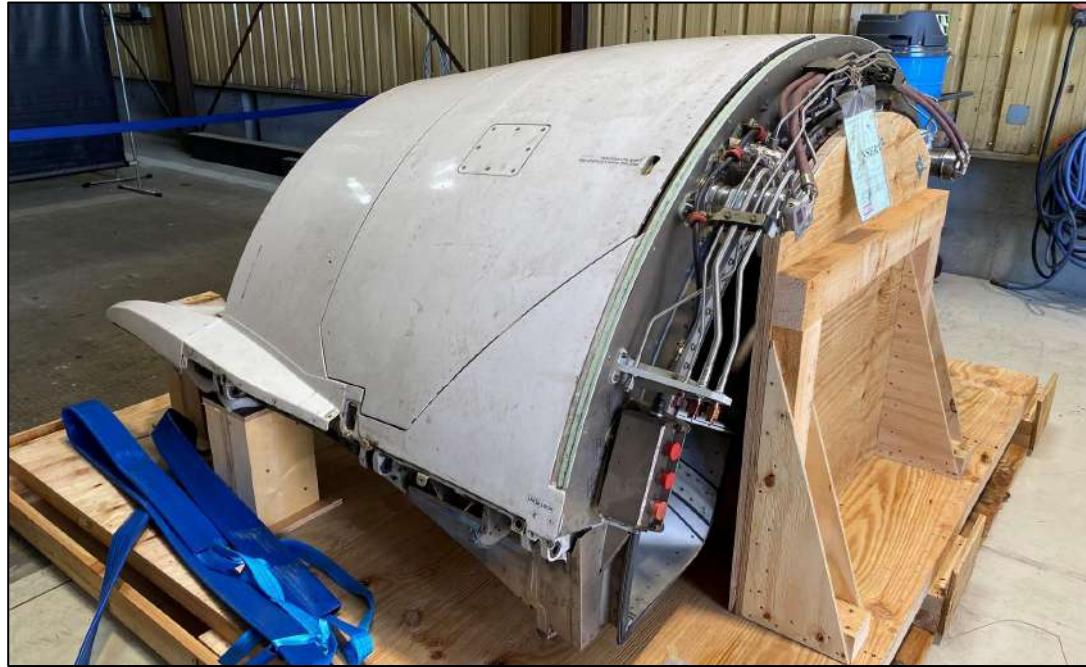
Figure 16. Engine #1 thrust reverser LH D-duct

Under supervision of the AIB, the BEA, the operator and the aircraft manufacturer, the OEM inspected engine #1 thrust reverser D-ducts at an OEM maintenance facility in France. The inspections revealed only minor defects. The conclusion was that none of these defects could have contributed to the thrust reverser not stowing.

Friction in the blocker door hinges was checked without the actuators installed. Friction was found to be very low. All four blocker doors moved freely.

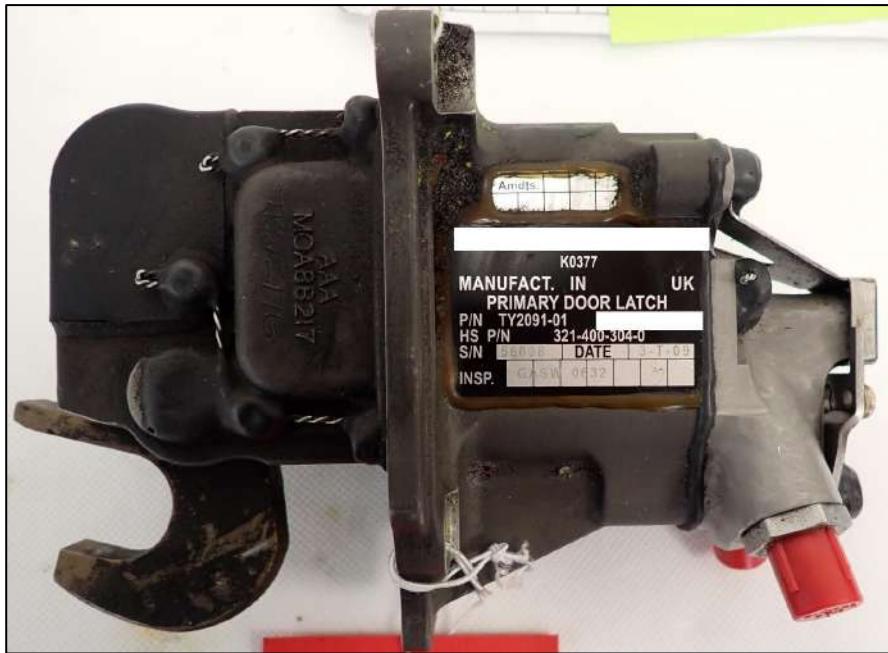
Figure 17. A PDL in as received condition

The detailed inspection of the HCU, PDLs and actuators revealed only minor defects, and the OEM concluded that none of the defects could have contributed to a degradation of performance of the thrust reverser system resulting in an inability to stow.

The subject PDL was replaced. A workshop inspected the PDL and found it in dirty condition with only a small amount of remaining grease. The PDL passed the CMM test.

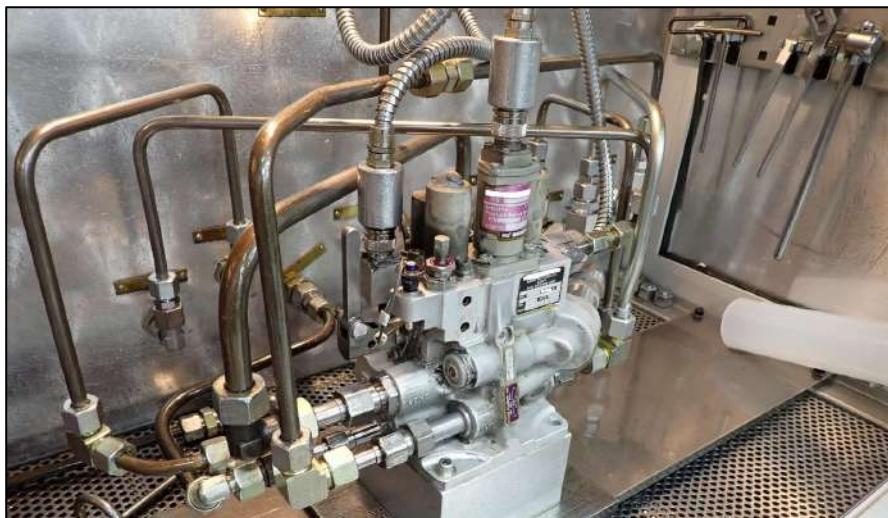
Figure 18. HCU in test rig

In accordance with the respective Component Maintenance Manuals (CMMs), the OEM tested the parts. All parts passed the tests in the CMMs. The test results are presented in the following appendixes:

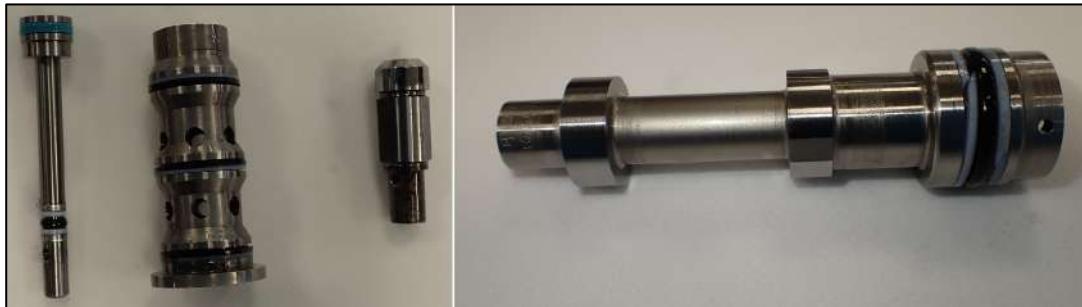
Figure 19. Isolation valve and associated parts shown left, and directional valve shown on the right

To verify that no damage existed on the pressurising valve and the directional valve in the HCU (as this could potentially have resulted in the valves to go periodically stuck), both valves and associated guides and parts were removed and inspected. No defects were found on any of the parts.

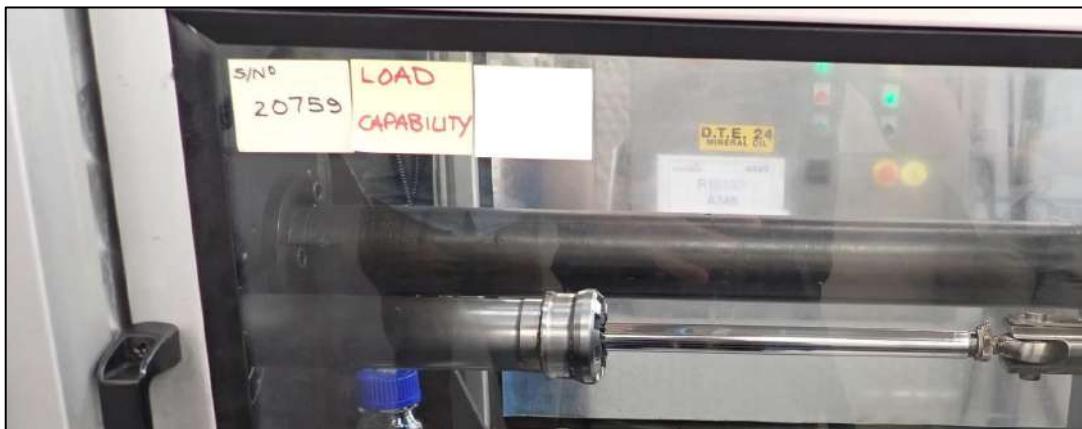
Figure 21. Actuator load capability testing

All tests confirmed that the actuators were able to stow when subjected to the event load with approximately 50 % additional load capability.

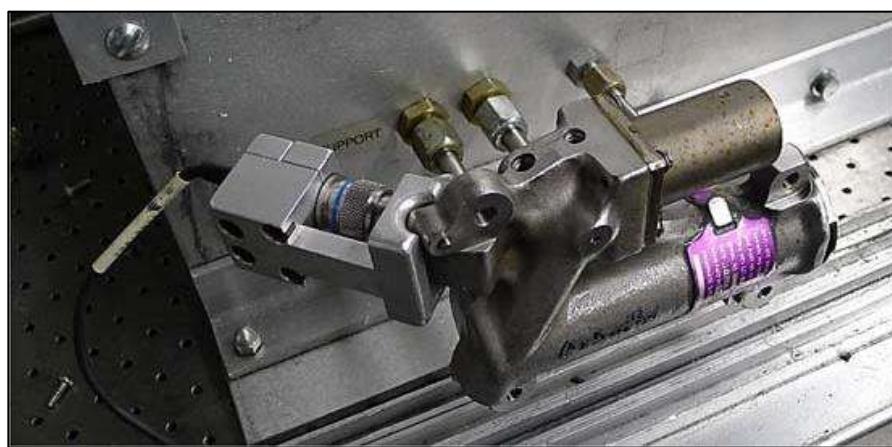
Figure 22. TRSOV in test rig

CMM testing of the component was conducted under the supervision of the NTSB and the FAA. The TRSOV passed all CMM tests.

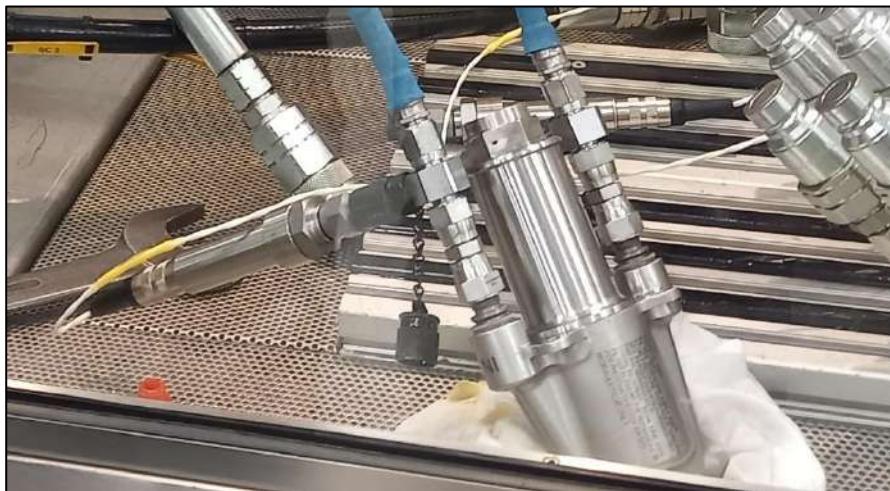
Figure 23. Filter housing test at the operator

The filter housing flow differential pressure test was slightly out of limit, and the shut off valve leak check failed. The operator informed that it had been a challenge in the past to test other filter housings within the CMM limit for the flow differential pressure test.

The leakage of the shut off valve also had no influence on engine #1 thrust reverser's inability to stow.

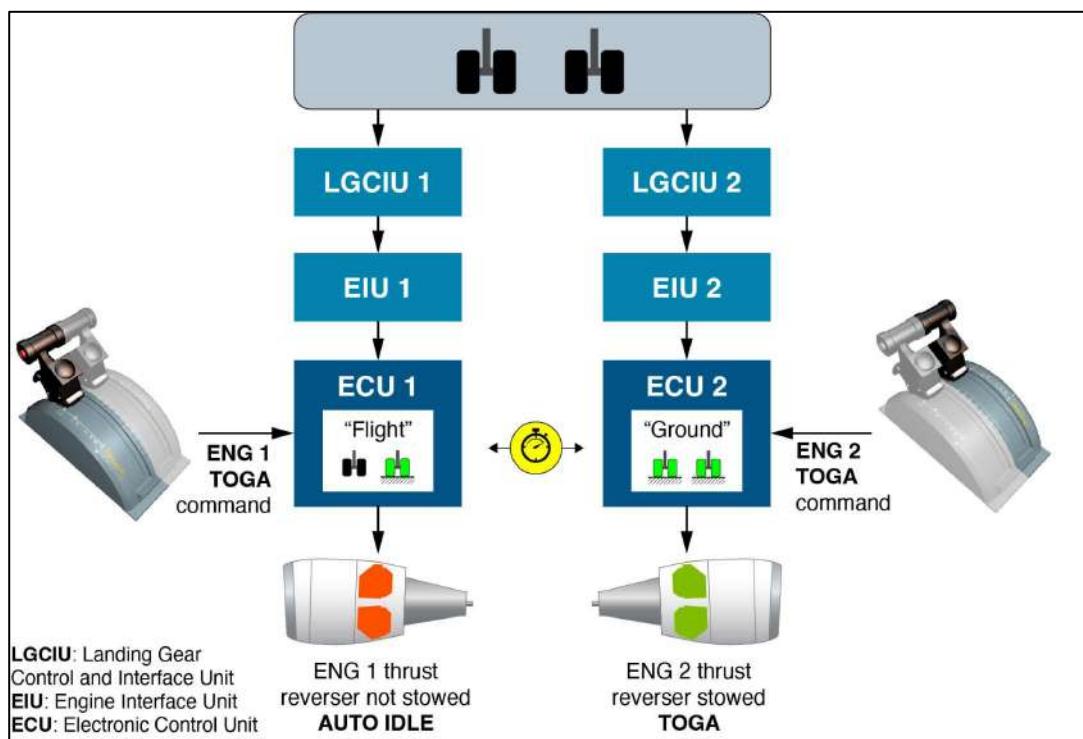
Figure 25. Illustration developed by the aircraft manufacturer to explain the difference in signals to the ECUs

The aircraft manufacturer concluded that due to the input scan and output update frequency combined with the processing time of each computer, ECU #1 received an air signal from the #1 set of computers while sensing the TLA stow signal. At the same time, ECU #2 received a ground signal by the independent #2 set of computers while sensing the TLA forward thrust signal. The opposite scenario was just as likely to have occurred.

**To prevent engine thrust reverser(s) not stowing on an A320 family aircraft during an aborted landing after ground contact, the AIB recommends EASA to ensure that the aircraft and engine manufacturer modifies the CFM56-5B ECU software, and that the software modification is mandated and embodied on the entire CFM56-5B fleet when ready for entry into service estimated in 2025.**
