Touchdown before threshold

Risks associated with a large aircraft
landing on a short runway

The Hague, 18 July 2024

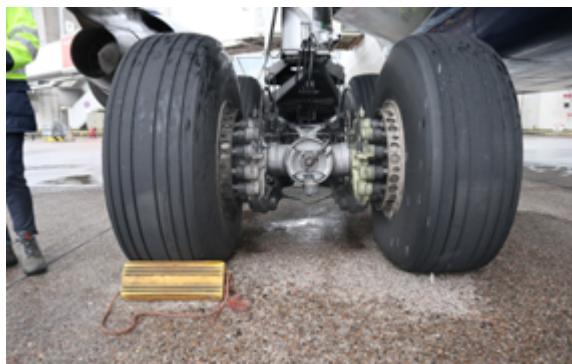
▲ Figure 3: Anti-rotation brake rod restraint cable.
(Source: Operator)

The aircraft sustained minor damage. The aft anti-rotation brake rod restraint cable of the right main landing gear was broken (see figure 3). Mud traces were visible on the rear of the fuselage (see figure 4).

As both main landing gears impacted objects during this undershoot occurrence, an analysis by Safran Landing Systems (manufacturer of the landing gear) was conducted to assess the experienced load levels. The conclusion of that analysis confirms that the landing gear components did not exceed their design limit loads.

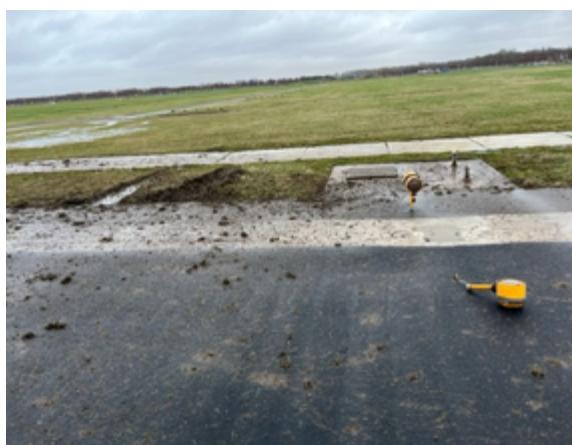
◀ Figure 5: One of the sheared off runway lights.
(Source: Amsterdam Airport Schiphol)

Two runway threshold lights were sheared off (see figure 5). The ground before the runway threshold showed two tracks consistent with the dimensions of the Airbus A330-300 main landing gear wheels. The left track, positioned 9.2 m left of centerline, was approximately 8 m in length and had a maximum depth of 5 centimeters. The right track, positioned 1.5 m right of centerline, was approximately 11 m in length and had a maximum depth of 5 centimeters.

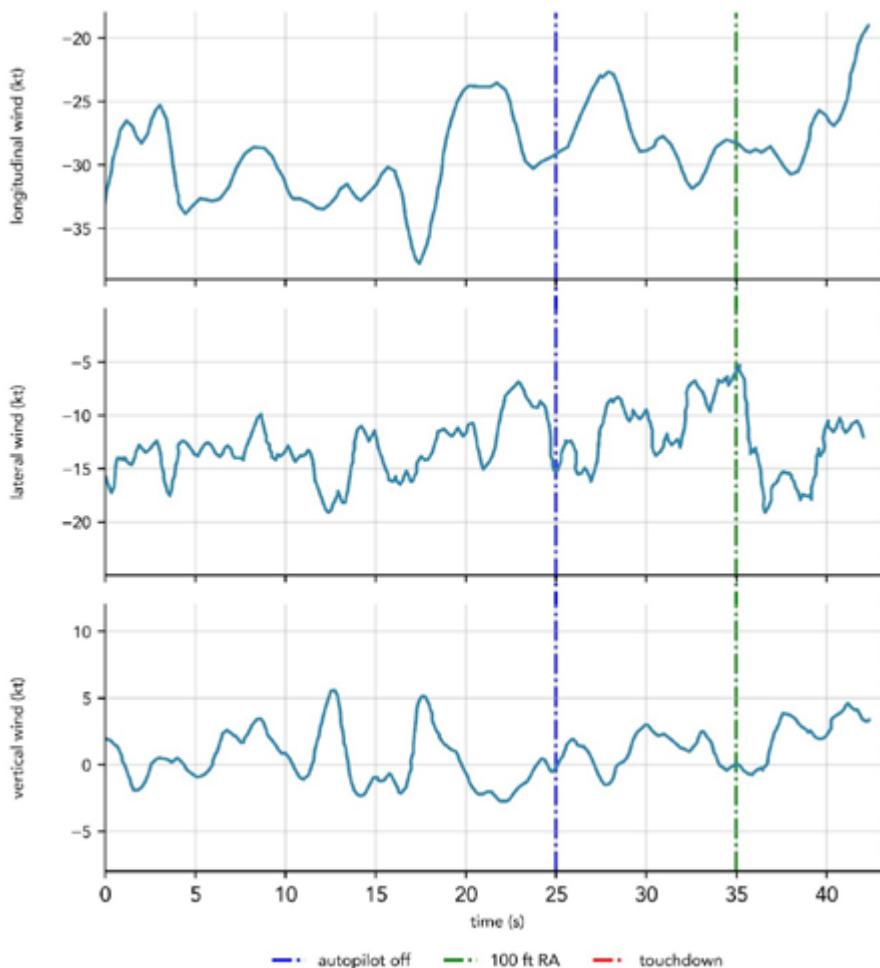
▲ Figure 7: Wind speed derived from FDR data. (Source: Airbus analysis)

The longitudinal wind component shows large wind variations, consistent with the gusty weather conditions. A 10 knot gust (headwind reduction) can be observed close to touchdown (red line). The lateral wind component shows a significant crosswind component from the right, averaging 15 knots. The vertical wind component is generally low (less than 5 knots) after autopilot disconnection (blue line). A small downdraft of 5 knots is visible shortly before touchdown.

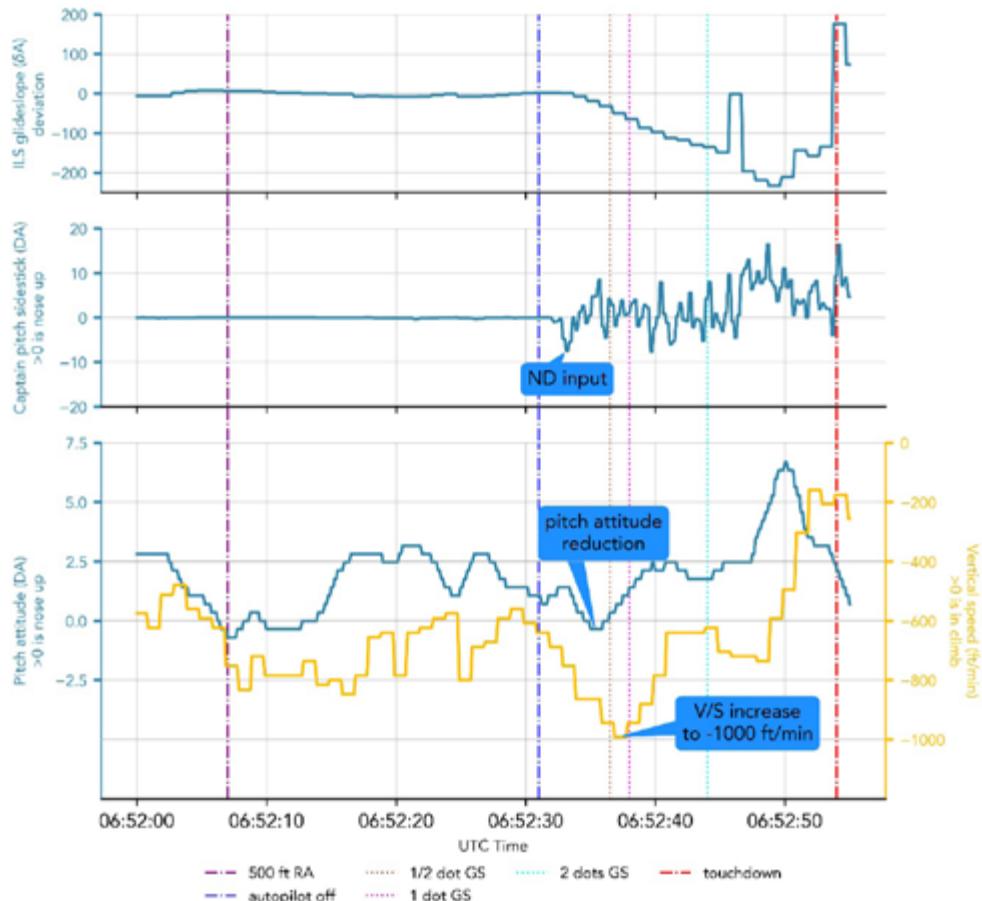
▲ Figure 11: FDR data prior to touchdown showing ILS glideslope deviation (top graph), captain pitch of the sidestick (middle graph) and the pitch attitude and vertical speed (bottom graph). (Source: FDR data and Airbus analysis)

(FDR) recorded a nose-down input from the captain's sidestick, decreasing the aircraft's pitch attitude from 1.4° nose up, to 0.3° nose down. The vertical speed increased and the aircraft started to descend below the glidepath. Two seconds later, the FDR recorded a nose-up input and the aircraft's pitch attitude increased to 2.5° nose up, however the descent below the glidepath continued to increase.

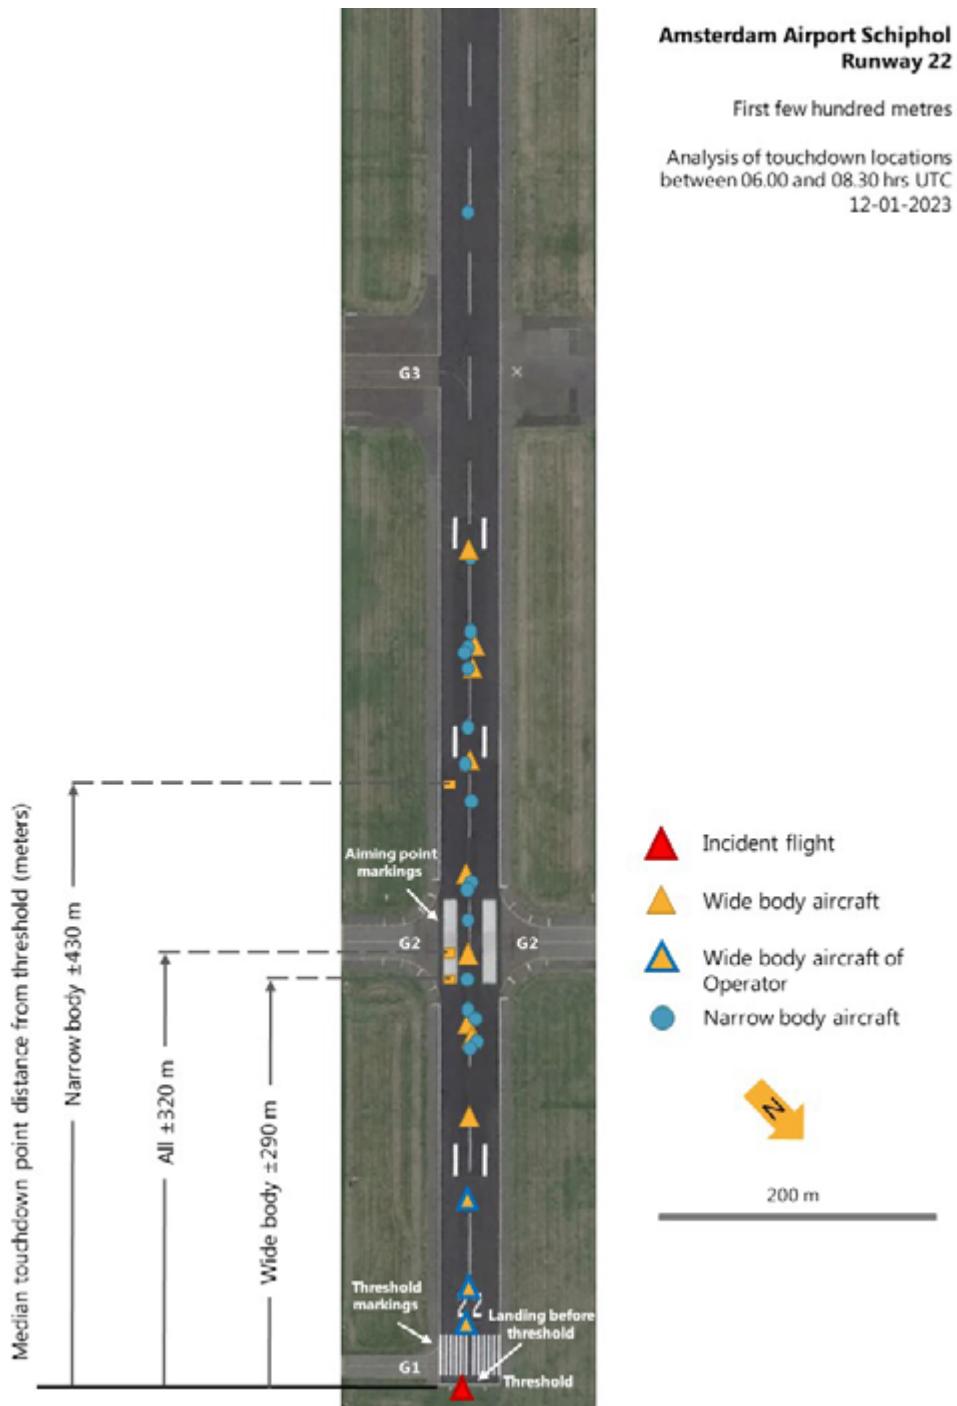
▲ Figure 14: Touchdown point of all aircraft that landed on Runway 22 on 12 January 2023 between 6.00 and 8.30 hours.

Data from Runway 22 at Amsterdam Airport Schiphol indicates that a number of wide body aircraft by the operator, identifiable by the triangles with blue outlines, have touched down earlier than other aircraft in the same timeperiod (see figure 14). Although the dataset is limited, the possible pattern observed stands out from the broader landing data. This could suggest the need for a detailed review to determine the consistency of this pattern and to explore potential operational implications.

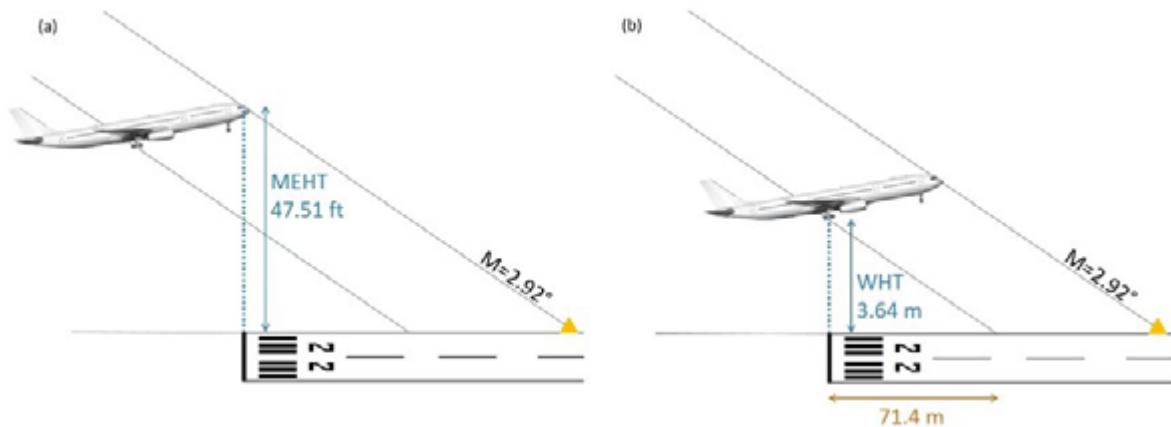
▲ Figure 15 Airbus A330-300 descent at Amsterdam Airport Runway 22 indicating the Minimum Eye Height over Threshold (MEHT) and the Wheel Height over Threshold (WHT). Note: The figure is not drawn to scale and is intended for illustrative purposes.

wheel-path height from the MEHT for the Airbus A330-300, gives a value of 11.95 ft (3.64 m) for the height that the main landing gear crosses the threshold (WHT).

The PAPI system, originally configured for aircraft profiles common in 1994, does not align with the current ICAO and EASA criteria for the threshold crossing height of larger aircraft such as the A330-300. This discrepancy contributed to the reduced safety margin.
