FINAL REPORT

INVESTIGATION INTO SERIOUS INCIDENT OF BOEING 777-368ER, Registration HZ-AK28
OF SAUDI ARABIAN AIRLINES FLIGHT SVA 806, OCCURRED ON 28 JUNE 2023
AT VGHS AIRPORT, DHAKA, BANGLADESH

REF. NO. 30.00.0000.013.33.002.22 (BOEING 777-368 ER (HZ-AK28, 28 JUNE 2023)/155

DATE: 23 JUNE 2024

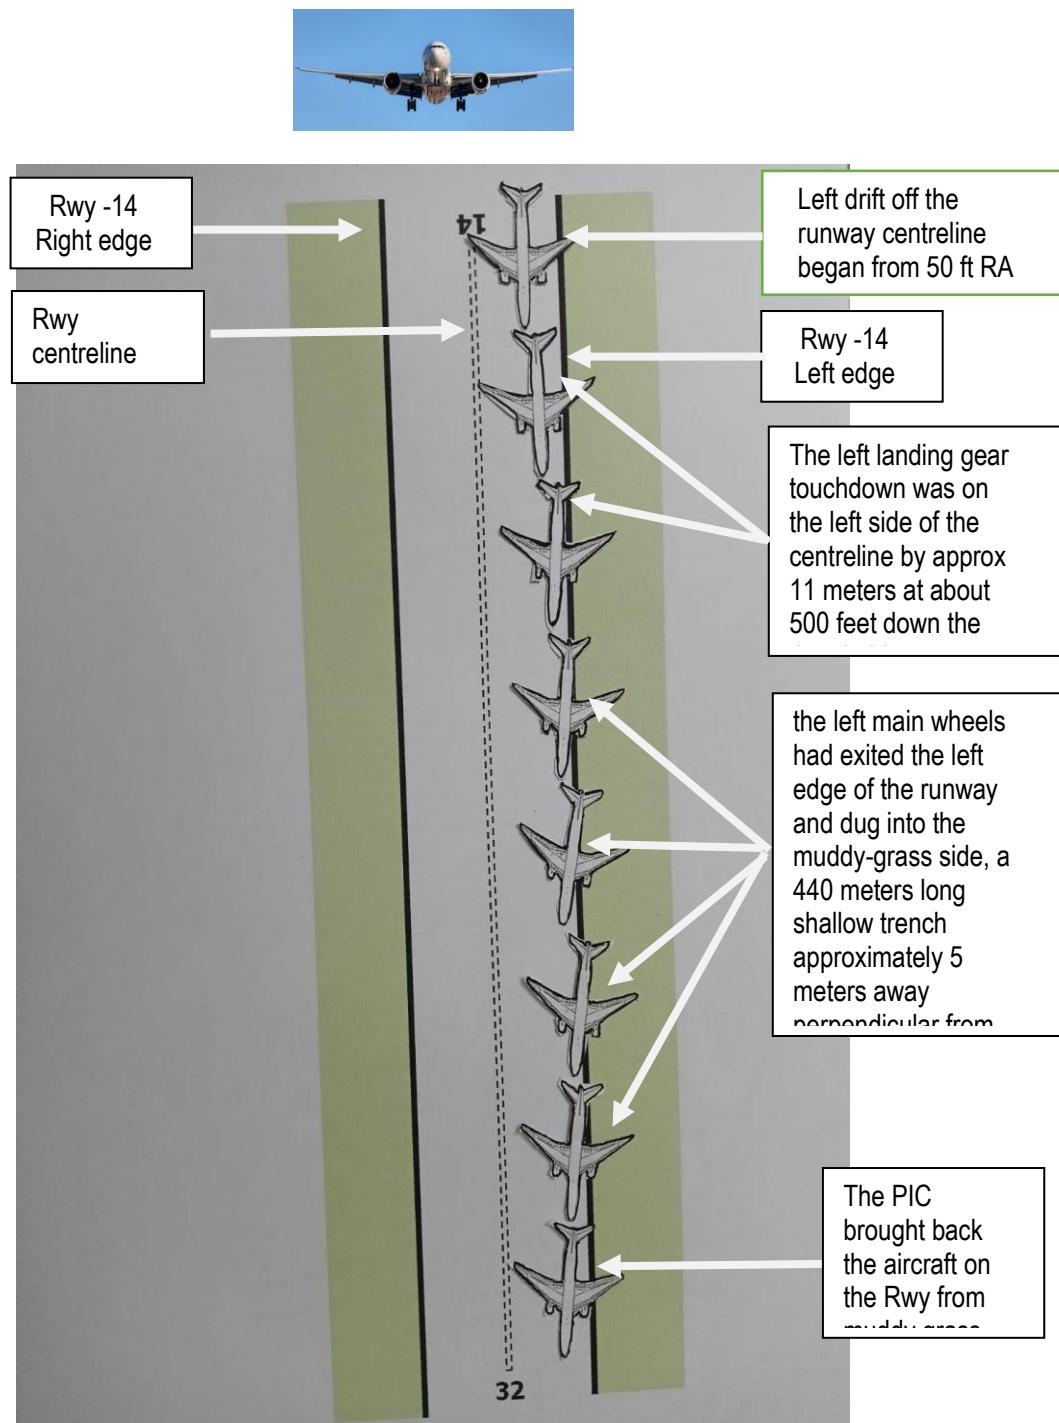
Figure- 2 The flight and events leading to the serious incident (Runway Excursion) including reconstruction of the significant portion

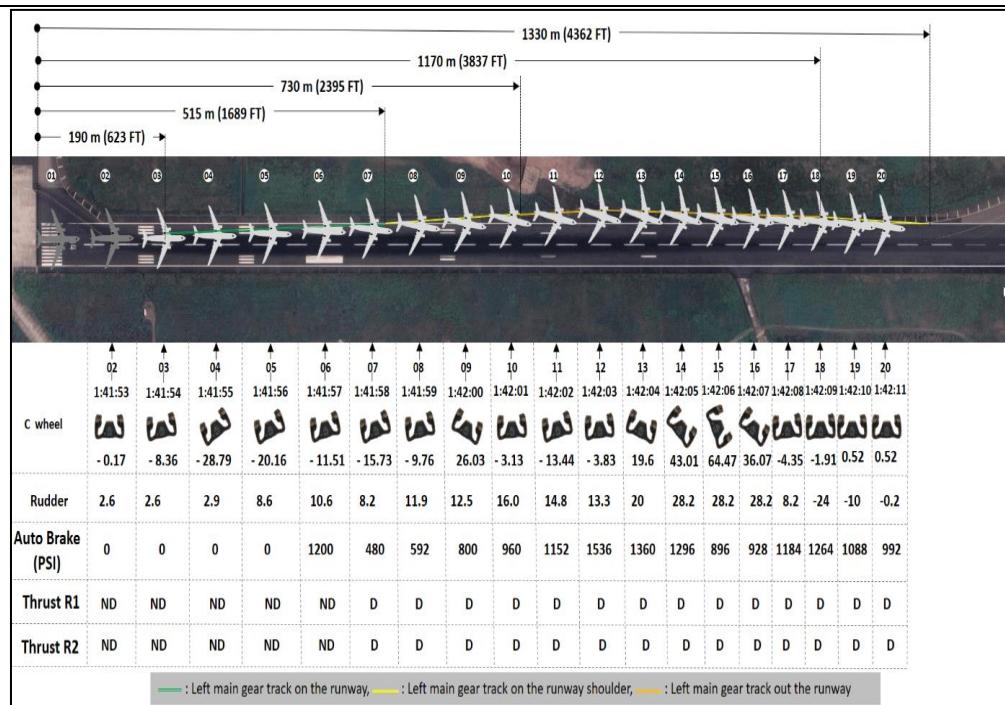
Figure 3
SVA806 landing excursion progression

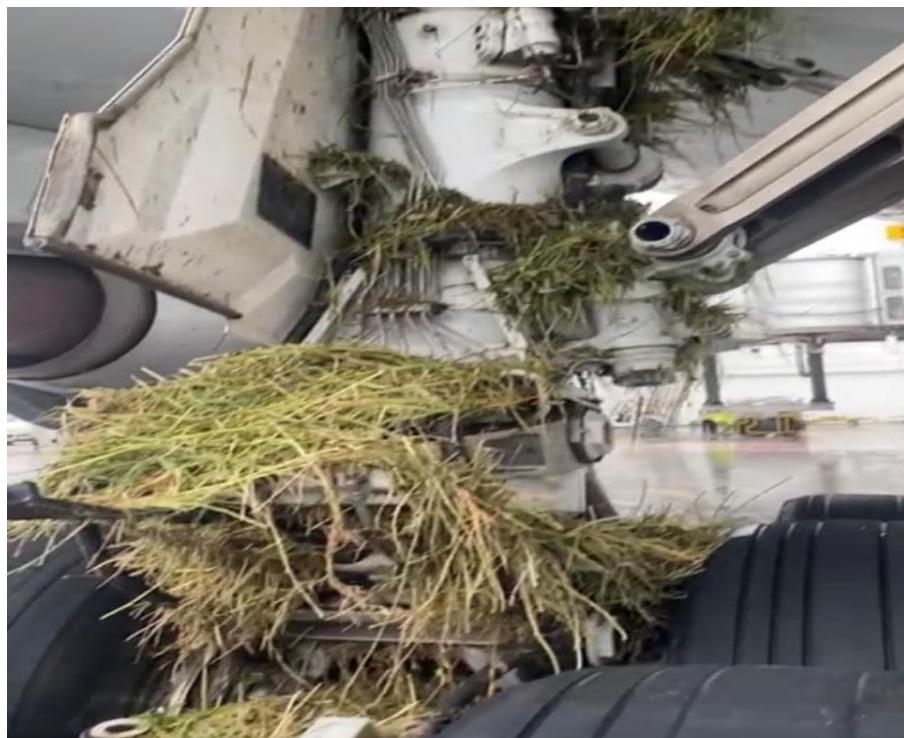
Figure- 6
Left landing gear condition, aft to forward view as the aircraft arrived at parking.

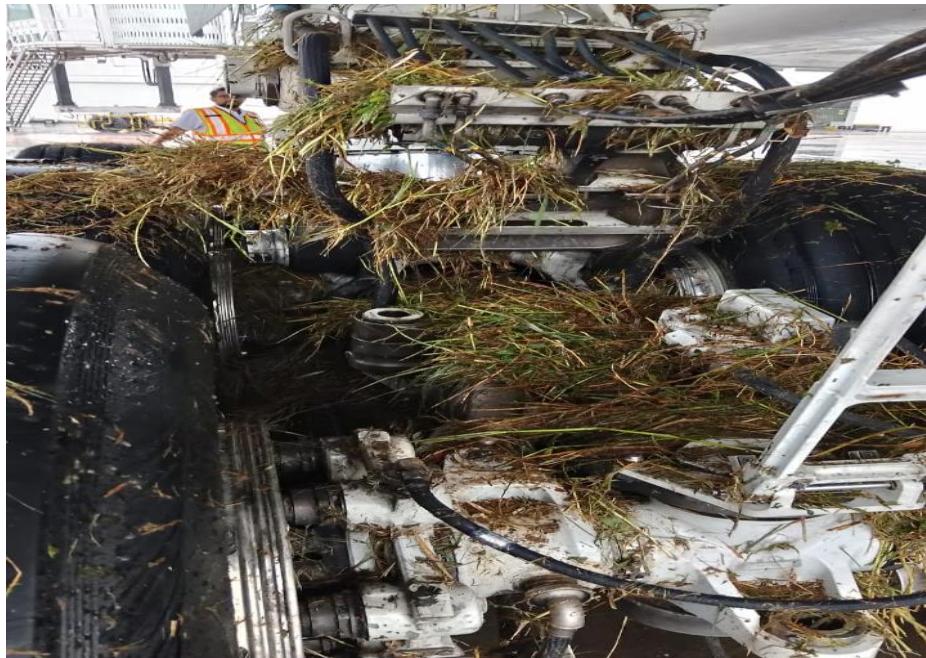
Figure-7
Left landing gear condition, forward to aft view after parking

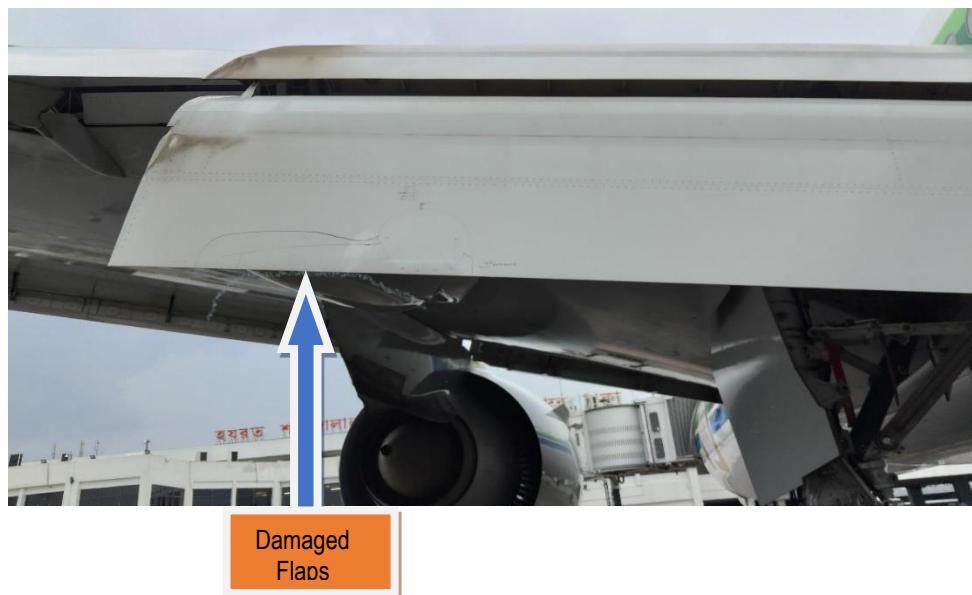
Figure- 8

| 3.1.3.2 Substantially damaged | <p>Aircraft inspection revealed damage to the Left Main Landing Gear assembly with following details:</p> <p>(1) 2 dents found identical in the opposite side at the left-hand inboard flap (Figure -8 and 9).</p> <p>(2) All the six tyres of the left main landing gear were found partially and/or completely torn and damaged with one wheel hub exposed. All wheels and wheel-well areas were full of grass and mud deposition. (Figure- 10)</p> <p>(3) Details of the damage:</p> <p>(1) Right hand aft harness connected to junction box torn, bracket displaced from clamp;</p> |

(12) 2 dents found identical in the opposite side at the left-hand inboard flap dimensions: -

(21) Damage to Inboard Flap Upper Surface with 2 dents beyond operational limits.

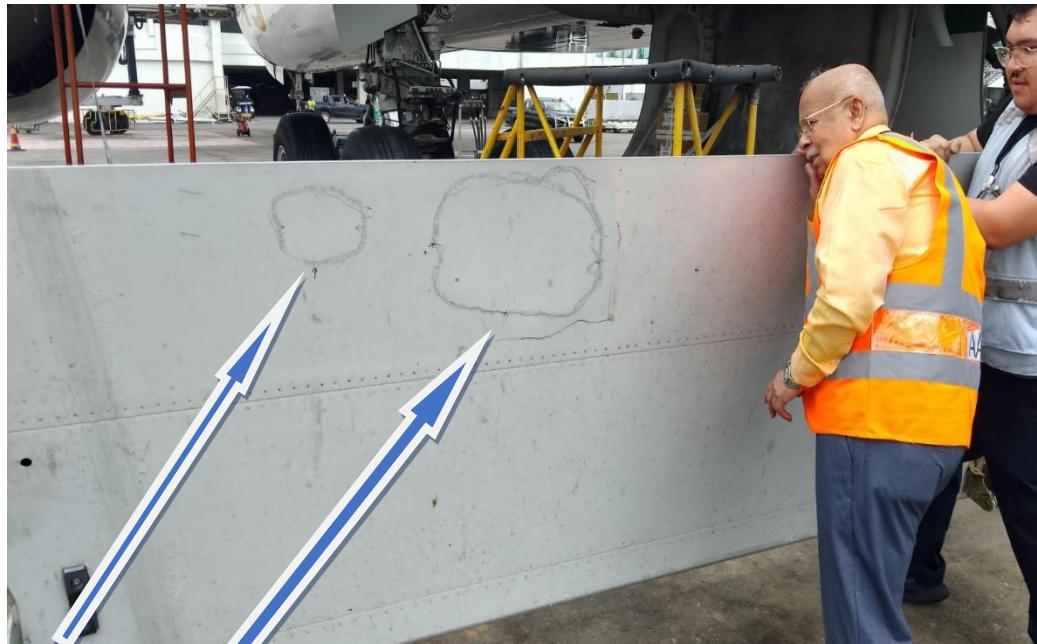
Figure- 9

Minor
bend/damage
to some
degrees of the
left inner flaps

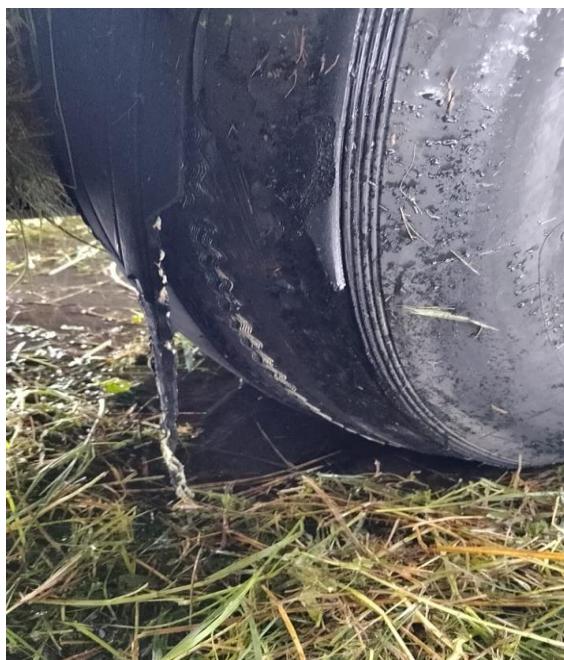
Figure-10

(17) Tires No. 5, 6, & 9 damaged however not deflated.

Tyres of the left
main landing gear
partially and/or
completely torn and
damaged

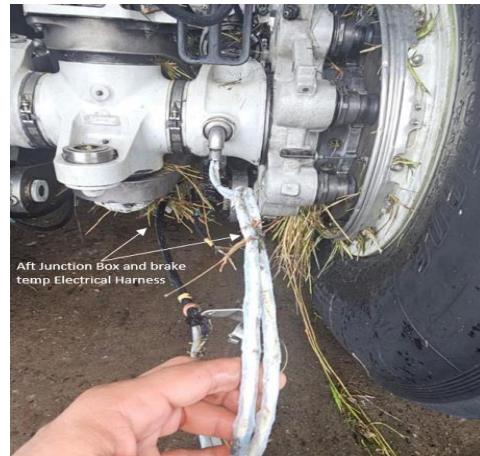
(13) Damage to all electrical harnesses out of the forward junction box. (Figure -11)

Figure 11
Electrical Harness pulled out

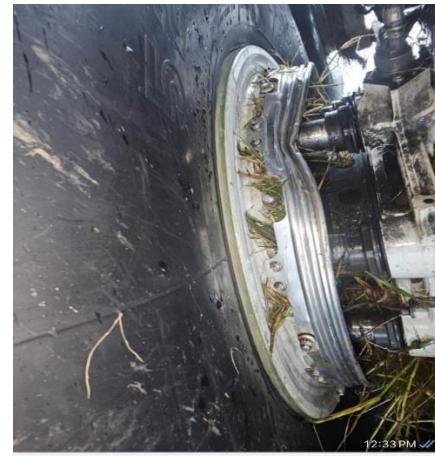
(19) Damage to all Left-Hand brake assemblies. (Figure- 12)

Figure 12
Damage to the Left-hand Brake Assemblies

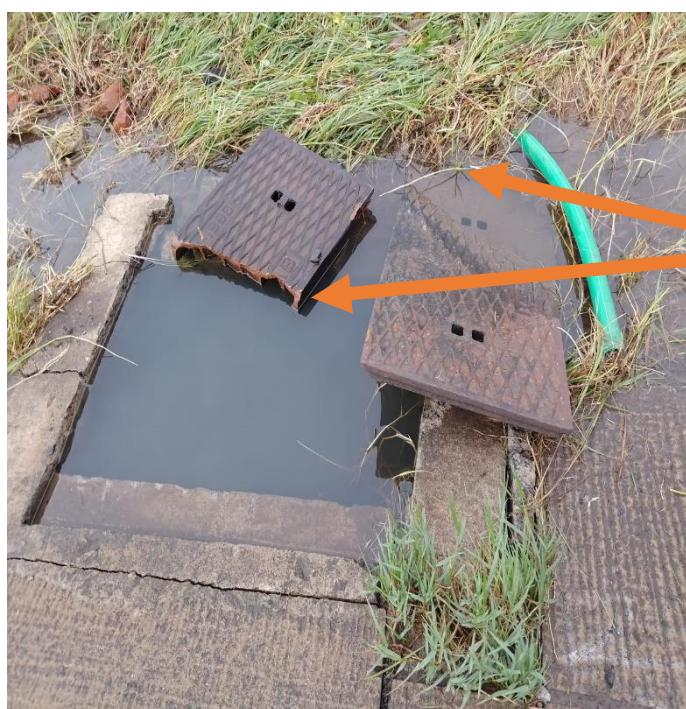
Figure- 13

(22) Concrete cable laying iron made pit-covers tops broken (Figure- 13)

Three (3) concrete cable laying iron made pit-covers and associated structures which, were located next to the runway edge line, were damaged and/or broken.

Concrete
cable
laying
iron made
pit-covers
tops broken

| 3.3.3.1 <i>Contributing Factor</i> | Contributing factor was the deteriorating changing weather of medium to heavy rain and crosswind conditions during landing. Damage to the aircraft and escalated safety risk was attributed by un-chamfered ground Cable Laying manholes. |

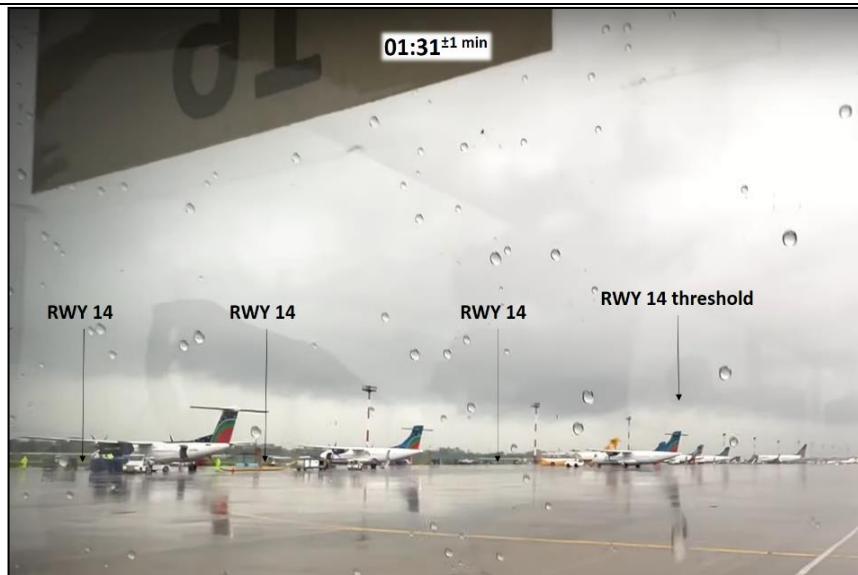
Figure- 15
Wet tarmac from recent rain. Locating sections of RWY 14 in the background are pointed out. This image was captured 11 minutes before landing.

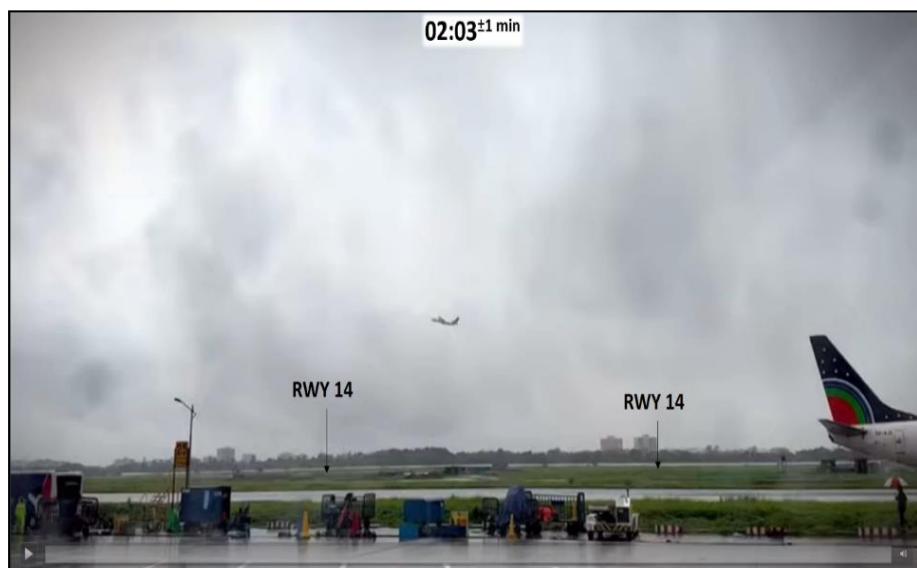
Figure 16
Visibility and cloud coverage at about 21 minutes after landing

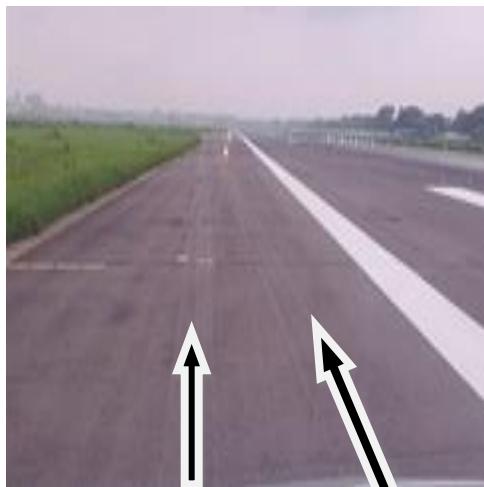
Left Outer tyres
(Figure- 20)

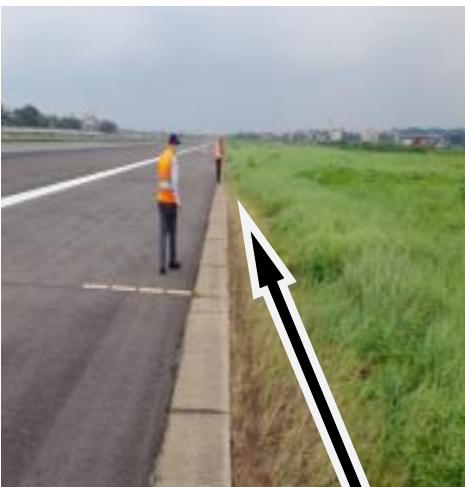
Point of left wheel getting into grass. Opposite direction of the landing (Figure- 21)

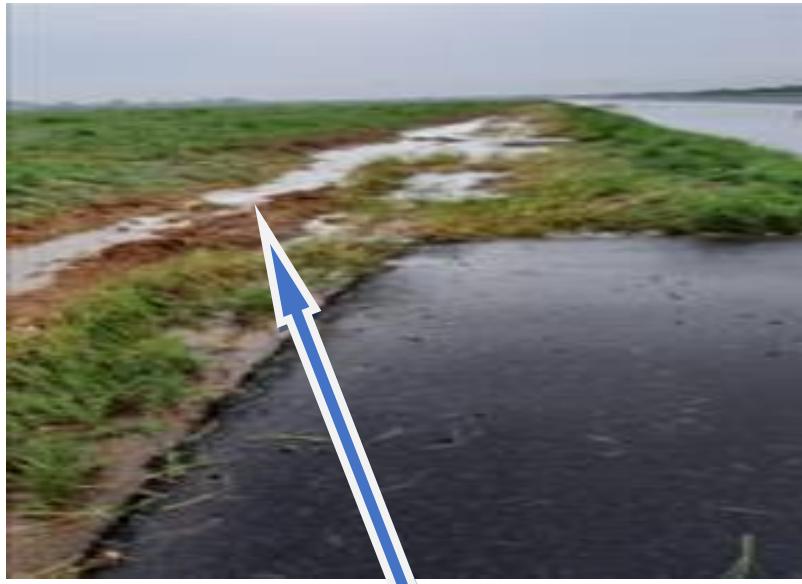
Left wheel of the aircraft touched down and rolled on the concrete outside the left RW edge Centre line. (Towards Landing direction)

Figure-22
Left wheel tyre marks on muddy grass

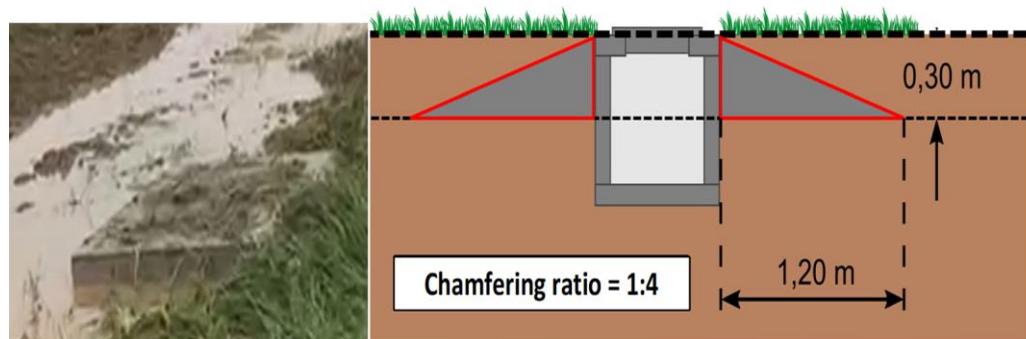
Figure-23

- (4) Previous Lateral Excursion occurrence, investigated by Bangladesh, recommended that, the aerodrome operator should consider locating and designing drains or any other underground electrical systems installation particularly for those to be installed with concrete encasement, manholes and handholds by chamfering or tapering design of the edge of those and/or locating those as far as practicable from the edge of runway. (See Figure- 23).

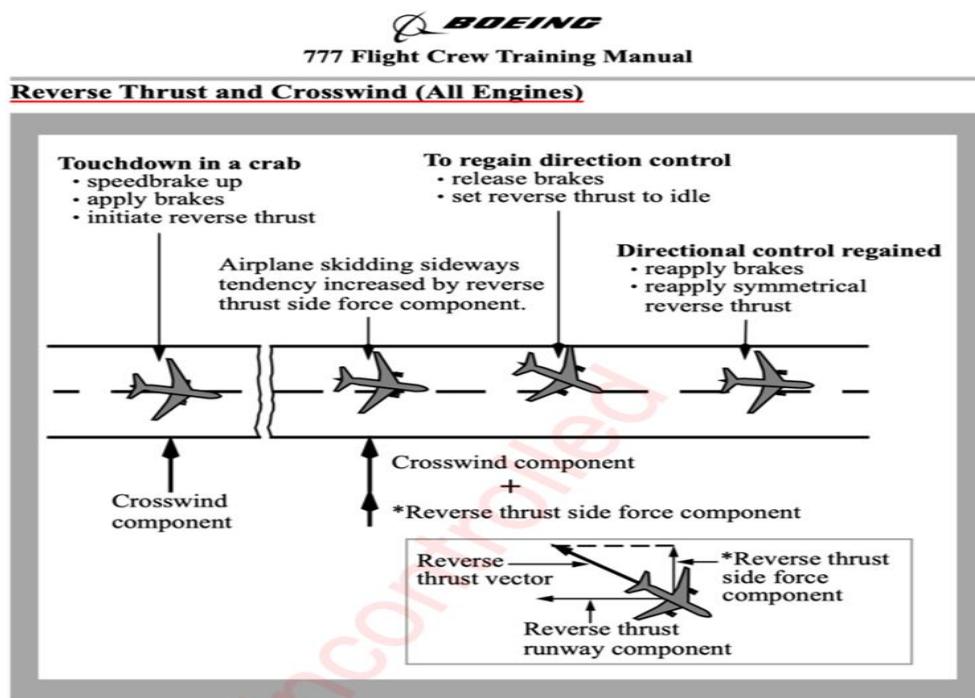
- (a) Human involvement for this serious incident was two flight crews, the PIC and the FO, who were rated and there was no evidence of their any disqualification associated with this occurrence. Both the flight crews were physically sound, well-rested and medically fit to operate the flight;
- (b) Having taken into consideration that, all Boeing commercial jet aircraft are equipped with multiple stopping systems, such as spoilers / speed brakes, thrust reversers, and wheel brakes, it is essential that Boeing 777 operating crew must be conversant and habitual with each system most effectively, specifically when the landing is made on a slippery runway. Strict observance of handling techniques specified in the Aeroplane Flight Manual and/or Operations Manual is required (see figure 24):

Figure- 24, Boeing FCTM landing on wet runway centreline correction manoeuvre
"@Boeing. Used with permission".

- (c) The investigation analyses that the given guidance by Boeing in its B-777 FCTM with regard to restoring directional control during a landing rollout on a slippery runway with a crosswind was not efficiently applied. To this reference, the Boeing guidance is given below:
