Serious Incident

Aircraft Type and Registration:	Boeing 737-8K5, G-TAWD	
No & Type of Engines:	2 CFM56-7B27E turbofan engines	
Year of Manufacture:	2011 (Serial no: 37265)	
Date & Time (UTC):	17 October 2023 at 0615 hrs	
Location:	East coast of UK, North Lincolnshire	
Type of Flight:	Commercial Air Transport (Passenger)	
Persons on Board:	Crew - 6	Passengers - 187
Injuries:	Crew - None	Passengers - None
Nature of Damage:	None reported	
Commander's Licence:	Airline Transport Pilot's Licence	
Commander's Age:	53 years	
Commander's Flying Experience:	18,000 hours (of which 1,600 were on type) Last 90 days - 291 hours Last 28 days - 86 hours	
Information Source:	Aircraft Accident Report Form submitted by the pilot

Synopsis

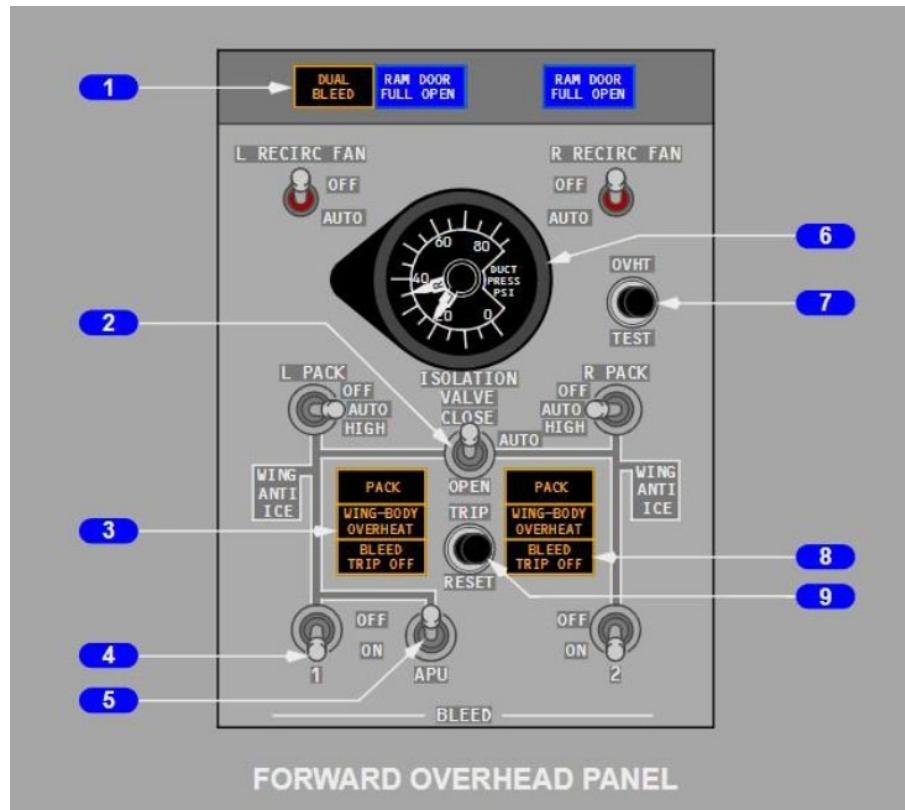
Figure 2

The engine bleed air controls and indicators on a B737-800 are on the right side of the overhead panel (OHP). The air conditioning panel is shown in Figure 2.

The engine bleed switches are indicated by the number 4. The commander pointed out the difficulty of seeing these switches from his seat position.

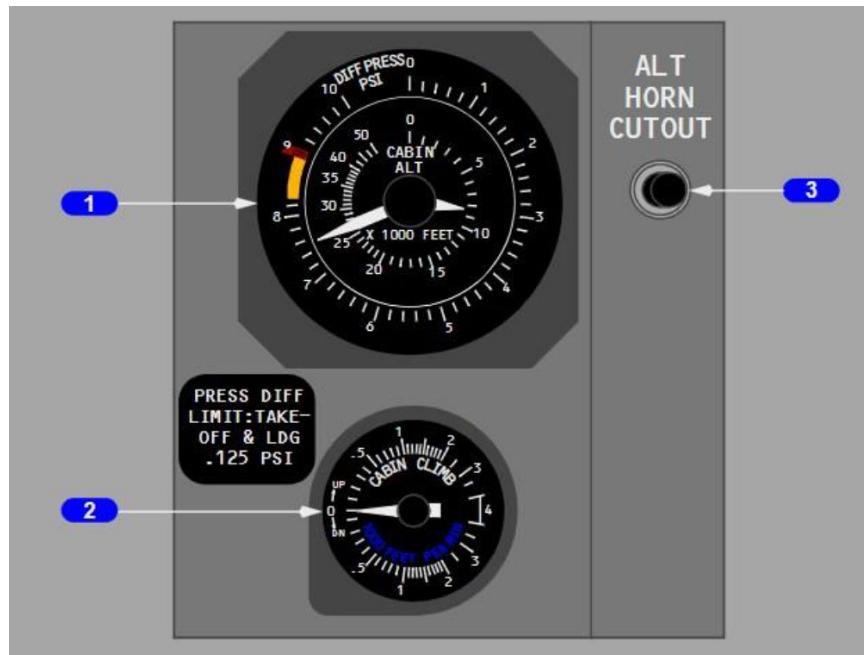
**Figure 3**

The cabin altitude indicators (Figure 3) are also in the OHP adjacent to the bleed air system controls. The cabin altitude gauge at number 1 has two needles. The longer needle indicates the cabin pressure differential to the outside air and the smaller needle indicates the cabin altitude. The gauge at number 2 shows the cabin rate of climb or descent. As these gauges are located close to the bleed switches the commander would have similar difficulty in reading them. The commander recalled the needle being between the one and 2 o'clock position on the dial but was uncertain if it was the large or small needle.

The aircraft manufacturer stated that the pressurisation system would control the cabin rate of descent at a maximum of 750 fpm. Once the bleed switches were selected ON it would have taken over nine minutes for the cabin altitude to reach 3,000 ft.
